Characterization of historic mortars and earthen building materials in Abu Dhabi Emirate, UAE

Benjamin L. Marcus¹

¹Building Conservator, Abu Dhabi Authority for Culture and Heritage (ADACH)

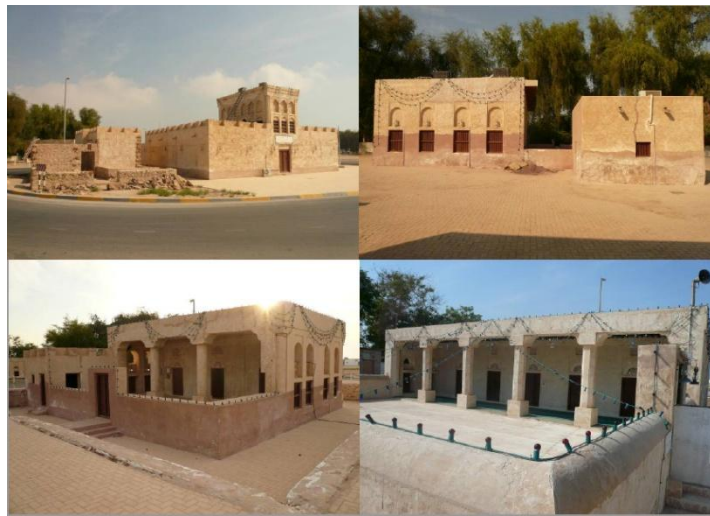
In 2009 ADACH began a conservation management plan (CMP) for four historic stone buildings located in the Old Town of Delma Island: the Bait al Muraykhi, or Pearl Merchants House, and the mosques of Al Muraykhi, Al Dawasari and Al Muhannadi (Fig. 2). Built around 1930, the decorated coral stone and plaster buildings reflect the wealth of the pearl trade, the main economic livelihood of Delma Island in the 19th and early 20th centuries. Pearl trading on Delma Island declined following World War Two and by the late 1980s the buildings had fallen into disrepair, with only one of the mosques still in active use. In 1993-94 all four buildings were restored and the Pearl Merchants House turned into a museum. However, the local coral stone and gypsum-based mortars used in the original construction and subsequent restoration contain salts that have caused significant damage to the buildings and their foundations. Structural problems, termites and the humid marine environment have also contributed to the deterioration of the exteriors and wooden elements such as doors and roof beams.

Figure 2: Clockwise from top left: Bait al Muraykhi and the Al Muraykhi, Al Muhannadi, and Al Dawasari mosques. Source: Donald Insall Associates (DIA).

Because much damage to the buildings was caused by gypsum, which expands with moisture, lime was favored as a more stable conservation material. Both hydrated and natural hydraulic lime was sourced within the UAE. To determine the right mix for the new render, over 20 different samples were installed on site employing various mixes of lime (*noura*), sand and *sarooj*, a traditional waterproofing material produced in the UAE and Oman. *Sarooj*, which is a mixture of fired clay and organic materials, is added to the mortar as a pozzolan to improve strength and decrease setting time. Multiple render samples were installed which allow conservators to test factors such as strength, porosity and bond with the wall, and thus be able to select the best mix for conservation works. The selected render will be used for conserving the damaged lower walls, repairing cracks, and potentially re-rendering the building exteriors. In addition, new drainage systems, termite treatment, and repair of exterior facades and roofs will ensure the long-term stability of the buildings.

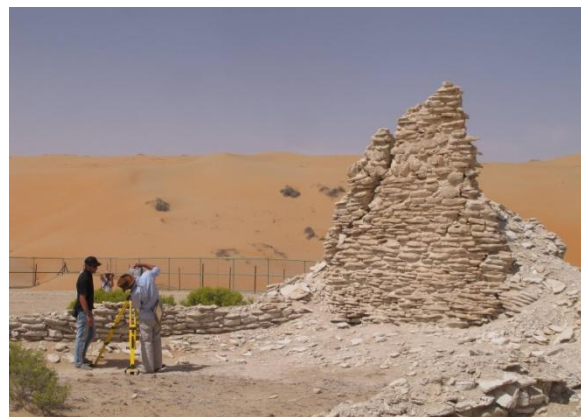
Figure 4: The site in 2011 during laser scanning. Source: photograph by author.

Qalat Umm Hisn is a ruined stone tower at the western end of Liwa oasis, near the mahdar of Arada. The UK and Saudi Memorials of 1955, drawn up at the time of the Buraimi dispute, state that the tower was built by the Manasir tribe in the early years of the Qatar-Abu Dhabi war (1883 – 1890) [4]. Originally consisting of a round tower between two low stone enclosures, today, the structure is largely collapsed with only one section of the tower wall standing (Figs. 3 & 4). Structural assessment carried out in 2010 on the standing wall highlighted the urgent need for stabilization through crack stitching, wall capping and repointing of eroded mortar joints.

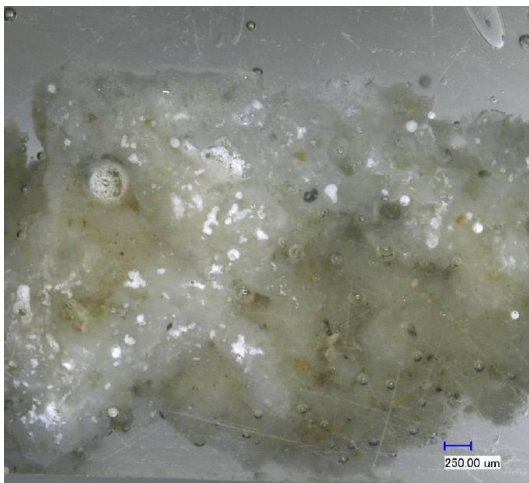
Figure 5: Resin-embedded mortar cross section under microscope. Source: Stefan Simon.

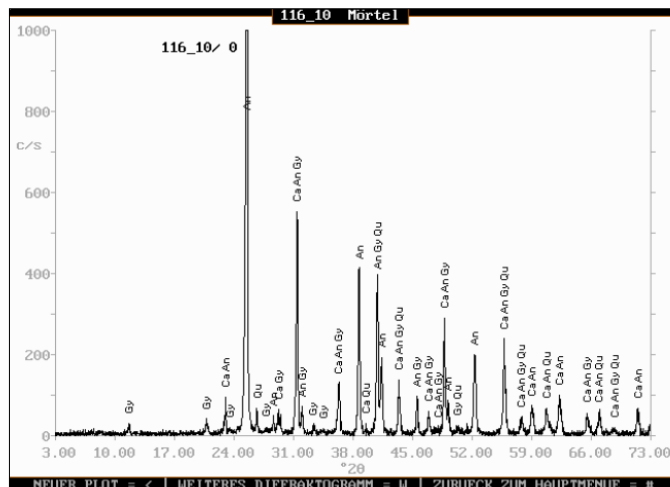
Figure 6: XRD results showing predominance of Anhydrite. Source: Stefan Simon.

Analysis revealed a composition of mainly Anhydrite (CaSO_4), which is the thermodynamically stable phase of gypsum ($\text{CaSO}_4 \cdot 2\text{H}_2\text{O}$) when it is heated above 42 degrees Celsius. The mortar is homogenous with small percentages of fine quartz, feldspar and calcite aggregate [5]. Anecdotal evidence provided by restoration craftsmen working in Liwa further clarified the source and method of mortar production. They state that the mortar is based on local gypsum stone which is mined from the valley floors between the dunes, burned using palm-wood fuel, then crushed to a powder and mixed with sand and brackish well-water to form a mortar [6]. The analysis provided information critical for developing compatible repair mortars such as the composition of the binder and the volume, size and type of aggregate. It also confirmed the use of gypsum stone suggested by the oral tradition, and will help conservators to select appropriate local materials for future testing of mortars and renders during conservation treatment.

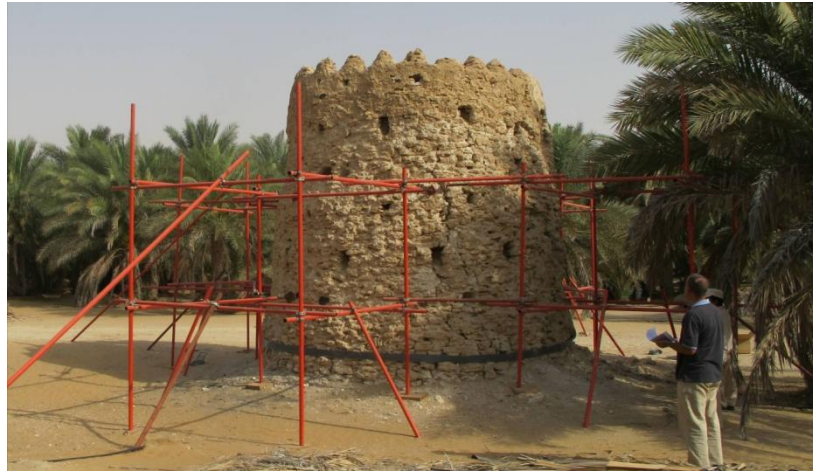
Figure 8: Hayla Tower in 2011 during installation of retaining straps. Source: photograph by author.

When first surveyed by ADACH, the tower was in extremely dangerous condition. With its roof and floors gone, the walls were left vulnerable and large cracks in the masonry had developed that threatened to cause total collapse of the structure. In 2009, support scaffolding was installed and the largest cracks were stitched with stone and mortar (Fig. 8). This was followed by additional structural stabilization including the installation of retaining straps around the tower exterior. A conservation management plan was initiated which guides conservation decisions and included documentation through 3D laser scanning and laboratory analysis of mortars.

While gypsum was identified as the main component of the building's mortar, conservators have chosen lime as a repair material over gypsum for its stability against moisture and salts. Trials of lime-based repointing mortars, injection grout, and a shelter coating were carried out in June 2011. As at Delma, various mixes of lime, coarse sand and the pozzolanic *sarooj* were tested on a small area of the tower. After evaluation of the trial mortars, taking into consideration factors such as strength, adhesion, color and porosity relative to adjacent materials, full conservation treatment will be implemented followed by fencing, signage, and interpretive features to make the site accessible to visitors.

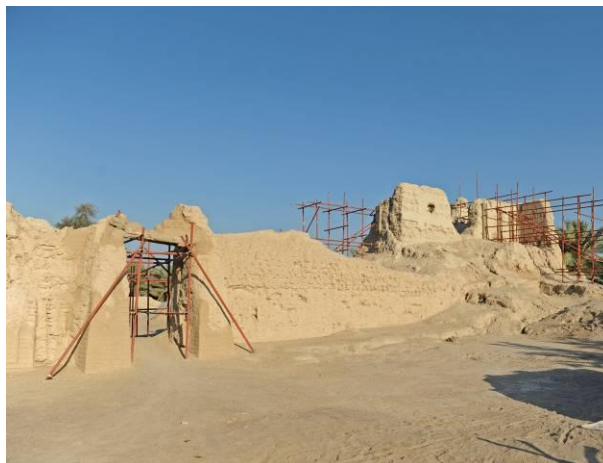
The Hamad bin Hadi al Darmaki House is an earthen structure located in Hili Oasis in northern Al Ain. Comprising several rooms and a tower situated around a courtyard, the site is enclosed with high earthen walls that rise several meters above the surrounding oasis (Fig. 9). Materials analysis including X-ray Diffraction (XRD), X Ray Fluorescence (XRF), and soil mechanics was carried out in 2007 to characterize the mud bricks and understand different phases of construction. Material sampling was carried out in two stages: first, 9 samples were taken for various tests, including 5 mud-brick samples, 2 plaster samples, 1 mortar sample, and 1 stone sample; the second stage was a continual study of the mud-bricks during which two more samples were taken. Since a number of different sizes of mud bricks were found, this study helped to identify the right size of mud bricks to be used in conservation.

Figure 9: Hamad Bin Hadi al Darmaki House, 2011.

The materials analysis at Bin Hadi house also confirmed the suitability of the clay from the Al Saad area for conservation, as it contained comparable quantities of montmorillonite and other key minerals that indicate compatibility with the historic bricks. The clay was taken from the source and combined with straw and sand to make mud bricks and plasters for repairing damaged areas. Many of these repairs have been in place for over five years with little damage or alteration, demonstrating their compatibility and the success of the analysis in determining appropriate conservation materials.

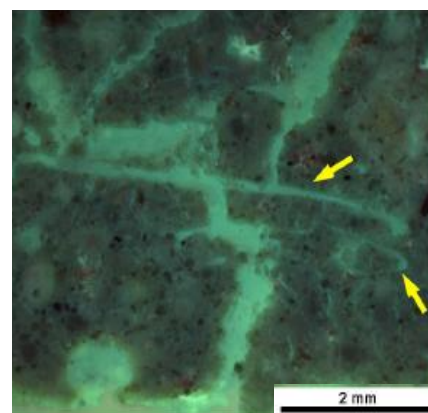
Microscopic analysis revealed a number of factors important to understanding the site's decay process; microscopy showed an extremely fine-grained material with few large particles. The sand fraction is limited to a maximum grain size of ca. 0.3mm, and the majority of the material is silt or clay sized fractions. Such fine grained material is much more susceptible to cracking than earthen material made with graded aggregates. Microscopy also showed elongated voids, indicating that the mud-bricks and plaster may have originally been reinforced with vegetable fiber (a practice that continues today) but that the fibers have disintegrated over time (Fig. 12).

Figure 12: Microscopic image showing elongated voids under UV light. Source: Christof Ziegert, ZRS.

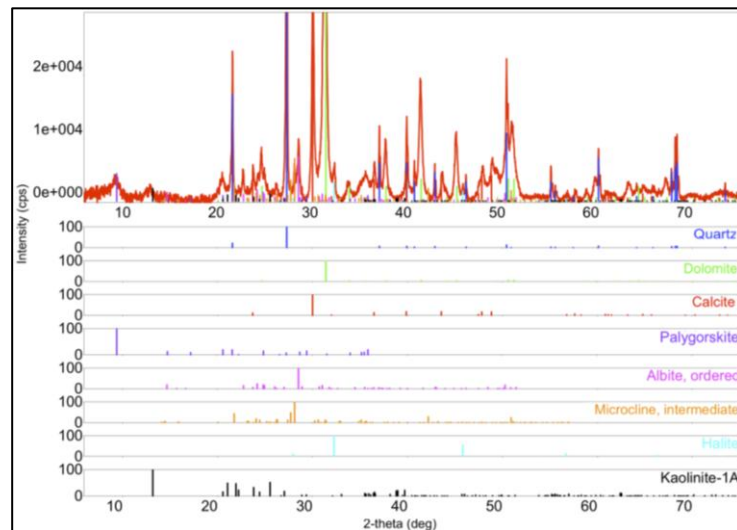
XRD results (Fig. 13) included minerals such as dolomite, kaolinite, calcite and albite. It also revealed the presence of swelling clays such as palygorskite, which is often associated with smectite [12]. Smectites are fibrous clays with small particle sizes and large internal surface areas. They have negative layer charges which allow them to absorb several times their weight in water. The presence of this type of clay, combined with precipitation and atmospheric moisture causes expansion and contraction of the clay surface and the subsequent cracks and deterioration seen at Hili 17. XRD also revealed a high concentration of halite (NaCl), or sodium chloride. Further testing using electrical conductivity showed nearly double the amount of soluble salts at the bases of the walls as at the tops. The high salt content may explain the deterioration of the lower walls, as wetting and drying causes cyclical salt dissolution and re-crystallization that erodes the wall.

Figure 13: Results of XRD analysis showing presence of swelling clay (palygorskite) and salts (halite). Source: Cristof Ziegert, ZRS.

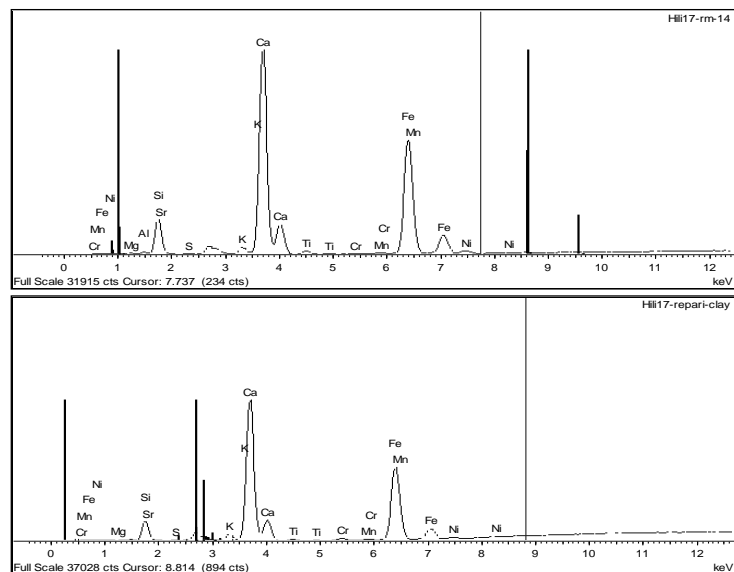
Figure 14: XRF results showing comparable composition of historic material (above) and repair clay (below). Source: Univ. of Sharjah.

XRF Analysis (Fig. 14) showed comparable amounts of key elements calcium, iron, magnesium, and silicon, and indicated that the new clay was indeed similar and compatible with the original. Based on the analysis results, the identified clay was mined from the source layer and brought to the ADACH workshop for further field testing. This white clay is used to make mud bricks, plasters and grouts for the repair of damaged areas.
