# The evaluation of damage mechanism of unreinforced masonry buildings after Van (2011) and Elazig (2010) Earthquakes

D Güney<sup>1</sup>, E Aydın<sup>2</sup>, B Öztürk<sup>3</sup>

**Abstract.** On March 8<sup>th</sup>, 2010 Karakocan-Elazig earthquake of magnitude 6.0 occurred at a region where masonry and adobe construction is very common. Karakocan-Elazig is located in a high seismicity region on Eastern Anatolian Fault System (EAFS). Due to the earthquake, 42 people were killed and 14'113 buildings were damaged. Another city, Van located at South east of Turkey is hit by earthquakes with  $M = 7.2$  occurred on October 23<sup>rd</sup>, 2011 at 13:41 (local time), whose epicenter was about 16 km north of Van (Tabanlı village) and  $M = 5.6$  on November 9<sup>th</sup>, 2011 with an epicenter near the town of Edremit, south of Van and caused the loss of life and heavy damages. Both earthquakes killed 644 people and 2608 people were injured. Approximately 10'000 buildings were seriously damaged. There are many traditional types of structures existing in the region hit by earthquakes (both Van and Elazig). These buildings were built as adobe, unreinforced masonry or mixed type. T

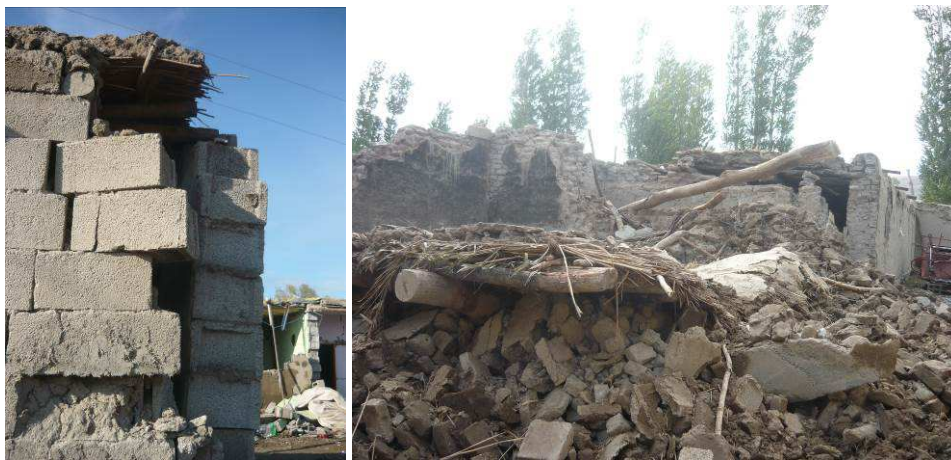
One of the most important reasons was the use of improper construction material. Rubble stone, briquette and soft stone blocks were the masonry materials widely used in the damaged or collapsed buildings. Their quality is low and production is out of standard. Therefore low quality materials caused serious damages as shown in Figure 11.

**Figure 11.** Low quality briquette and adobe

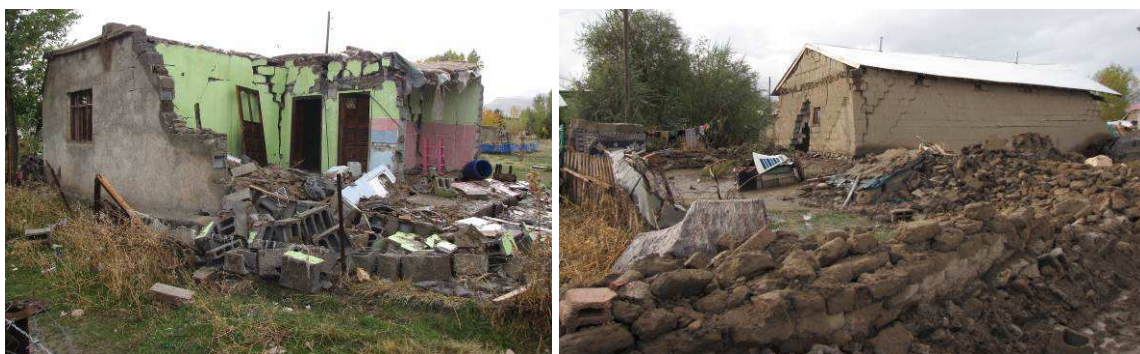
The use of mud mortar for adobe and briquette blocks cause low lateral force resistance. Mud as mortar has low strength and has poor bonding characteristics. As a result of this, masonry buildings performed very poor lateral resistance to seismic forces and damaged or collapsed easily as shown in Figure 12.

**Figure 12.** Improper mortar use such as mud

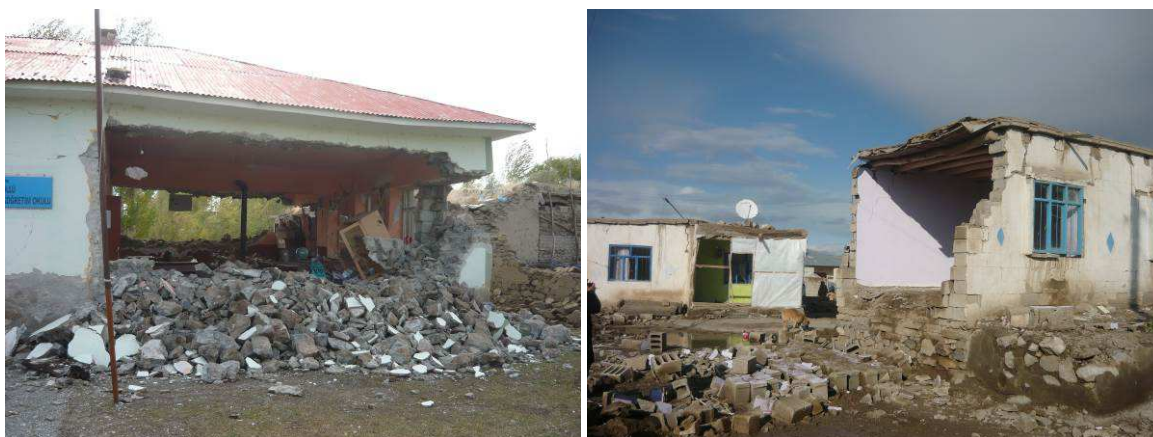
In addition to previous reasons, construction method is also against basic structural design criteria. Wall-to-wall and wall-to-floor connections are very poor. Therefore infill walls collapsed easily during the earthquake as shown in Figure 13.

**Figure 13.** Poor wall-to-wall and wall-to-floor connections

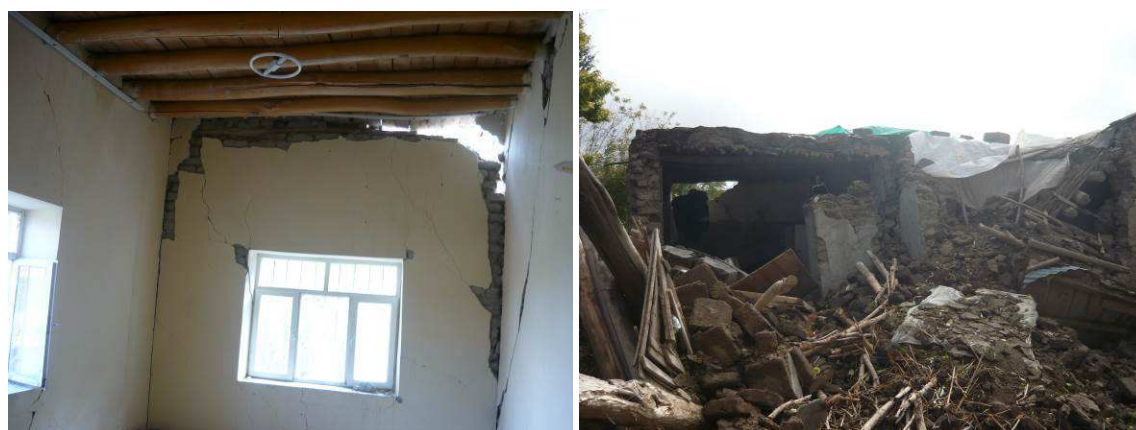
Many damaged buildings have flexible floor diaphragm, which prevents the transfer and distribution of lateral forces in a uniform manner as shown in Figure 14.

**Figure 14.** Flexible floor diaphragm

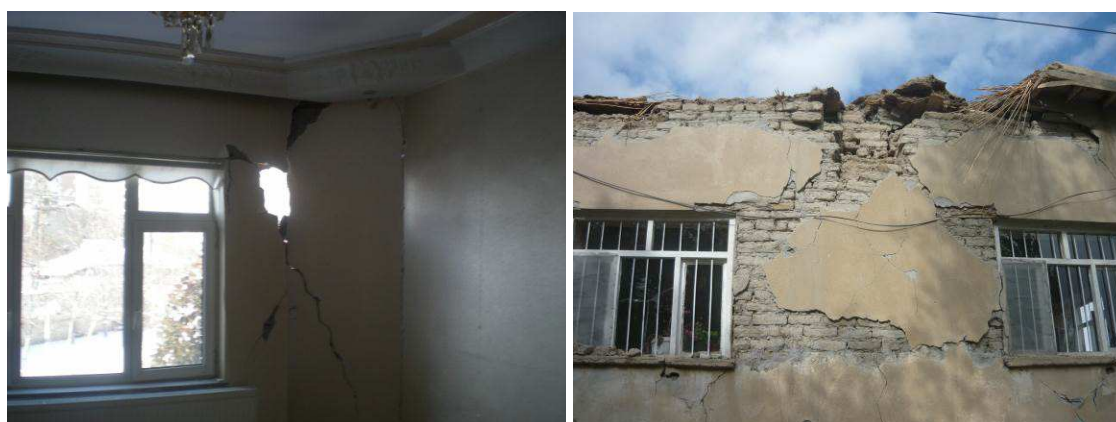
Improper placement of door and window openings in walls caused serious damages in the region, which creates vulnerable and weak zones in the structure as shown in Figure 15.

**Figure 15.** Improper placement of door and window openings
