## The experience of retrofit design in using CFRP of building case study of the ramp structure of palm oil mill in South Sumatera

Johannes Tarigan and Albert Simbolon

Departement of Civil Engineering, Universitas Sumatera Utara, Medan, Indonesia

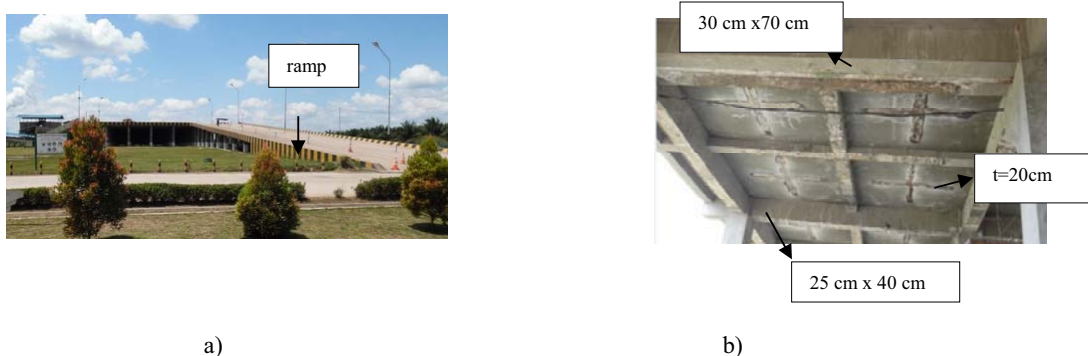
The analysis steps were collection of as-built drawing, the concrete quality check, and the field visit to visually examine the condition. The construction of the ramp structure can be seen in Figure 1a, in which the length of the ramp is 104 m and the width is 20 m. The space between columns is 8 m in both longitudinal and transversal. The plate was designed with a two-way slab with a span of 4 m. The dimensions of the primary beam are 30 cm x 70 cm, the secondary beams are 25 cm x 40 cm, and the slab thickness are 20 cm.

**Figure 1.** a) the span of Oil Mill in South Sumatera, b) the structural condition

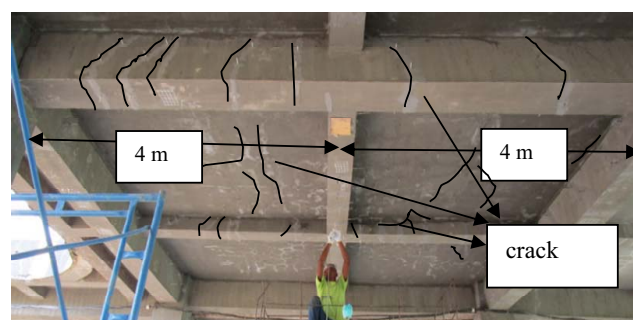
Meanwhile, the damage can be seen in figure 2. The type of damage was cracks in the primary beams, the secondary beams, and the slabs. The cracks occur along of the primary beams, the secondary beams, and the slabs. In accordance with the survey results, there was no significant deflection of the beams. No crack was found at the columns, and no differential settlement was also found in the foundation.

**Figure 2.** The cracks on the primary beams, the secondary beams, and the slabs.

The next step was the analysis of the cracks. There are three types of cracking which are physical crack, chemical crack, thermal crack, and structural crack. The types of cracks occurred in palm oil mill were the physical crack and the structural crack. Therefore, to repair the structural crack, CFRP was used, and physical crack was handled with chemical injection.

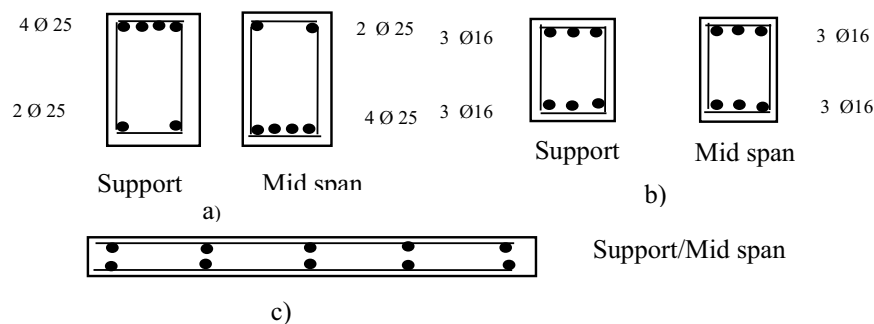
The reinforcement of the primary beams, the secondary beams, and the concrete slabs of the ramp of Palm Oil Mill can be seen in figure 3, which are according to the as Built drawings that plain bar have been used. For the concrete according to the investigation it has been found that the quality of concrete around 20 Mpa. According to an Indonesian Standard, the concrete class is  $f_{c'} = 20 \text{ Mpa}$  [1], and the steel reinforced class is BjTP 24 [2].

**Figure 3.** a) Existing primary beams, b) Secondary beams, and c) Slabs

For the secondary beams with the size of 25 cm x 40 cm, in which the upper side of the mid span reinforcement was 3 Ø 16 mm and the lower side was 3 Ø 16 mm, the moment capacity which occurred was  $M_d = z_1 \cdot F_s = 0.332 \times 65 = 21.58$  kNm, while the moment which occurred was 37.3 kNm (unsafe for the negative moment).

Based on the calculation, it can be concluded that the secondary beams were unsafe and need retrofitting.

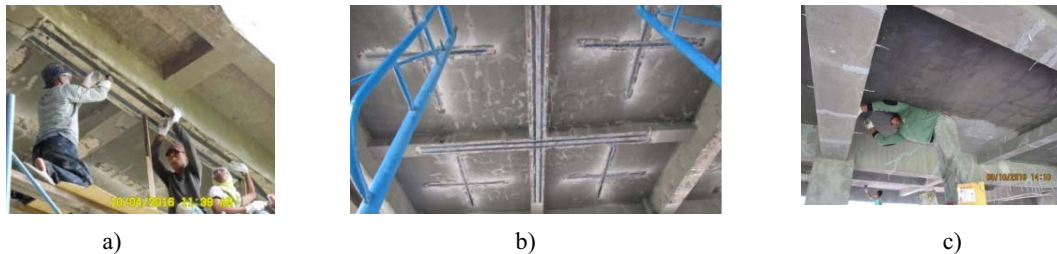
**Figure 8.** a) CFRP installation on the primary beams, b) CFRP installation on the secondary beams and the slabs c) injection at the crack of the beams and the slabs

For the primary beams and the secondary beams have been added with two strips of CFRP (thickness of 1.2 mm and a width of 100 mm), while in the slabs, one strip of CFRP with a thickness of 1.2 mm and a width of 100 mm was added. The calculation result can be seen in table 2, showing the moment capacity with and without CFRP.

The retrofit of ramp structure can be shown in figure 8 which are CFRP have been used. Figure 8a showed the strengthening of the primary beams, figure 8b showed the strengthening process using CFRP in the secondary beams and the slabs, while Figure 8c showed the injection process at the cracks in the beams and the slabs.

In the selection of repair selected method was using strengthening with CFRP. The strengthening process was conducted by adding two strips of CFRP with a thickness of 1.2 mm and a width of 100 mm in the primary beams and the secondary beams, while only one strip of CFRP added in the slabs. Now, the improvement was finished, and the project operated well.
