# Identification of corrosion and damage mechanisms by using scanning electron microscopy and energy-dispersive X-ray microanalysis: contribution to failure analysis case histories

**G Pantazopoulos and A Vazdirvanidis**

ELKEME Hellenic Research Centre for Metals S.A., 252 Pireaus Street, GR-17778 Athens, Greece

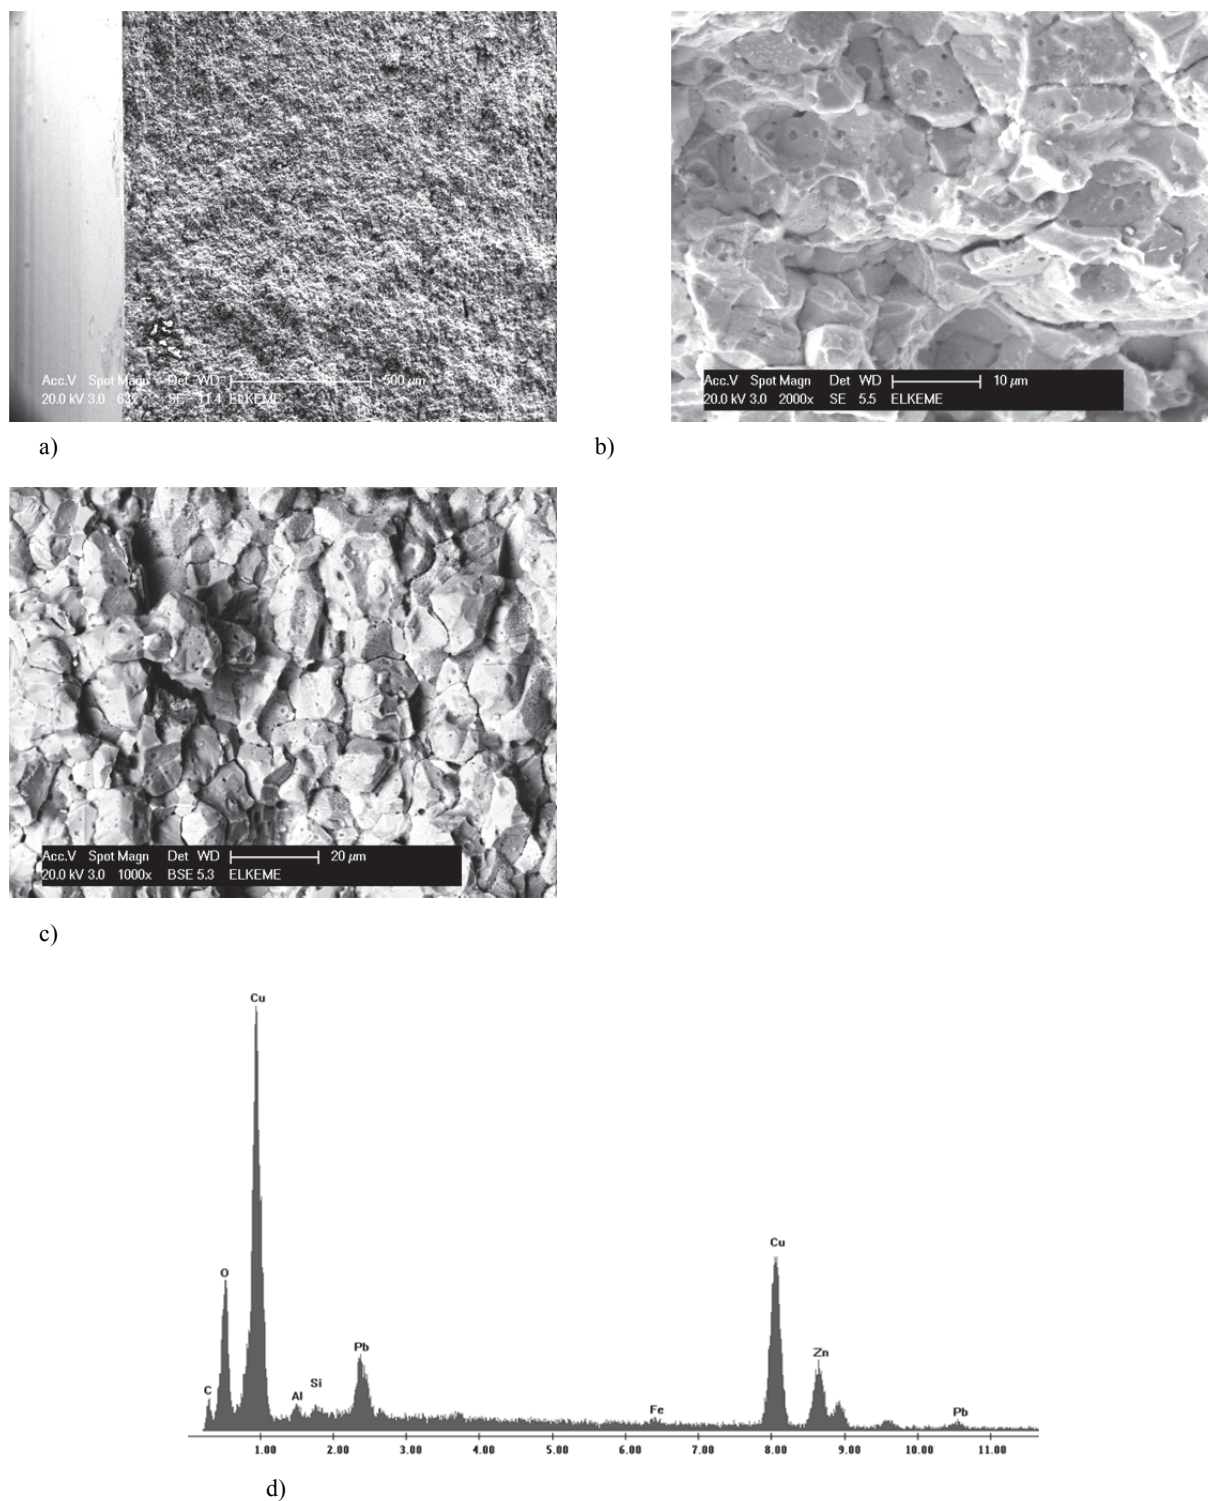
Water distributor is a component that is used in various plumbing installations, dividing and adjusting the main water supply flow to various stream lines for further use. Fracture surface examination of a brass distributor revealed a characteristic intergranular fracture mode, while the surface was covered by corrosion products (figure 1). SEM observations of a transverse section indicated intergranular cracking with multiple branching, which strongly suggests the occurrence of stress corrosion cracking (SCC) (figure 2). The SCC process is induced by the synergistic action of corrosive environment and stress fields (e.g., residual or applied tensile stresses from component fabrication and/or over torque during installation). The material sensitivity against SCC is enhanced to be result of surface work hardening (due to cold working from machining operations) and local stress concentration imposed by abrupt section/design changes. SCC is initiated on the metal surface and is favoured by three main contributing factors: sensitive material, residual or applied tensile stresses and corrosive environment. SCC is considered as a delayed failure process, where cracks are initiating and propagating at slow rates until stresses applied in the remaining section exceed the fracture strength of the material. SCC is also termed in copper and copper alloys systems as “season cracking” and is mainly promoted by the presence of  $\text{NH}_3$  and humidity and it is a more common failure mode for cold worked brasses with more than 15 % Zn. Two main models of SCC general corrosion mechanism are proposed [3]:

**Figure 1.** a-c) SEM micrographs (BSE and SE imaging) showing the fracture surface of the ruptured brass component; note the intergranular fracture mode; d) EDS spectrum indicating the elemental chemical composition of fracture surface – the presence of Cu, Zn oxides is evident (ZAF corrected - standardless).

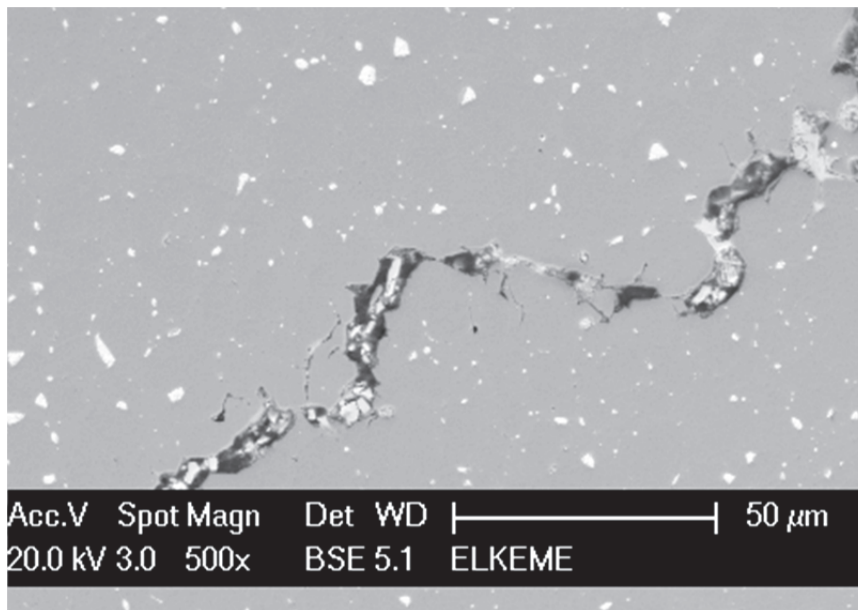
**Figure 2.** SEM micrograph of as-polished section, transverse to the main crack direction, depicting intergranular cracking and secondary branching remaining also as characteristic indications of SCC in machineable brass. The areas of white contrast in the matrix correspond to lead particles that segregated preferably at grain boundaries.

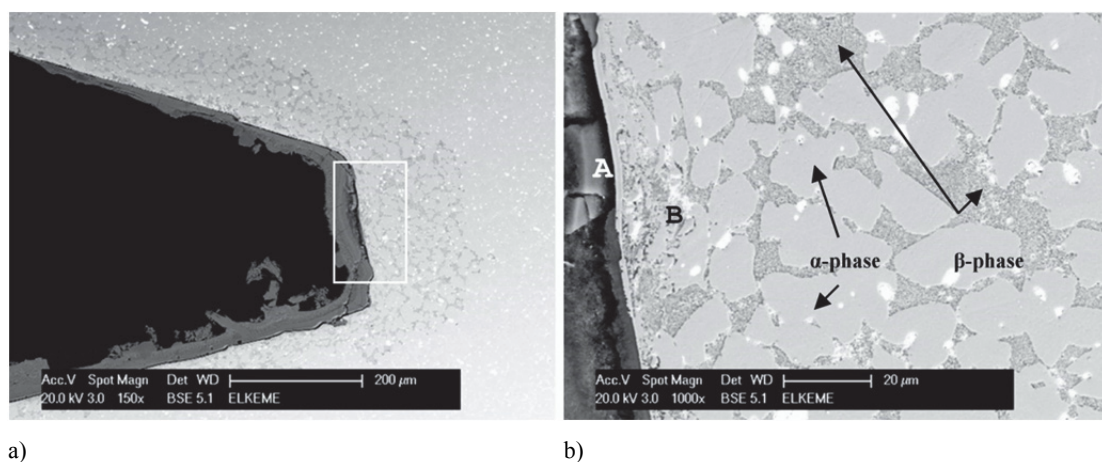
A threaded brass component demonstrated progressed dezincification, reaching a depth up to  $\sim 100\ \mu\text{m}$  (figure 3). Dezincification kinetics follows a parabolic rate law controlled by diffusion, see also [7]. In two phase  $\alpha+\beta$  brass alloys the difference in electrochemical potential of the adjacent phases establishes a galvanic coupling, stimulating selective dissolution of Zn ions originating mainly from the  $\beta$ -phase, followed by an equilibrium concentration among neighbouring grains. The degradation of the  $\alpha$ -phase occurs at an advanced stage of the dezincification process. In parallel migration through the porous network aggravate the corrosion conditions, accelerating dissolution leading to chemical attack on copper, through the formation of  $\text{CuCl}_2^-$ -complex anions. Sensitivity of brass dezincification is significantly reduced in case of single  $\alpha$ -phase brass and especially for Zn contents lower than 15 %, see [8].

**Figure 3.** a) BSE-image of as-polished section showing a dezincification area in the threaded brass component. b) Detail of the boxed area presented in a). The morphology of corrosion layer suggests that it is the result of layer (uniform) dezincification.

The addition of minor alloying elements, such as Sb and As operating as inhibiting constituents, improves significantly the dezincification corrosion resistance of brasses in aqueous service environments. Depending on service environment conditions (e.g., temperature, corrosive media), two main forms of dezincification are encountered: uniform and plug-type (localized) dezincification, where penetration is steep and leads very frequently to perforation and leakage [9]. SEM micrographs and EDS spectra showing the form of degradation and Zn concentration gradients and selective attack of  $\beta$ -phase, due to differential Zn dissolution are shown in figures 3 and 4.

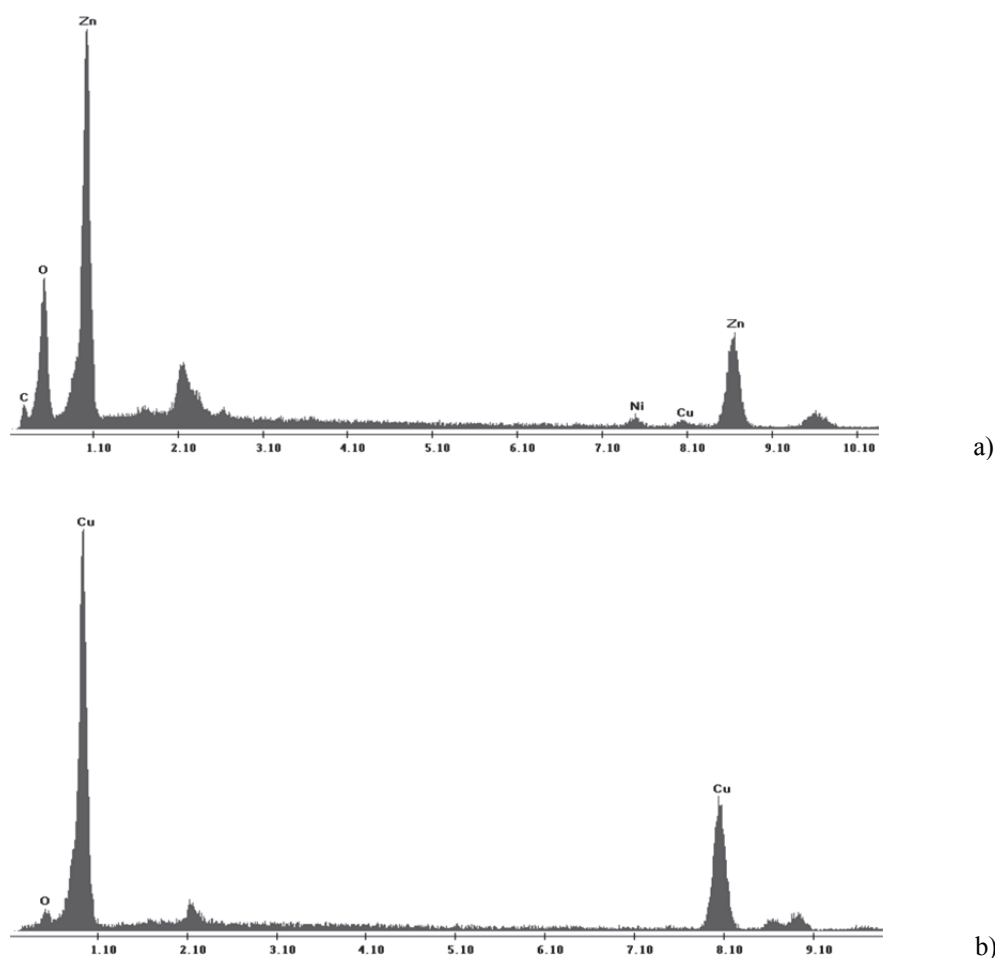
**Figure 4.** EDS spectra (ZAF corrected - standardless). a) The scale consisting mainly of ZnO (approximate location – A in figure 3b; b) the Zn depleted area showing predominantly the presence of Cu (approximate location – B in figure 3b).

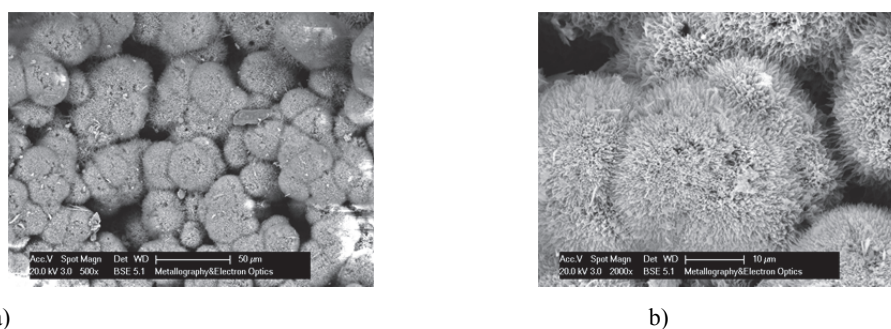
failure was found. The nature and stacking sequence of scale deposits, addressing the operated corrosion phenomena, was evaluated by SEM-EDS analysis. The examination of outer surface scale (green copper patina) indicated the presence of characteristic spherical nodules composed of acicular crystals, corresponding to complex copper carbonates (malachite), see figure 5. Transverse sections adjacent to the leakage area were made to highlight the form of corrosion. The inner tube surface suffered from severe pitting corrosion, while corrosion product inner surface deposits located on that area fell in to two main categories: mixed hydroxides-chlorides on the floor of the pit, copper oxide crystals ( $\text{Cu}_2\text{O}$ ) and outer-thick copper hard scale (e.g., carbonates), see figure 6.

**Figure 5.** SEM micrograph (BSE images). a) Pit cap surface showing the presence of characteristic nodular aggregates composed of malachite crystals; b) detail of a) revealing the acicular nature of malachite crystals.

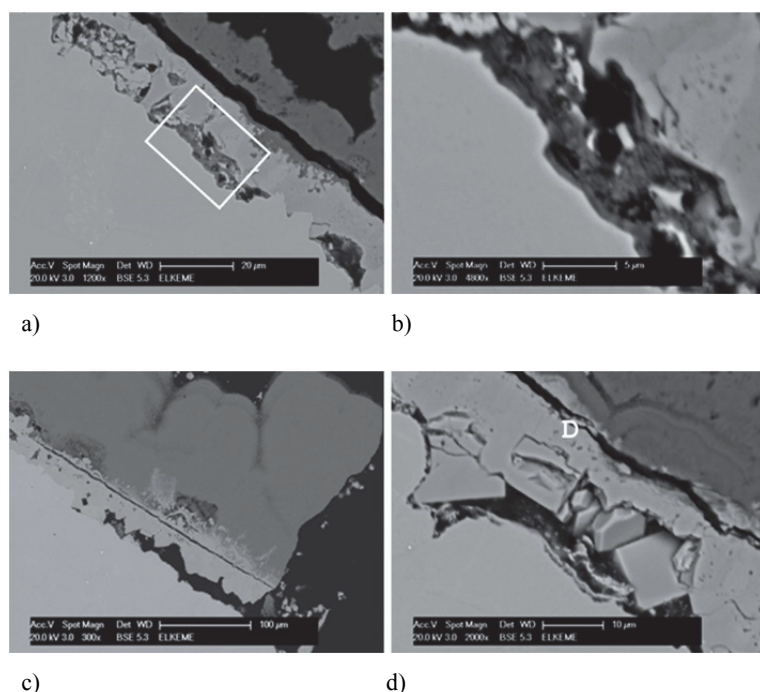
**Figure 6.** SEM micrograph (BSE images) of a polished transverse section of the corroded inner surface of a CuDHP water tube. a) Layered structure of corrosion products: mixed copper chlorides alternating with copper oxide ( $\text{Cu}_2\text{O}$ ) and on top copper carbonates; b) the rectangular area outlined in a) at higher magnification; c) nodular malachite crystals on the pit cap at another location on the transverse section; d) cubic oxide crystals close to the metal/oxide interface.

Perfectly formed cubic copper oxide crystals ( $\text{Cu}_2\text{O}$ ) are found underneath the carbonate deposits (see figure 6d) while discontinuous layers of mixed copper chlorides were detected on the floor of the pit. Though the presence of complex hydroxyl-chlorides compounds such as  $\text{CuCl}_2 \cdot 3\text{Cu}(\text{OH})_2$

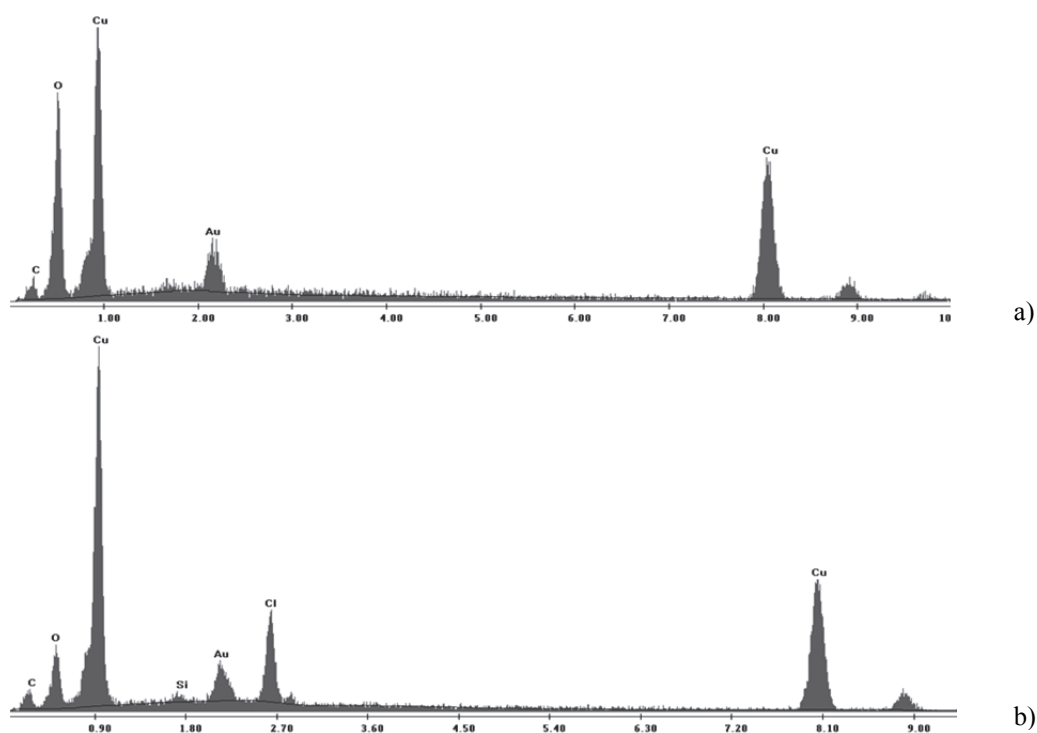
initially decreases the corrosion rate, their porous nature and poor adhesion to the base metal frequently leads to detachment and loss of the film sustaining the corrosion process [10]. Selective area elemental analysis conducted by EDS, verified the presence of mixed hydroxy-chlorides and carbonates (figure 7). The presence of carbonates and chloride salts causes cold water type pitting corrosion, referred to as Type I-pitting (see also Refs. [11-12]). Type I pitting is a very severe form of corrosion, leading to accelerated corrosion rates, and it is influenced by the concentration of chlorides and bicarbonates. Corrosion pits can provoke failures through stress corrosion cracking (SCC) as they constitute stress concentration sites. Failure analysis of copper tube affected by the synergy of pitting corrosion and SCC is presented in [13]. Several case histories of copper tube damage in service, including SCC, microbiologically influenced corrosion (MIC), pitting corrosion and fatigue are reviewed in [14, 15]. In the majority of the investigated cases, water supply conditions and quality were the major failure contributors. Water chemistry (physicochemical and microbiological parameters including pH, conductivity, total organic carbon, etc.) should be investigated to pin-point precisely the root cause of the leakage failure. Regular water quality monitoring during installation together with sufficient maintenance and appropriate water treatment (adjusting salinity and hardness as well as dosing corrosion inhibitors and controlling the microbial content) as well as avoidance of stagnation periods are suggested as further actions to prevent corrosion failures.

**Figure 7.** EDS spectra (ZAF corrected – standardless analysis). a) At the surface of the pit confirming the presence of copper carbonate crystals (malachite) – approximate location D in figure 6c; b) Scale attached to the metal substrate consisting of mainly copper (hydro)oxide-chlorides (approximate location – C in figure 6b). Note the presence of significant Cl, considered to be a contributing factor to passive layer destabilisation and pitting initiation. Also note that the energy scale is different on spectra a) and b).
