Fracture Failure Analysis on a Bolt

Chunxia Fu^{1,*}, Facai Ren², Jiakun Hu³

Abstract—A bolt used in the production equipment broke during the use. This paper analyzes the root cause of bolt fracture. Through the analysis on the chemical composition, mechanical properties, microstructure, micro morphology and micro area composition of the broken bolt, it is considered that the physical and chemical properties of the bolt meet the requirements of the standard. Because of the existence of machining cracks, the bolt is affected by the stress in the use process, resulting in fatigue fracture.

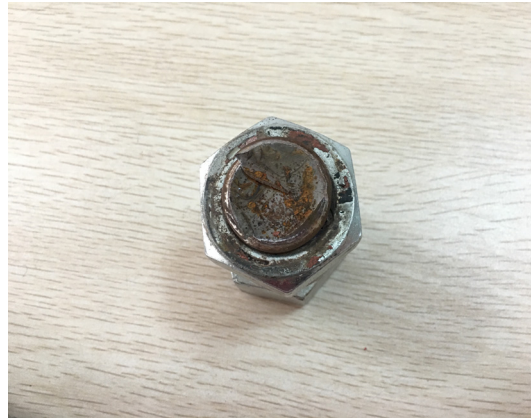
The bolt surface has been galvanized, and most of the fracture surface has been rusted. See Fig. 1. From the cross-section, there are two fatigue sources, both located at the bottom of the thread, and the two fatigue sources differ by one pitch in radial direction. No obvious plastic deformation is found on the fracture surface.

Figure 1. Bolt fracture surface.

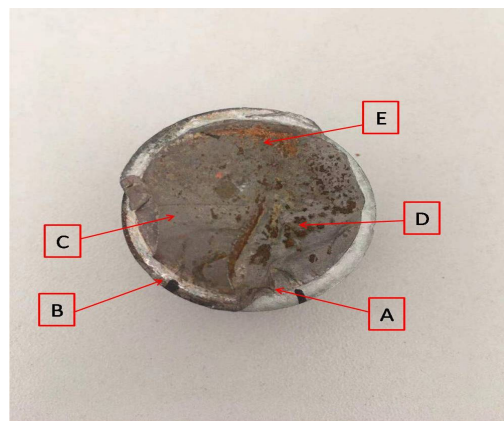
The bolt fracture surface is roughly divided into three areas: Area A and B are the starting point of fracture, belonging to the fatigue source area; area C and D are the fatigue extension area, with obvious fatigue fracture characteristics such as bainite lines; area E is the instantaneous fracture area, with relatively small area, rough fracture surface, and a small area of shear lip shown in Fig. 2. The fracture property of the bolt can be preliminarily judged as fatigue fracture by the macroscopic characteristics of the cross section.

Figure 2. Different regions of fracture surface.

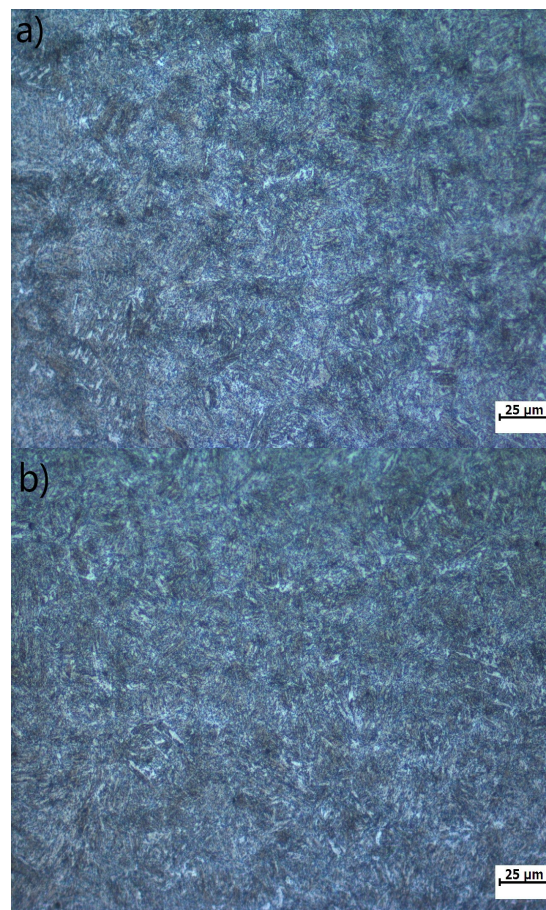
Take a metallographic analysis on the sample from the crack place using Imager.A1M microscope and the microstructure is tempered sorbite which is shown in Fig 3.

Figure 3. Microstructure of crack area.

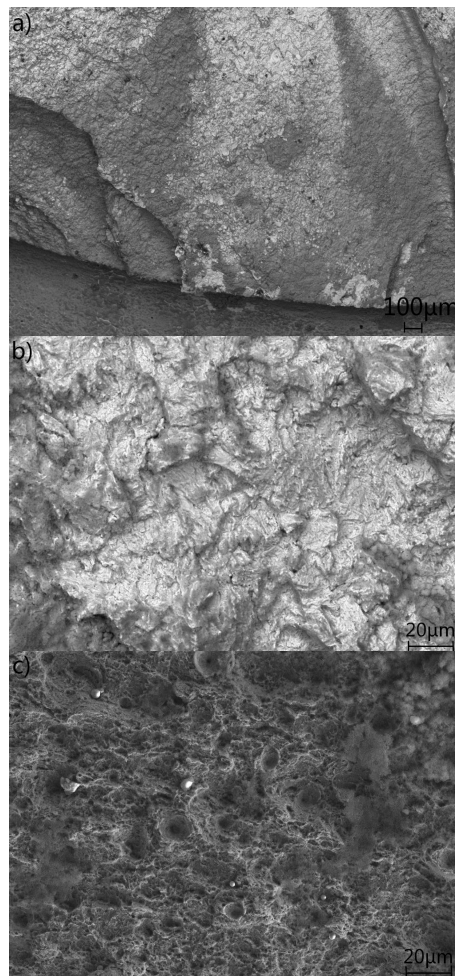
The micro morphology of the fatigue source region, the fatigue propagation region and the instantaneous fracture region were analyzed by using Quanta200 SEM as shown in Fig. 4. The fracture appearance of the extension area shows muddy flower pattern which is the typical pattern of stress corrosion [4].

Figure 4. Micro morphology of different fracture areas (a) The starting point of fracture (b) The fatigue extension area (c) The instantaneous fracture area.

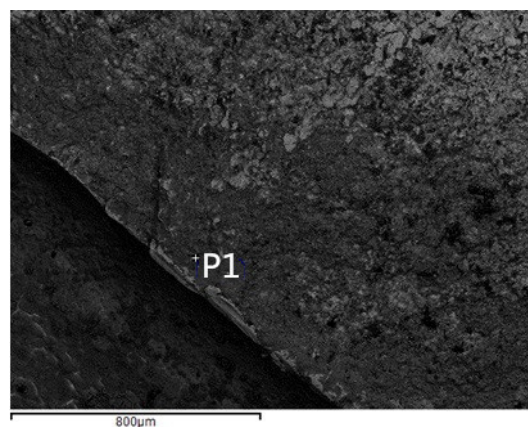
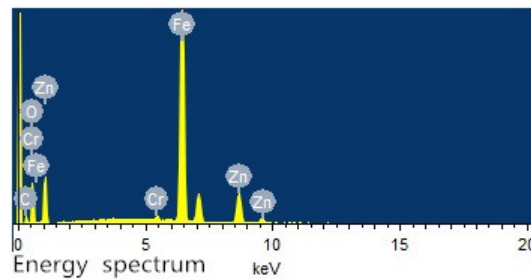
It is found that there are a lot of zinc in the fatigue source by analyzing the composition of the fatigue source as shown in Fig. 5. No zinc is found far away from fatigue source as shown in Fig. 6.

Figure 5. Energy spectrum of fatigue source.

According to the results of micro region composition, a large number of zinc is found in the fatigue source, but not in the area far away from the crack source. Under normal circumstances, there should be no large amount of zinc in the fatigue source. The bolt is subject to over heating galvanizing treatment, so the zinc inside the fatigue source should be infiltrated into the fatigue source by the zinc liquid. That is to say, there are microcracks on the bottom of thread before galvanizing.

The existence of microcracks at the bottom of screw thread is the direct cause of bolt fracture. When the bolt works under stress, the microcracks continue to expand, which eventually leads to fracture failure.

For bolts under stress, micro crack detection should be carried out before use to eliminate the fatigue source caused by processing factors.

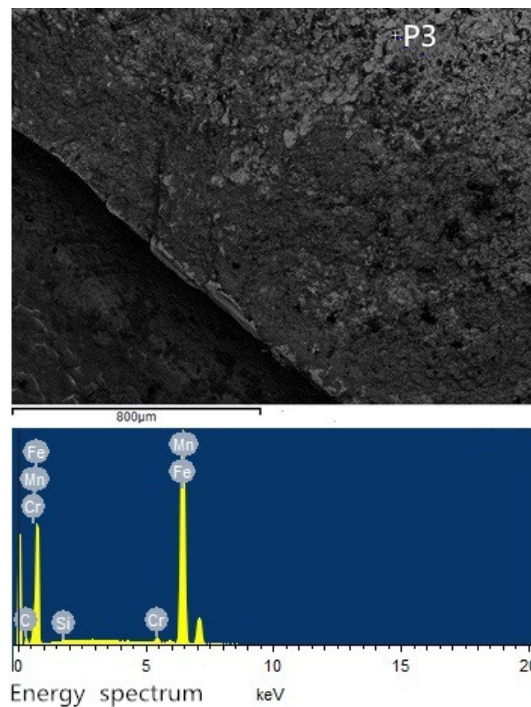
Figure 6. Energy spectrum away from fatigue source.
