# Defect Analysis and Process Improvement of Metal-Oxide Arrester

Liwei Wu\*, Caihong Guo, Jinping Wu and Zhenzhen Xie

Zhangzhou Electric Power Supply Company of State Grid Fujian Electric Power Co., Ltd. State Grid Fujian, Zhangzhou 363000, China

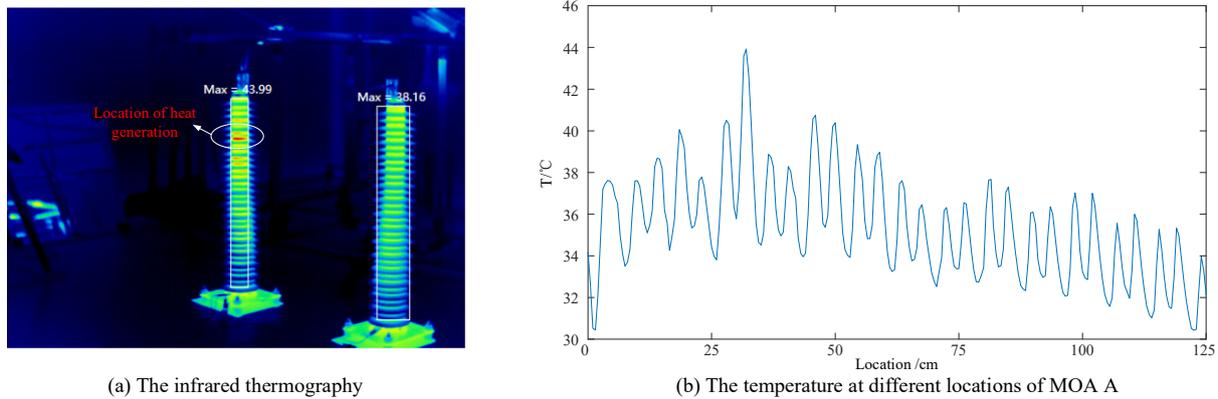
Fig.2 The infrared thermography infographic

AC voltage is applied to MOA A and MOA B respectively, and leakage current and infrared thermographic tests are carried out. The resistive current ( $I_{TP}$ ) and full current ( $I_X$ ) detections are performed on both MOAs during the voltage application. The experimental results are shown in Table 1. As can be seen, the full current of MOA A is higher than MOA B, and the resistive current of MOA A is large, accounting for 40.1% of the full current, more than 20% of the reference value. The resistive current changes significantly, and it is judged that there is moisture or the deterioration of the varistor inside the MOA. Fluke TIX640 infrared thermal imaging, as shown in Fig.2 After 10 minutes of voltage application, the temperature of MOA A was 5.8°C, higher than MOA B. Using the software of Fluke Connect and Smart View to analyse the temperature distribution curve of MOA A, it was shown that the highest temperature was located in the upper middle area.

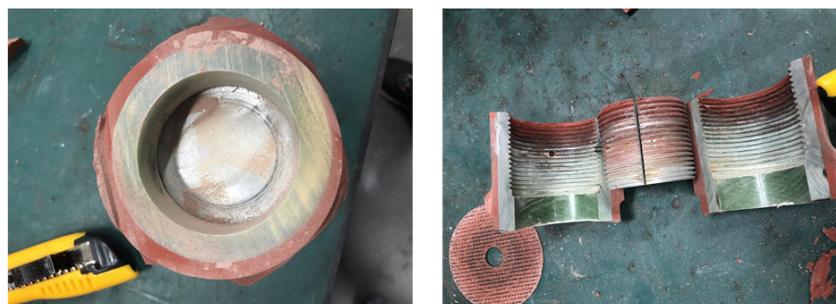
Fig.3 Anatomical view of the MOA body

After dismantling MOA A, as shown in Fig.3, there were water marks inside the epoxy resin insulating cylinder. The silicone rubber jacket was cut and the resulting powder was clumped with water on the metal flange and the insulating cylinder. The inside of the insulating cylinder was not filled with quartz sand or silicone gel, there was no compression spring and the varistor was not wrapped in a heat shrink sleeve. The metal flange was loose and obvious. No sealant was applied to the joints between the insulating cartridge and the flange, and there were obvious traces of uncured silicone rubber infiltration on the threads. The resistor tabs were separated and named in order from the bottom to top. The insulating coating on the side of the varistor No. 24-31 of the upper half of the core group was deteriorated and discolored, and the aluminum electrode showed signs of oxidation and blackening. The six aluminum conductive blocks also showed varying degrees of rust and

corrosion. Comparing the arrangement of the upper and lower varistor, the color difference of the glaze layer is obvious. To sum up, the internal moisture traces of MOA A are more obvious.

The internal and external screw threads of the epoxy insulating cylinder are complete, which eliminates the possibility of loosening of the screw thread slipping or other raw material quality problems. The metal flange and the insulating cylinder can be easily separated and the silicone rubber is not fully cured when it seeps into the flange gap, indicating that the flange contact surface threads are not coated with glass sealant for waterproofing. The thermal expansion coefficients of the epoxy insulating cylinder and the metal flange do not match, therefore, when the glass sealant is not applied for sealing, tiny moisture absorption channels will form at the joints, resulting in moisture inside the MOA. The coatings on the side of the varistors are discolored, the upper and lower aluminum layers are rusted and blackened. Furthermore, the  $U_{1mA}$  of the varistors increase significantly after drying. The appearance inspection and test result also prove that the varistors at the top of the MOA are affected by moisture. Therefore, the damping of the MOA leads to the deterioration of the varistor, which is the main reason for the defect.

The lack of sealant on the contact surface between metal flange and epoxy insulating cylinder flange is the direct cause of this defect. Besides, there are deficiencies in the overall structure design of the MOA and the process of varistor. The article proposed improvement suggestions from three perspectives.
