Analysis and Treatment of Abnormal Defects in Transformer Oil Chromatography

Guangxi Key Laboratory of Intelligent Control and Maintenance of Power Equipment,
Electric Power Research Institute of Guangxi Power Grid Co., Ltd,
Nanning 530023, China

Abstract—This article analyzes the cause of an abnormal defect in the oil chromatogram of a transformer, and puts forward control measures and suggestions. It is analyzed that the cause of the abnormal oil chromatogram of phase A and B of the main transformer is the poor contact of the dynamic and static contacts of the unloaded tap changer, high temperature and overheating, and the development of contact ablation, resulting in abnormal oil chromatogram. The cause of the ablation of the dynamic and static contacts of the no-load tap-changer may be due to the installation and transportation (or electrodynamic shock or U-switch design and other factors), the contacts are not in close contact, the larger contact resistance causes the contacts to overheat, and high temperature conditions Sulfur corrosion occurs on the surface of the lower contact, and the corrosion product gradually deposits on the surface of the contact, which further aggra

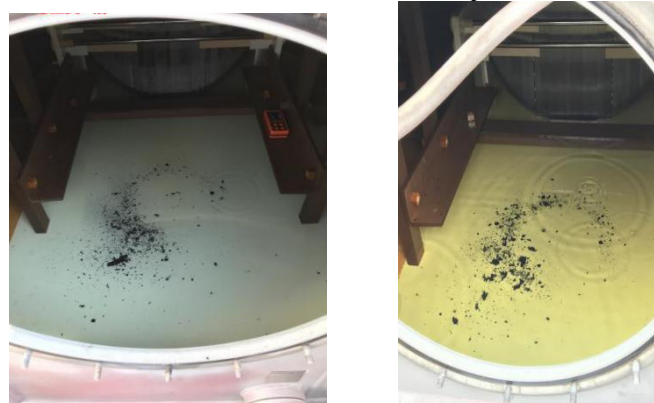
Figure 1 The bottom of the main transformer A and B phase oil tank

(1) Sludge-like black deposits are found under the no-load pressure regulating tap-changer at the bottom of the main fuel tank of A and B phases, and the shape and distribution are highly similar; no black deposits are found at the bottom of the main fuel tank of phase C.

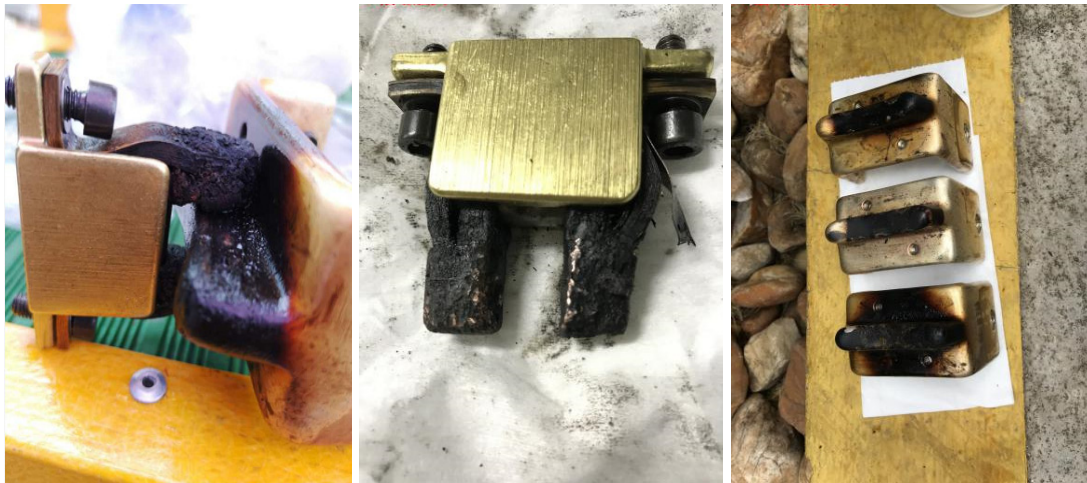
Figure 2 Main transformer A and B phase no-load tap changer dynamic and static contacts

(2) There are various degrees of ablation on the moving contacts and the first-grade static contacts of the A and B-phase no-load tap-changer, and the effective conductive contact area is seriously insufficient compared with the normal equipment, and the static contacts at other positions have no obvious abnormality. (The main transformer has been running in the 1st gear for a long time); There is no obvious abnormality in the dynamic and static contacts of the C-phase no-load voltage regulating tap-changer, and there is no bolt loosening in the tap-changer contacts.

(6) There are various degrees of ablation on the moving contacts and the 1st gear static contacts of the A and B-phase no-load tap-changer, and there is no obvious abnormality in the other gears (the equipment has been running in the 1st gear for a long time).

(7) It is also understood that the tap changer found with ablation defects during the power outage maintenance of a main transformer is also a U-shaped tap changer produced by a company (the same model as the main transformer), and the reason for the switch defect is inferred to be insufficient mechanical strength. The installation and tightening are not in place. Based on the above facts, it is believed that the reason for the abnormal oil chromatogram of the main transformer A and B phases is that the dynamic and static contacts of the no-load tap-changer have poor contact and high temperature overheating, which developed into contact ablation, resulting in abnormal oil chromatogram. The reason for the ablation of the dynamic and static contacts of the no-load tap-changer may be that the contacts are not in close contact due to installation and transportation (or factors such as electric power shock or U-type switch design), and the large contact resistance causes the contacts to overheat and high temperature conditions. Sulfur corrosion occurs on the surface of the lower contact, and the corrosion products are gradually deposited on the surface of the contact, which further aggravates the poor contact. Although passivation agents are added later, the protective effect of the passivation agent at high temperature is limited and cannot protect the contacts. Under the action of the current, the dynamic and static contacts with poor contact are gradually ablated.

Processing of the A-phase and B-phase no-load tap-changer: replace the moving contact of the main transformer A-phase and B-phase no-load tap-changer on site, and replace the 5th-grade static contact of the no-load pressure regulating switch to the 1st gear (running After replacing the dynamic and static contacts, carry out DC resistance and contact resistance tests, and the test data meet the requirements of the regulations; use qualified transformer oil to rinse and clean the contact parts of the No. 1 main transformer no-load switch and the tank wall, etc. respectively. The overhaul of the main transformer and the replacement of the GOE casing have been completed and put into operation on August 15, and it has been running normally since it was put into operation.
