# Seismic screening and structural investigation of heritage buildings for adaptive reuse: a survey study at Iloilo City, Philippines

Richard De Jesus<sup>1,5</sup>, Andres Winston Oreta<sup>1</sup>, Mary Earl Grio<sup>2</sup>, Rodolfo Mendoza, Jr. <sup>1</sup>, Lessandro Garciano<sup>1</sup>, Rhodella Ibabao<sup>3</sup>, Giacomo Sevieri<sup>4</sup> and Carmine Galasso<sup>4</sup>

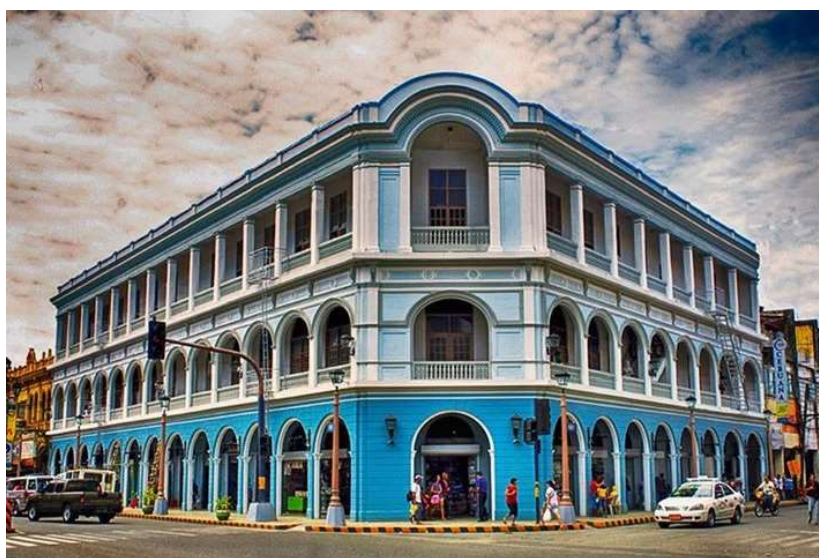
**Figure 2.** Villanueva Building (01-008), one of the CH structures in Calle Real

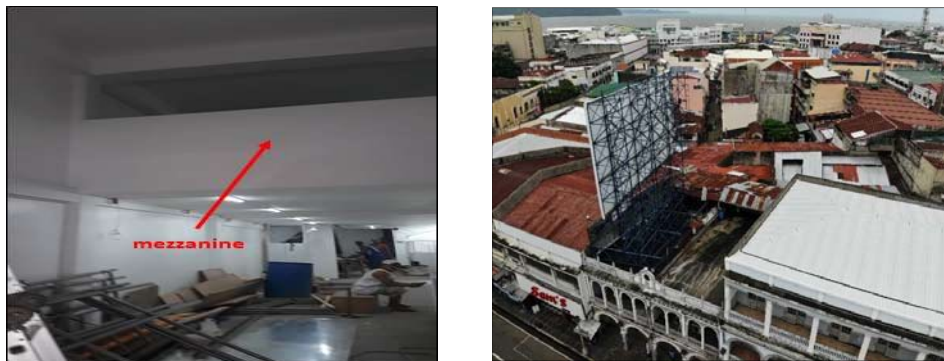
During the site survey, several functional and structural issues were found in cultural heritage structures in Calle Real. Structure owners, to maximize earnings from their property with the least expense, put their property up for commercial lease based on the as-is condition of the structure. Since Calle Real is one of the busiest commercial areas in Iloilo City, rental fees are significantly high and as a result, tenants have imposed modifications on the structure to maximize the usable commercial space of the structure. Some of these modifications are conversion of spaces for storage, installation of the mezzanine for additional storage area (figure 8a), removal of a building component (e.g., column) to increase

commercial space, installation of billboards on top of the structures (figure 8b), conversion of entire 2<sup>nd</sup> floor to storage, and cutting off a portion of roof for other purposes.

**Figure 8.** (a) Installation of mezzanine; (b) installation of billboards on top of the structure

Issues about structural integrity were also discovered during the site survey. Based on the preliminary survey, although a truss system was installed to provide support for the billboard structure placed on the roof deck of the building, no evidence is seen on the improvement of the structural elements of this building to carry the additional load. Roof alterations were also observed in some structures to accommodate the installation of a water supply tank. Other structural integrity issues found in some buildings are the conversion of entire floors as storage spaces and also the installation of mezzanines for additional storage. These building use alterations have caused excessive sagging of the floor due to excessive weight brought about by stored supplies.
