Study of the Features of the Operation of a Dump Truck BelAZ 75131 at the Enterprise of JSC “AGD DIAMONDS” in the Conditions of the Far North

I Toskunin¹, A Tyagunin², A Lagunov², Yu Kutinov³ and Z Chistova³

¹JSC "AGD DIAMONDS", Arkhangelsk, Troickij prospekt, 168, Russia; 163001

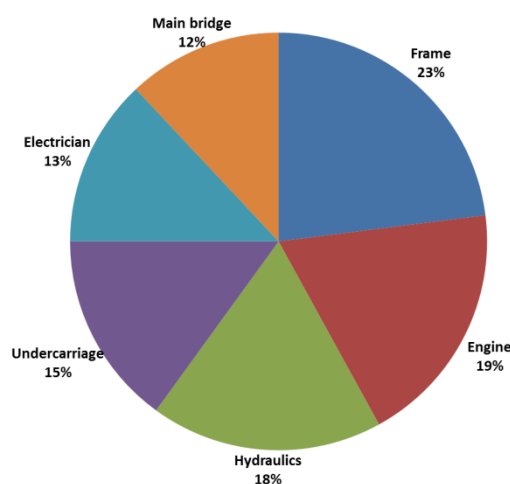
The imperfection of the maintenance system, imperfection of the repair base, lack of necessary components in the warehouse, insufficient operational and repair manufacturability explain the long repair time. Analyzing the documents received in the service department of the enterprise such as: "statements of the replacement of units"; "Accounting of BelAZ repairs"; "List of technical conditions", it was found that 23% of all breakdowns of the BelAZ 75131 dump truck are in the frame, 19% is the engine (Fig.3).

Figure 3. Damage to the BelAZ 75131 dump truck systems.

Hydraulics breaks in 18% of cases. The main malfunctions are wear of nozzles and high-pressure hoses. Failures associated with the chassis occur in 15% of cases. The main failures are wear of pivot fingers; wear of the gearbox of the wheel motor; wear of articulated bearings; failure of brake resistors. We recorded cases of damage to the drive axle at 12%, and damage to the power supply system in 13 % of cases. Failures associated with normal wear and tear are less than half the cases.

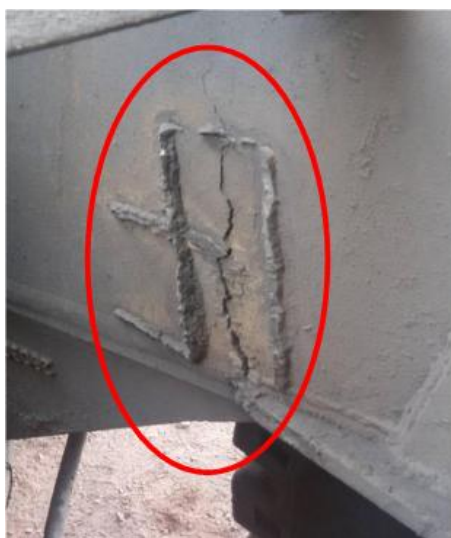
Figure 5 and 6 presents frame defects that occur during operation of the truck.

Figure 5. Dump truck frame crack.

Negative temperatures affect the quality and duration of repair work during their manufacture in the open air, because, with a large temperature difference in the weld metal and the heat-affected zone, large thermal stresses arise and carbides of alloying elements precipitate, which leads to an increase in the fragility of structural materials and a decrease in the operational reliability of repaired parts.

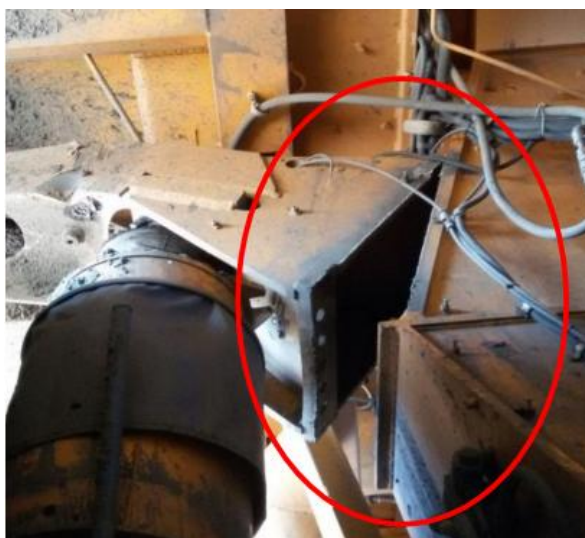
Figure 6. Front suspension defect.
