Cause analysis of circumferential cracking of reheat steam hot section pipeline of 300MW unit

YanfeiZhang *1, Lei Lv 1, Wenxuan Fang 1, Zefeng Li 1

¹. Inner Mongolia Electric Power Science Research Institute, Hohhot, Inner Mongolia, 010020, China

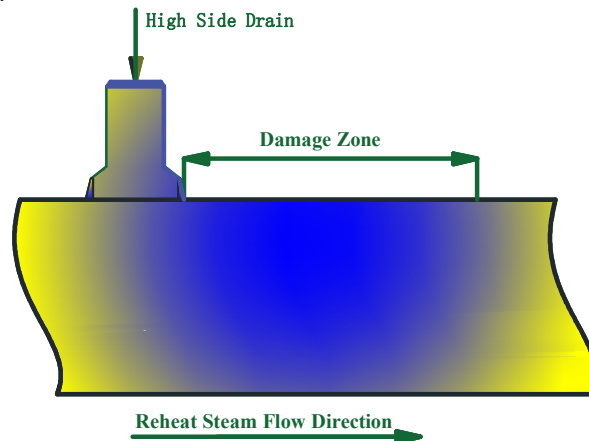
medium temperature is 540°C. The High-pressure Bypass warm pipe comes out after the high-pressure bypass temperature and pressure reducing valve, i.e. under normal operating conditions, the pipe is connected with the cold section pipe, and its medium temperature and pressure are the same as the parameters of the cold section pipe. The connection between the connecting pipe and the hot section pipe is shown in Figure 1.

Figure 1 Connection mode of hot section pipe

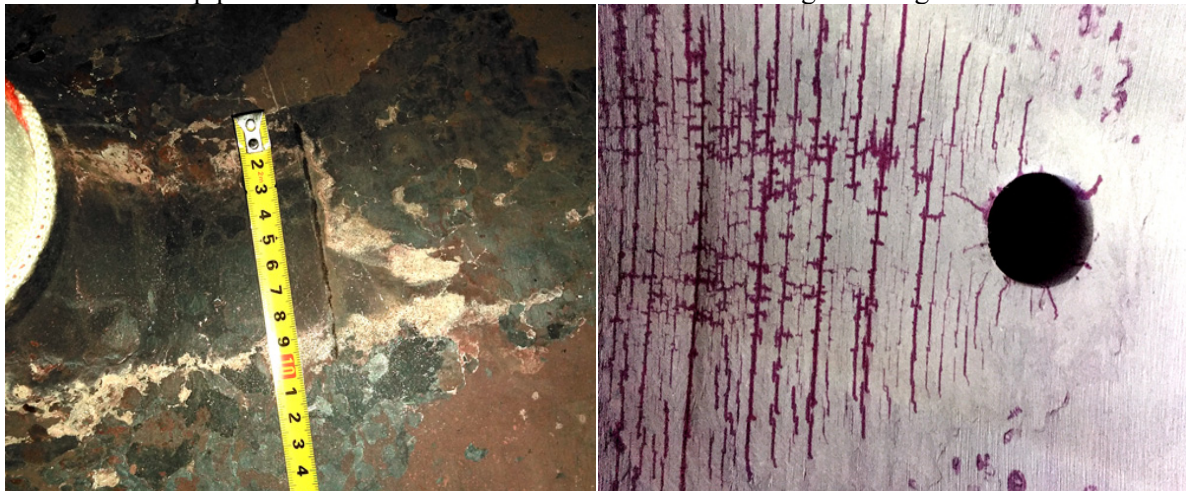
The cracking position of hot section pipeline is 11 o'clock to 1 o'clock in the direction of media flow, 140 mm behind the high-pressure bypass warm pipe socket. The cracks are circumferential and 100 mm in length, as shown in Figure 2. Through penetration inspection, it is found that there are a large number of cracked circumferential cracks with different lengths and lengths in the 1200 mm range of inner wall of the pipeline, and there are many radial cracks in the holes of the tube socket of the inner wall warm pipe socket. As shown in Figure 3. It can be seen that the distribution and shape of cracks in the inner wall of pipeline have obvious characteristics of thermal fatigue damage.

Figure 2 Cracks on the outer wall of the pipeline Figure 3 Cracks in the inner wall of pipeline

The main reason for circumferential cracking of reheat steam hot section pipeline during operation is thermal fatigue damage. The material has low yield strength and poor resistance to thermal fatigue, which accelerates the expansion of thermal fatigue. Unreasonable arrangement of High-pressure Bypass warm pipe system, incorrectly introduces cryogenic medium directly into high-temperature medium environment for mixing temperature. Because no measures such as inner sleeve are taken to protect high-temperature pipeline, cryogenic medium directly impacts the inner wall of pipeline and forms periodic temperature fluctuation, which causes the inner wall of pipeline to bear alternating thermal stress for a long time and finally causes fatigue cracking failure of pipeline in hot section of reheater steam. It is recommended to change the arrangement of the hot water drainage pipe system of the high pressure bypass pipe and introduce the warm pipe medium into the low pressure drainage expansion vessel of the steam turbine so as to avoid the "cooling" effect and impact of the low temperature medium on the hot section pipe of reheated steam, which can not only avoid the fatigue damage of the pipe, but also improve the thermal efficiency of the unit.

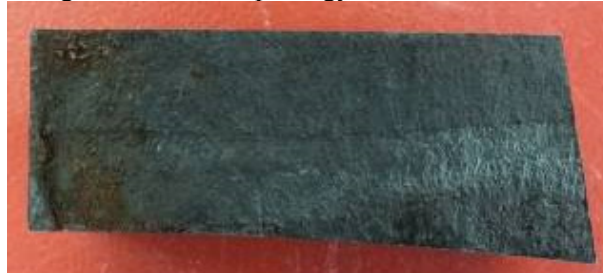
The fracture surface is smooth with no obvious plastic deformation. Severe oxidation products are present on the surface and the fatigue glow extending radially from the inside to the outside is clearly visible as shown in Figure 4. Scanning electron microscope (SEM) is used to analyze the micro-morphology of the fracture. It can be seen that the fatigue crack originates from the inner wall

Figure 4 Macro-morphology of fracture

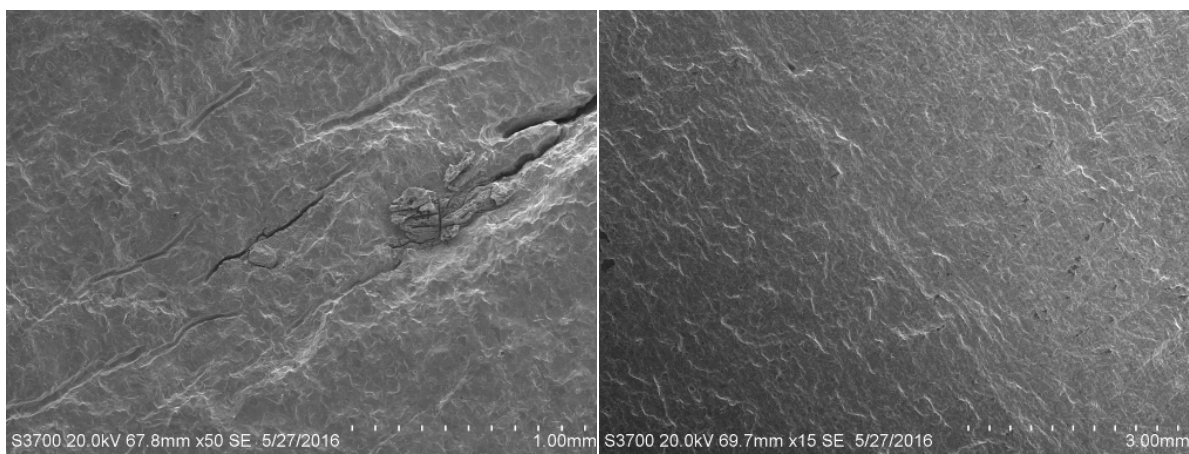
of the pipeline and propagates radially. The tear ribs are radially distributed with cracks and friction marks[9]. It shows typical fatigue fracture morphology characteristics as shown in Figure5.

(a) Splitting source area

(b) Expanded area

Figure 5 Micro-morphology of fracture

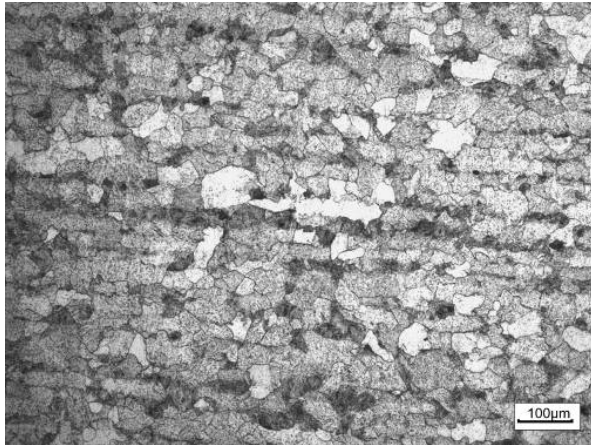
Microstructure examination was performed on the cracked reheat steam pipe samples. The structure state of inner wall, half wall thickness and outer wall of pipe base material is relatively uniform, which is composed of pearlite + ferrite + granular bainite with uniform axial distribution and no obvious spheroidization is observed, as shown in Figure 6. There are several parallel cracks propagating radially in the inner wall, and there are oxide layers inside each crack, but the length and degree of internal oxidation of each crack are different, which indicates that the time of crack formation is different. As shown in Figure 7.

Figure 6 Microstructure at 1/2 wall thickness

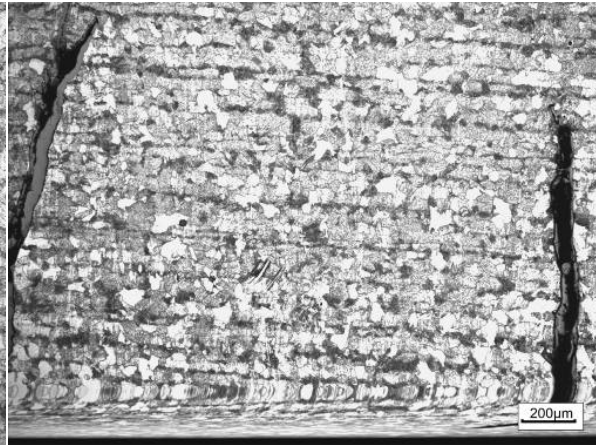
Figure 7 Internal wall cracks and oxide layers
