# Analysis on the Problem of Blocking of the Storage Pump Caused by Peak Load Regulation of the Unit

**Abstract.** A unit frequently participated in the deep peak load regulation of the power grid. In the process of deep peak load regulation, the time of oil feeding and stabilization of combustion was relatively long, which caused the blocking of the pipeline at the inlet of the ash storage pump at the rear of the electrostatic precipitator. According to the analysis, it was found that it was caused by the spontaneous combustion and coking of mixture of oil and pulverized coal which had not been thoroughly burned in the ash bucket.

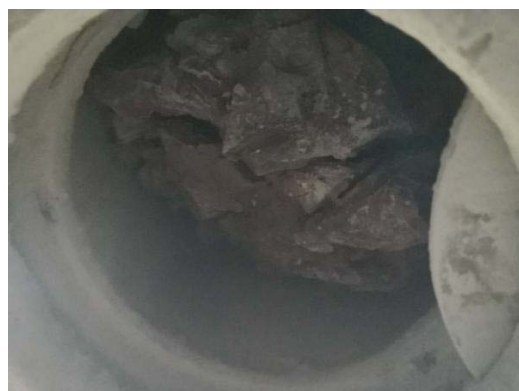
The ash bucket in the upper part of No. 8306 storage pump of a power plant gave an alarm of high level of material, but the feeding gate of the storage pump was opened and closed normally. After the inspection, it was found that the small ash bucket in the upper part of the short pipe for ash discharge was blocked by a lot of coke substances, as shown in the figure 1.

**Figure 1.** Blocked short pipe for ash discharge.

By dredging the small ash bucket blocked, it was found that there were a lot of coke substances in it, they were very hard, it was difficult to dredge and there was a high risk of flying dust.

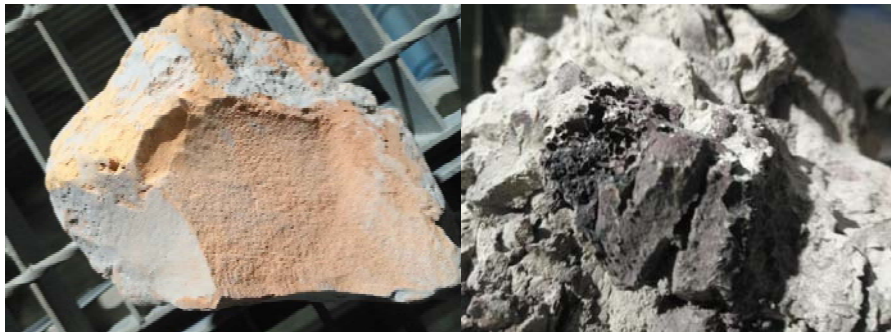
The appearance inspection was made on the cokes removed. There are basically two kinds of cokes. One type is yellowish red and has a low density. The other type is black fluid sludge with a high density, as shown in figure 2.

**Figure 2.** Appearance inspection of coke.

The unit operated at a low load for a long time and oil and coal were burned together, so that the content of combustibles in the ash was relatively high. When oil and coal were burned together, there was the problem of tacking for fan by the fuel. When a different type of coal is used, especially when the volatile matters are quite different, the coal difficult to burn may be burned partly, so that the content of combustibles in the flying ash is relatively high and the volatile matter cannot completely precipitate. (With the conventional sampling method in the conventional sampling period the low load period and the content of combustibles in the flying ash when oil and coal are burned together may not be collected.) And the fume temperature is relatively low during operation at a low load and oil and coal are burned together, so that it is easy for them to adhere to the internal wall of the ash bucket and gradually precipitate or accumulate. Over time, the ash with high carbon content and a few volatile matters may cause spontaneous combustion when the fluidization fan supplies air, form the slag block in the shape of fluid sludge, transfer heat to other ash, cause the smoldering of other ash, and form the yellowish red slag block.
