## Fracture failure analysis of conductive arm spring of isolation switch in 500kV substation

Jun Wang<sup>1</sup>, Yungen Liu<sup>2</sup>, Junjun Chen<sup>1</sup>, Rong Huang<sup>1</sup>, Xianhui Cao<sup>1</sup> and Chao Feng<sup>1</sup>

<sup>1</sup> State Grid Hunan Electric Power Company Limited Research Institute, Changsha 410007, China

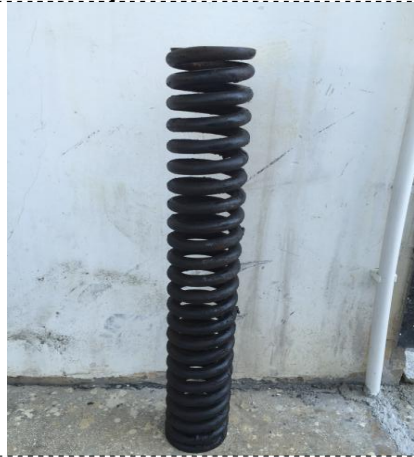
Figure 1. Big balance spring

The balance spring in the lower conductive arm is a cylindrical spiral compression spring, and the large balance spring is severely corroded, as shown in Figure 1. The small balance spring is severely corroded and broken into multiple sections, as shown in Figure 2. The diameters of the large and small balance springs are all over 8mm, and it can be inferred that they are all manufactured by hot-rolling process. The balance spring of the isolating switch was severely corroded after only 9 years of operation, indicating that the anti-corrosion process of the spring was poor when it left the factory. In order to analyze the reasons for the fracture of the small balance spring, the small balance spring was further tested and analyzed.

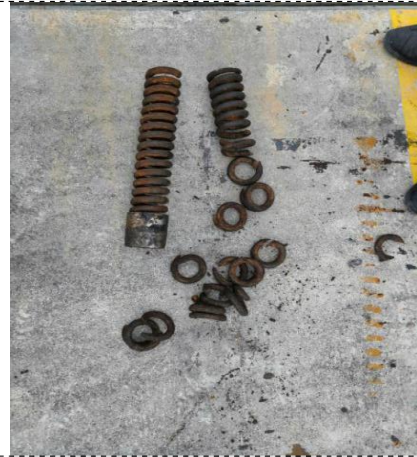
Figure 2. Small balance spring

There are a large number of micro-cracks on the surface of the heavily rusted spring, which increases its notch sensitivity. When the electric operation is performed during the overhaul process, the springs with greatly degraded performance cannot withstand the stress of too fast loading speed, and a large number of micro-cracks rapidly expand and break into multiple segments.

1) Poor spring manufacturing process and anti-corrosion process lead to serious deterioration of spring performance, and brittle fracture occurs under the action of the stress of faster loading speed.

2) Check the isolating switches of the same manufacturer, the same batch, and the same type, and replace the balance spring during power outage maintenance.

3) Strengthen the quality inspection of new replacement springs to ensure that its performance and anti-corrosion quality are excellent.

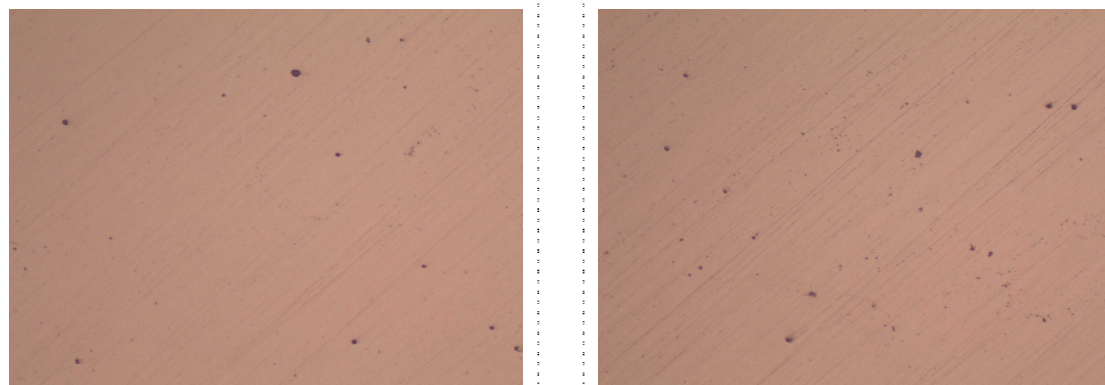
Figure 3. Graphite carbon in spring

According to the standard GB/T 13302-1991 "Method for Microscopic Evaluation of Graphite Carbon in Steel", the entire cross-section of the broken spring was taken, after being ground and smoothed, it was carefully polished with velvet. The unetched test surface of the sample was placed under a microscope with a magnification of 250 times for comprehensive observation, as shown in Figure 3. It can be seen that there are obvious fine clusters of flocculent graphitic carbon in the spring steel, and its graphitic carbon grade is rated as 1.0 through comparison with the standard rating chart. The standard GB/T 1222-2016 "Spring Steel" stipulates that the silico-manganese spring steel after heat treatment should not have visible graphite carbon on the fracture surface, so the graphite carbon inspection of the spring steel is unqualified.

As the aforementioned analysis shows, the design material of the spring is 60Si2Mn alloy spring steel. Since silicon is an element that promotes graphitization, graphitic carbon is easily precipitated when the spring is quenched and tempered. If the spring manufacturing process is not well controlled, the precipitation of graphite carbon is equivalent to reduce the carbon content of the spring steel. On the one hand, it will reduce the strength and hardness of the spring. On the other hand, it will cause the spring to be incompletely austenitized during the heat treatment process. After quenching and tempering, a large amount of ferrite will remain, resulting in unqualified microstructure and greatly reducing the toughness of the spring. Due to the poor manufacturing process of the spring, the performance of the spring itself is poor.

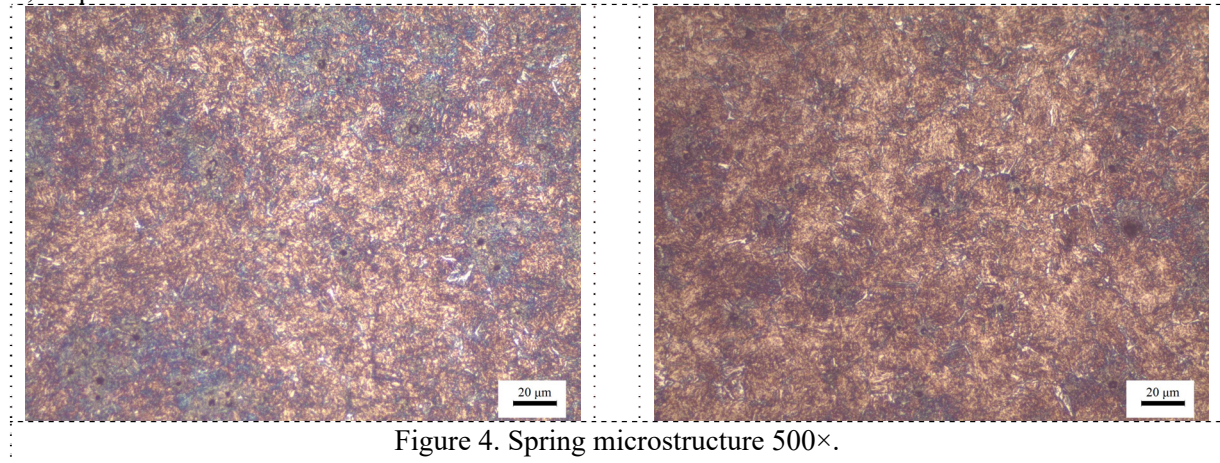
A sample is cut from the spring, ground, polished and etched with a 4% nitric acid alcohol solution, and then the microstructure is observed under a Zeiss Axio Observer A1m metallurgical microscope at 500 times, as shown in Figure 4. By comparing with the medium temperature tempered structure rating chart in the standard JB/T 9129-2000 "60Si2Mn Steel Coil Spring Metallographic Inspection", it can be judged that the microstructure is tempered troostite + massive ferrite, which is rated as Level 5, unqualified.
