# The corrosion analysis and prevention of secondary cable joints used in outdoor terminal boxes of substation in humid environment

**Abstract.** The reasons for corrosion cracking of secondary cable joints used in outdoor terminal boxes of a 220 kV substation in humid environment were investigated by scanning electron microscopy (SEM), X-ray diffractometer (XRD), infrared spectroscopy (IR) and ion dissolution test. According to the results of ion dissolution test, polyvinyl chlorid (PVC) insulated and sheathed cable material would precipitate chloride (Cl) ions under humid environment and at a certain temperature, which leads to accelerated corrosion cracking of the exposed copper core wires of secondary cable. In addition, the newly supplied PVC and cross-linked polyethylene (XLPE) materials without Cl precipitation under the same experimental conditions, indicating that PVC materials would precipitate Cl after reaching a service time threshold. Therefore, it is recommended that XLPE used for the insulation materials and accessories of secondary cable in outdoor terminal box of substation, as well as humidity in the terminal box should be controlled.

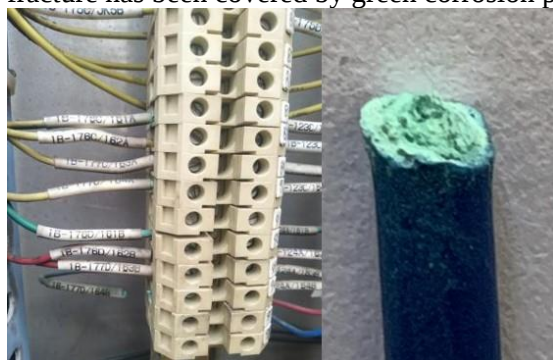
According to the local investigation of this 220 kV substation, the surface of terminal near terminal block was green in the 610 terminal box of the No. 1 main transformer, especially the white number cylinder. As can be seen from Figure 1, one of the black secondary cable has been broken and its fracture has been covered by green corrosion product.

Figure 1. Corrosion morphology of secondary control cable joint in terminal box.

Corrosion on copper core wires of secondary cable in 610 terminal box for this substation is caused by that Cl ions precipitating from PVC insulation materials accelerate electrochemical corrosion. And high humidity in terminal box will give rise to lots of Cl ions precipitation.

Firstly, it is recommended to apply for a power outage as soon as possible, check the secondary cable terminal of each terminal box in this substation, and replace or reinstall all corroded secondary cable joints. At the same time, the sealing design of terminal boxes should be optimized, the moisture removal device in boxes should be improved, and the operation and maintenance management for terminal boxes should be strengthen.

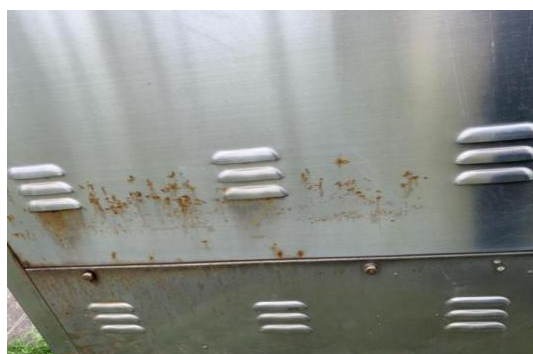
Figure 2. Corrosion morphology of the external wall of terminal box.

Moreover, two of terminal boxes, far away from the exhaust gas window of high-power heater, were found corrosion on external wall, as shown in Figure 2. While, there was no corrosion on external wall of the remaining boxes, including boxes in the nearby high-power heater. The terminal boxes are manufactured by 304 austenitic stainless steels, and corrosion will occur only in the presence of Cl under humid conditions.

Corrosion on external wall of stainless steel terminal box near exhaust moisture window is also caused by Cl ions, in accordance with the corrosion theory of austenitic stainless steel <sup>[4]</sup>.

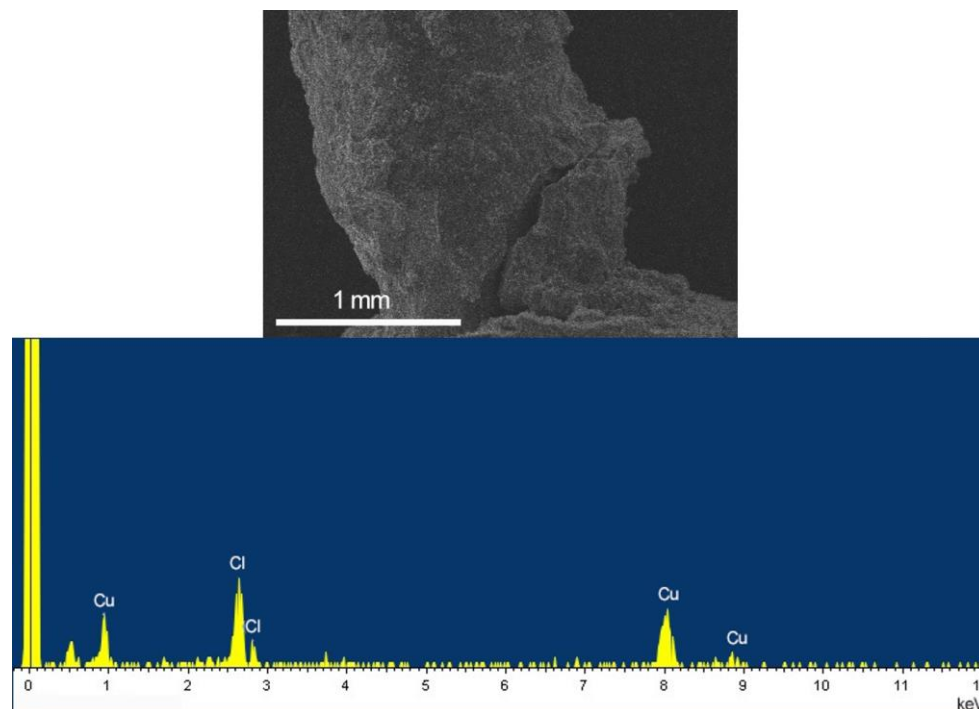
SEM with EDS was used to analyse element of corrosion product on copper core wires. As shown in Figure 3, we can find that Cu and Cl are the main elements of corrosion product, and the atomic percentage of Cl is 38.16%. Therefore, it could be considered that corrosion product is copper chloride

Figure 3. Morphology and EDS spectra of corrosion product on secondary cable

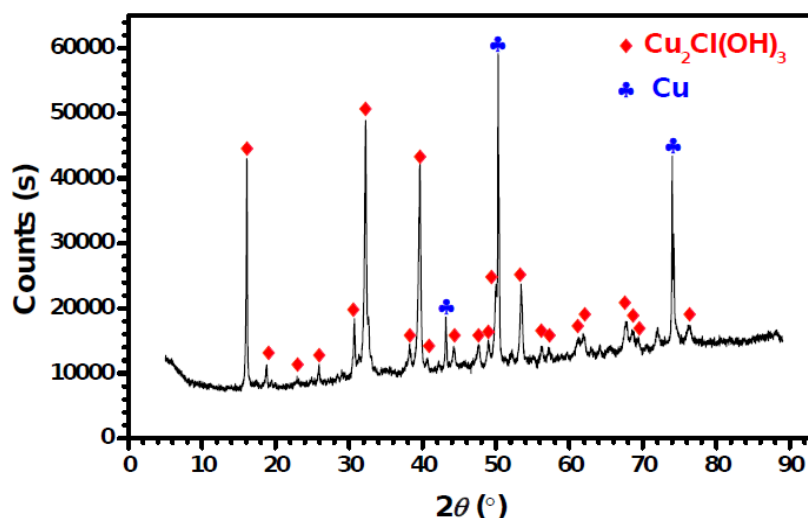
The components of corrosion product on copper core wires of secondary cable joints were studied by XRD analysis, and the results are presented in Figure 4. There are only Cu and  $\text{Cu}_2\text{Cl}(\text{OH})_3$  can be observed in the characteristic lines of XRD spectrum. Cu stem from the copper core wires. And  $\text{Cu}_2\text{Cl}(\text{OH})_3$  can be inferred as corrosion product, combining on the results of the analysis.

Figure 4. XRD spectrum of corrosion product on copper core wire of secondary cable joint

According to analysis results of corrosion product on copper core wires of secondary cable, the existence of Cl ions in corrosion product was verified. And XRD results identifies it is  $\text{Cu}_2\text{Cl}(\text{OH})_3$ .

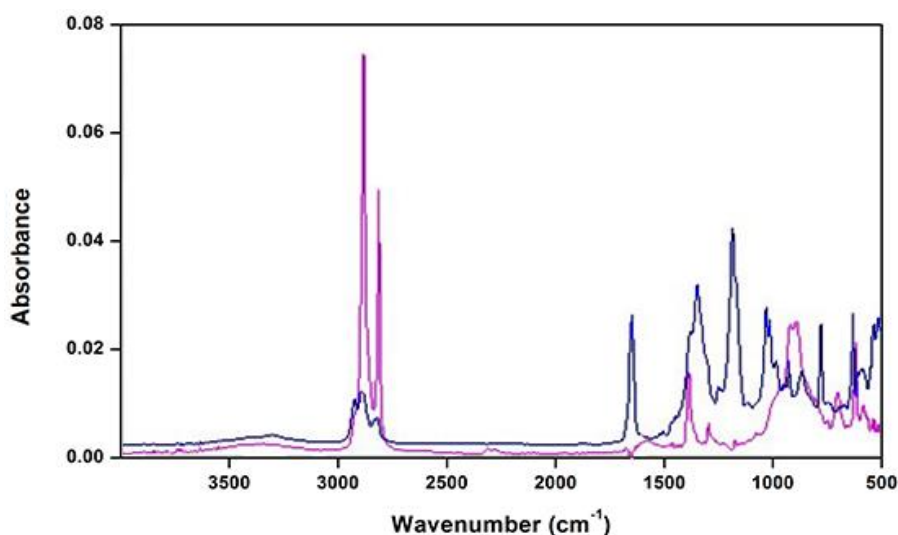
The chemical structure of secondary cable insulation and number cylinder materials were characterized by IR analysis, and the IR spectra are shown in Figure 5. It can be obviously distinguished two different characteristic lines on spectra. Among them, the blue line is PVC material which belongs to insulation of secondary cable, and the other red line is XLPE material which is owned by number cylinder.

Figure 5. IR spectra of insulation of secondary cable and number cylinder materials.
