## ANALYSIS OF QUALITY CONTROL PLANS FOR BRIDGE OVER THE RIVER MAZA JUGLA ACCORING TO COST TU 1406 METHODOLOGY

This article analyses and compares different Quality Control Plans developed according to COST TU 1406 methodology for the existing bridge over the river Maza Jugla, located on regional road P10 at km 34.80 in Latvia.

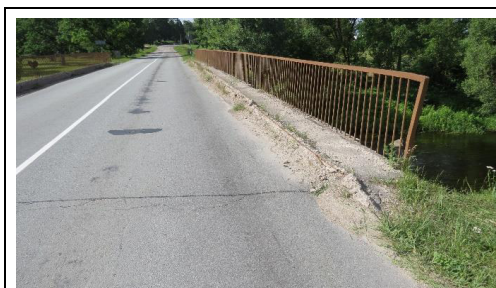
Fig.6-1. Pavement, sidewalks and railings

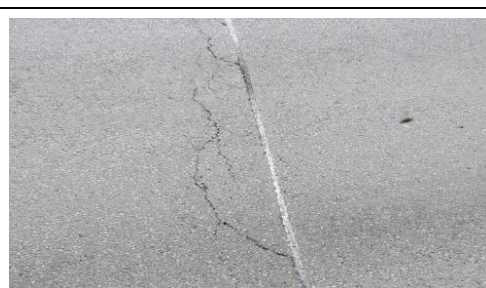
Fig.6-2. Saw cut in asphalt pavement

| Structure | Group | Element / Material | Observations | | | Damage process | Vulnerable zone | Failure mode | Primary KPI | Evaluation | KPI value | |
|---|---|---|---|---|---|---|---|---|---|---|---|---|
| | | | cracks next to cut, delamination | 40% | all length | weak foundation, aging of material | - | driving comfort | Safety (S) | 2 | | |

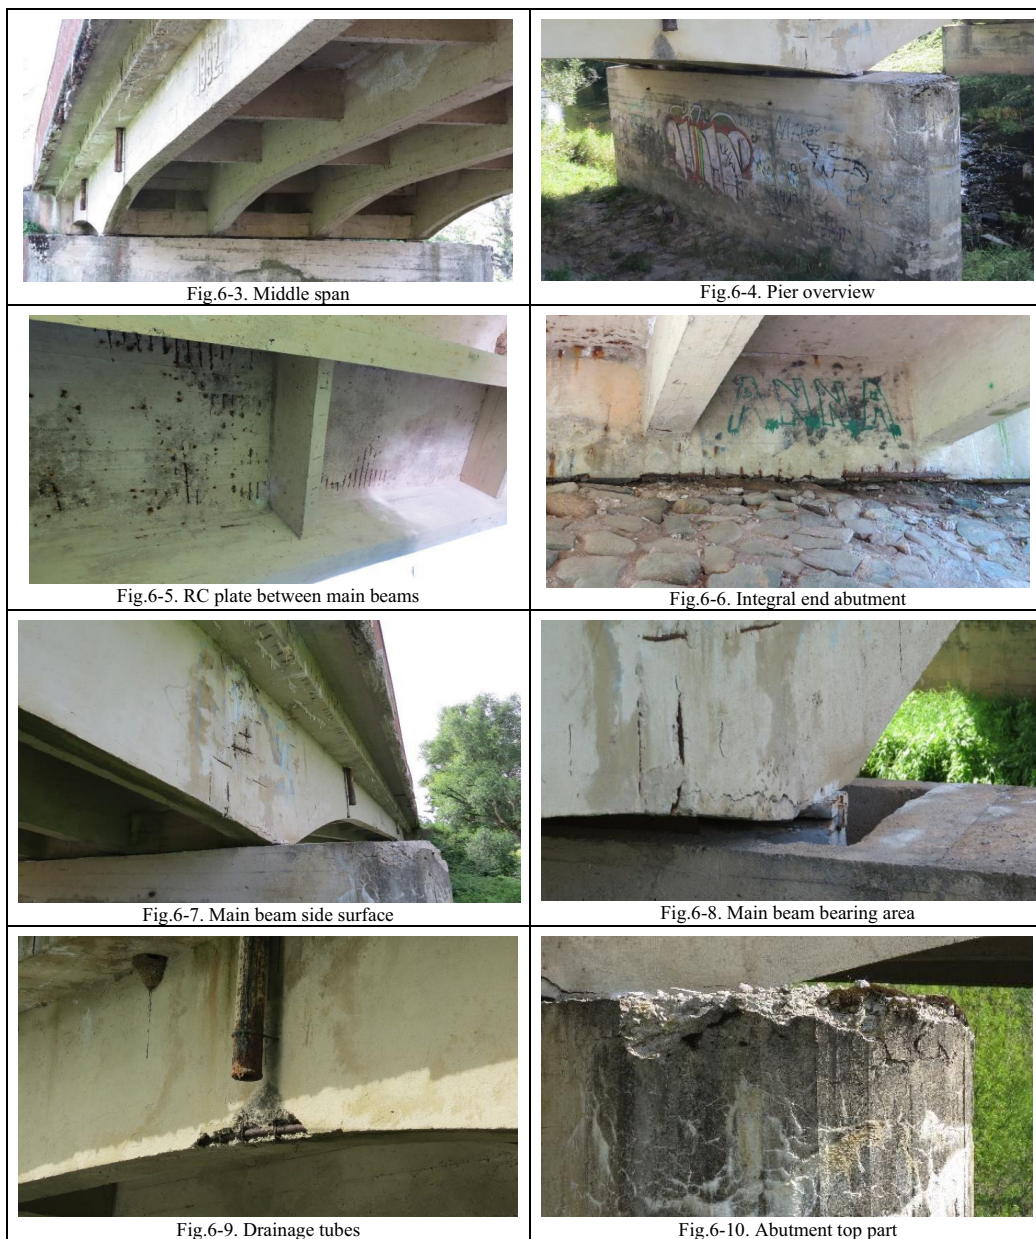
Figure 6. Overview of bridge main defects

| Structure | Group | Element / Material | Observations | | | Damage process | Vulnerable zone | Failure mode | Primary KPI | Evaluation | KPI value | |
|---|---|---|---|---|---|---|---|---|---|---|---|---|
| Continuous multiple span semi-integral beams | Structural elements | Main Beams / RC | concrete spalling, reinforcement corrosion | 15% | side beams, outer side surface | corrosion, deterioration | HS, HMS, HMH | Bending and shear failure mode | Reliability (R) | 2 | | |
| | | | concrete spalling, reinforcement corrosion | 100% | side beams, next to drainage pipes | corrosion, leakage | HS, HMS, HMH | Bending and shear failure mode | Reliability (R) | 4 | | |
| | | | longitudinal cracks, concrete delamination | 50% | side beams at supports | corrosion, deterioration, freeze-thaw | Bearing area | Shear failure mode | Reliability (R) | 3 | | |
| | | Water proofing / bitumen layer | Efflorescence | 90% | all below sidewalks | leakage | - | - | symptom | 4 | | |
| | | Overlay / asphalt pavement | corrosion, loss of section, too short pipes | 100% | all pipes | corrosion, inappropriate design solution | HMS | Bending failure mode | Safety (S) / Reliability (R) | 3/3 | | |

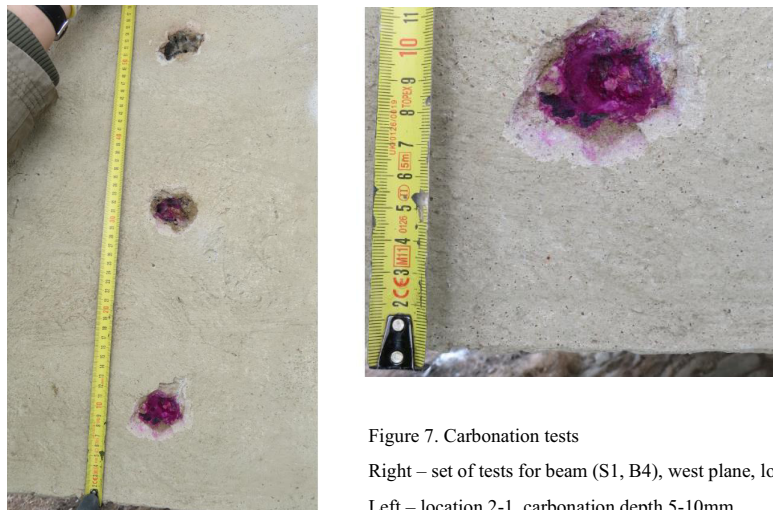
Figure 7. Carbonation tests

Carbonation test results show that there is significant scattering of results. It is observed that concrete material structure has major influence on carbonation depth. As bridge beams were cast-in-situ more than 60 years ago it was observed that beam high webs in bottom are poorly compacted, therefore carbonation depth is much higher than in shallow elements.

Right – set of tests for beam (S1, B4), west plane, location 2

Left – location 2-1, carbonation depth 5-10mm

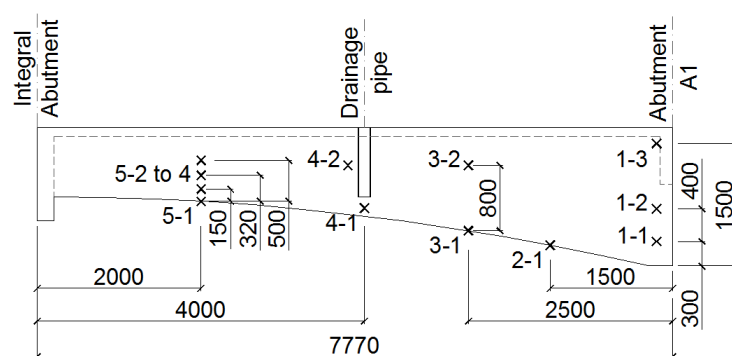
Figure 8. Performed carbonisation depth measures for Beam (S1, B1), east plane

| Element | Location | Carbonisation depth (mm) | Material structure | Notes |
|---|---|---|---|---|
| | 2-1 | >50 | porous structure | reached re inforcement |
| | 3-1 | >50 | porous structure | reached re inforcement |
| | 4-1 | >50 | porous structure | Under drainage pipe, often wet conditions |
| | 5-1 | >50 | porous structure | reached re inforcement |
