Analysis and Countermeasure of Burnout of Electromagnetic Voltage Transformer of High Altitude Area in Western China

Abstract. 3 burning accidents of electromagnetic voltage transformer of Qinghai power grid in the southern high altitude area was introduced in this paper, and the cause of the accident was analyzed, which is due to a phase grounding line, then the other two phases voltage rising caused voltage transformer damaged; occurrence of Ferro resonance over-voltage, which resulting in serious core saturation, and the over-current caused voltage transformer damaged; due to open delta is short circuit, when the single-phase grounding fault occurred, because the voltage output of 100 V from open delta winding, a very large current is formatted, and a lot of heat is made, also led to the current in primary side very large, resulting in burning TV. In view of these three reasons, the corresponding prevention measures are put forward to ensure the normal operation of the power system.

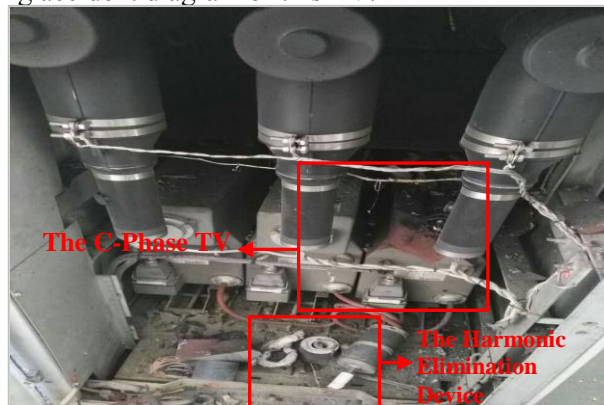
One day, 22:00, * line B phase line in 110kV substation * is grounding, At the same time, the C phase voltage is abnormal, and the #3521 circuit breaker is opened in the distance, and the equipment is required to be checked in the field. Through on-the-spot checking, Operation and maintenance personnel found that the cabinet closed door 35kV I bus open, the whole cabinet body deformation, side opening. After examination, the appearance of TV in A phase was normal, The B phase TV has a burn mark on the side of the C phase, and the C phase TV burst, harmonic elimination device crack.

Figure.1 the 35kV Voltage Transformer Burning Accident Diagram

After investigation, we found that B phase of the single-phase ground fault occurred at 22:00, the phase voltage of A and C phase changes into line voltage, resulting in C phase 35kV voltage transformer explosion. When B is connected to the ground, the equivalent circuit diagram is shown in Figure 4.

From the formula (1) we can obtained that: The main parameters affecting the instantaneous magnetic flux in the core are the initial phase angle α and the remanence Φ_r when the failure occurs. It can be seen that when single phase grounding occurs, the voltage of the non-fault phase is abrupt to the line voltage; the core enters the saturation area and produces inrush current in the winding. When the core enters the depth saturation, its inrush can reach dozens of times of the steady current, and its heat is enough to cause the damage of the voltage transformer [2].

- 1) To improve the insulation level of the distribution network and reduce the condition of single-phase grounding;
- 2) To add appropriate arc suppression coil to restrain the occurrence of intermittent arc grounding;
- 3) To improve the excitation characteristics of the voltage transformer so that the voltage transformer is not easy to enter the saturation area.
- 4) To adopt a new type of heat resistant material to increase the heat resistance of voltage transformer.

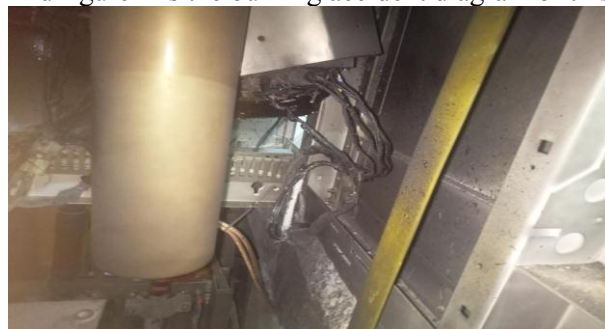
The substation is 4200 meters above sea level. A dispatch notification is received at 15:16 a day, and the voltage of the B10kV bus voltage of the substation B phase voltage disappears. At 19:20, Operation and maintenance personnel arrive at the station to check 10kV and 35kV high voltage rooms, after entering, there was a strong smell of smoke. The protection action information of overcurrent I section on the protective device of * Road is found at 10:08. The operation and maintenance personnel apply for the 10kV bus TV to be checked carefully after the operation of the reacting scene. At 20:15, the operation and maintenance personnel opened the 10kV cabinet door, and found B phase TV burst. And figure 2 is the burning accident diagram of this TV.

Figure.2 the 10kV Voltage Transformer Burning Accident Diagram

From analysis of the information collected from the protection device and its fault recorder, at 14:55 we found that U_a, U_b, U_c all change suddenly; U_b, U_c transcends the upper limit, and U_a goes beyond the lower limit. A-phase voltage disappears, indicating the occurrence of grounding fault in A-phase.

the charge or eliminating the ground fault during operation, the ground capacitance of the power grid is matched to the excitation inductance of the B phase voltage transformer. When a grounding fault occurs in A-phase, the condition of the excitation of ferromagnetic resonance is produced, which makes the core of the voltage transformer saturate and produces the neutral point displacement. These conditions are met, so the judge is ferromagnetic coil voltage transformer Ferro-resonance, excitation inductance decreases, the saturation voltage transformer excitation current depth will increase sharply, and finally burned B-phase TV. Figure 5 is the voltage waveform diagram when a metal grounding fault occurs in A-phase.

1) Installing a micro-computer harmonic elimination device at the open triangle terminal of the remaining voltage winding.

This device can identify various forms of ferromagnetic resonance overvoltage, including frequency division, fundamental frequency, and three frequency doubling. When a certain resonance is determined, a specific harmonic elimination program is introduced. The open delta winding is short circuited, and the damping current is output to the grid, so that the resonance overvoltage is eliminated quickly. At the same time, it is noted that the voltage transformer is a full insulation design.

2) Parallel one resistance (incandescent lamp) in the remaining voltage winding open triangle terminal. Linear damping resistors or incandescent lamps are installed at the opening end of the TV open triangular winding. This method is simple and is especially easy to be realized. When the excitation characteristic of TV is good, it can play zero sequence damping effect, but because the resonance excited by non-metallic grounding cannot be restrained, the high voltage fuse of TV is easy to fuse.

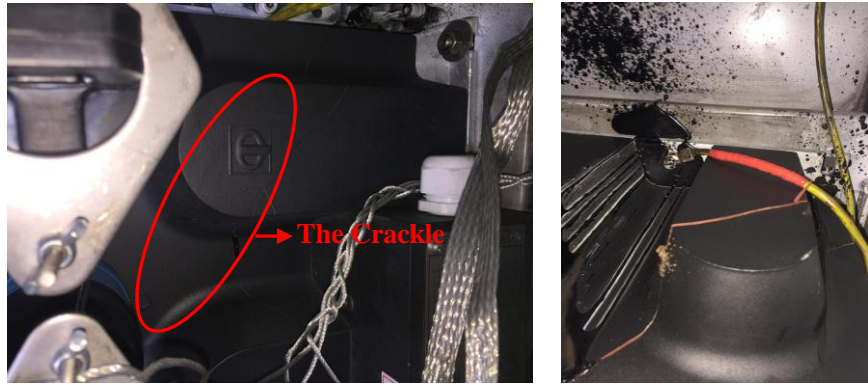
The substation is 3800 meters above sea level. At 22:19 one day, the dispatch department noticed that low backup protection of #1 main transformer in this substation have actioned. Measurement and control device display the bus-bar TV broken line and alarm. At second days 09:00, the dispatching department notifies the voltage anomaly of the 10kV bus in the substation. At 13:16, operation and maintenance personnel arrive at the scene, and found the 10kV TV door opened by burst. At 13:37, apply for the dispatch department to transfer the 10kV bus TV to the overhaul. At the same time, open the door to check, found TV explosion, at 14:40 the 10kV bus TV isolation after the restoration of power supply. And figure 3 is the explosion scene diagram of this TV.

Figure.3 the 10kV Bus TV Explosion Scene Diagram

normally. Only when the single phase grounding fault occurs will cause serious damage to the voltage transformer equipment. Therefore, it is suggested that in the process of substation completion and acceptance and operation inspection, we should strengthen the wiring inspection of the secondary opening triangular circuit of voltage transformer, so as to avoid the occurrence of open triangular short circuit [5].

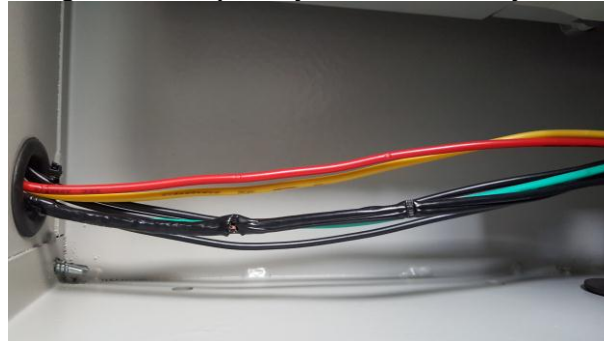
After the field investigation, it was found that the two lines of C601 in the TV cabinet were bonded together with the N600 insulated wire skin as shown in figure 8. Unlock the secondary line of the TV side and check it. It is found that the secondary line N600 in the TV cabinet is connected with the L650, and the discharge coils of the N600 and the capacitor in the 10kV capacitor cabinet are found together. The open triangle is short circuited. Under normal conditions, the output voltage of the open triangle winding is basically 0, so the $3U_0$ is 0. The short circuit of the open triangle winding does not affect the normal operation of the voltage transformer. When a single-phase grounding fault occurs, the voltage of the open triangle winding output is 100 V. Once the connection is short circuited, that is, the secondary side of the voltage transformer is short circuited, which will form a very large current and heat, and will lead to a large current in primary side. It eventually led to the burning of TV.

Figure.8 Secondary Connection Short Connection Schematic

The direct cause of the 10 kV voltage transformer fault is the short circuit of the two connection of the open triangle winding of the voltage transformer. If the secondary wiring of the secondary opening trigonometric winding of the voltage transformer is short circuited by the construction unit, it is difficult to find the conventional inspection and acceptance. When the equipment is running normally, the external check will not find any exception. Or the short connection of the secondary connection leads to the open triangle short circuit. In this case, there is no problem when the system is running
