# Failure Analysis of a Flexspline of Harmonic Gear Drive in STC Industrial Robot: Microstructure and Stress Distribution

Jianlin Zheng<sup>1, 2, \*</sup> and Wei Yang<sup>1</sup>

<sup>1</sup>State Key Laboratory of Mechanical Transmission, Chongqing University, Chongqing 400030, China

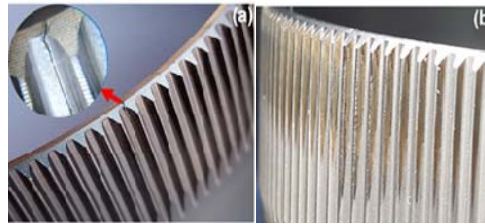
**Figure 2.** Gear teeth profile of failed flexspline.

Gear teeth profile of failed flexspline as is shown in Fig. 2. Obvious cracks were observed at the tooth root of the failed flexspline (Fig. 2a); local spalling and wear were found near the top of the tooth surface, and the spalling and wear were more serious in the vicinity of the fracture area (Fig. 2b). Literature [5, 8, 14] lead to the fact that wave generator and flexspline of harmonic gear drive were apt to vibrate under the condition of heavy load and high speed, thus the meshing between flexspline and circular spline was interfered, and the tooth top part of the failed flexispline had strict abrasion, even appears flange and burr.

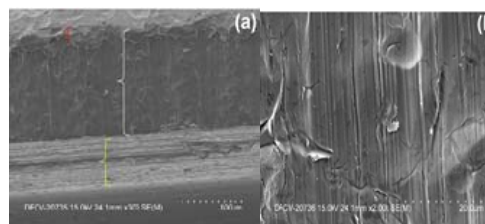
**Figure 3.** The surface morphology of the tooth top of the failed flexspline.

The surface morphology of the tooth top of the failed flexspline was shown in Fig. 3. The area of the tooth top was divided into two parts: the working side (the white frame area of Fig. 3a) and the free side (the yellow frame area of Fig. 3a). More marks that parallel to the direction of the gear tooth were discovered in the free side. These marks were judged as tool marks after processing materials. In addition, at the junction of the tooth top and the working surface, the sharp tooth top corner became blunt through impact, and the deformed metal turned to the tooth top (the red frame area of Fig. 3a). The scratches, which were formed in the process of operating and perpendicular to the direction of the gear tooth, were observed from the morphology of the enlarged working side (Fig. 3b).

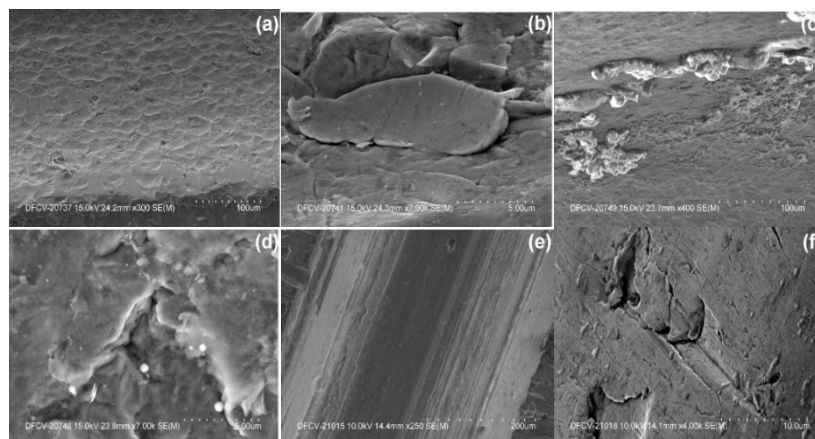
**Figure 4.** The morphology of the gear tooth bottom.

SEM image of the failed flexspline as was shown in Fig. 4. In Fig. 4a, the working surface of the gear tooth became uneven after impact and was covered by the impact craters. Figs. 4b to 4d were observed in the images of local enlargement of working surface. As we can see clearly from these figures, plastic deformation was serious (Fig. 4b), there were slight local spallings and some iron filings in the matrix (Fig. 4c), and the cracks were generated in some regions (Fig. 4d). It can be concluded that the failure of the flexspline was caused by the high speed impact rolling deformation of the working surface, therefore, the size of the tooth surface had been changed, the micro cracks were produced locally, and the wear resistance of the material surface was destroyed.

In addition, Fig. 4e shows the morphology of the gear tooth bottom. In this figure, the transition arc was complete, the surface of the gear tooth on both sides was rough and the tool marks were still obvious. These morphologies indicate that the gear tooth bottom was not treated by polishing. Fig. 4f shows the morphology of the working face close to the gear tooth bottom. Impact traces were not found on the tooth surface, but wear and tear traces were strong. The tool marks, abrasive wear and metal mosaic were observed on the working surface. In a word, the tooth surface of the failed flexspline is without polishing pretreatment, so surface is roughness, tool marks are clear, all these will lead to abnormal contact of the working process, partial rupture, easy dregs, and it is difficult to form oil film lubrication layer.

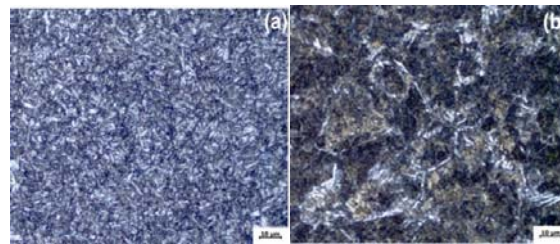
**Figure 5.** Metallographic structures of the flexspline.

The specimen was cut from the fracture surface of the failed flexspline. Metallographic structures of the failed flexspline and the SNCM439 standard flexspline were observed as shown in Fig. 5. As the figure shows, there is no brittle inclusion in the crystallization phase of the failed flexspline. The structure were mainly sorbite and a small amount of ferrite (Fig. 5a), while the tissue of the SNCM439 standard sample was the sorbite (Fig.5b). In addition, the grain size of the failed flexspline was the grade of 8.5, while the SNCM439 standard sample has a grain size of the grade of 11. The strength and plasticity of flexsplines were different from those of the SNCM439 standard ones, was concluded based on two aspects of comprehensive factors that the ferrite strength is poor and the coarse grain would result in a decrease in both plasticity and strength (Hall-Petch formula).

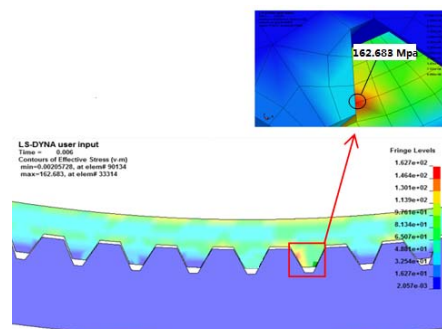
**Figure 7.** Stress distribution of the failed flexspline meshing parts.

The FEA result of stress distribution of the failed flexspline meshing parts was shown in Fig. 7. The stress was indicated in Mpa units. According to the FEA, the weakest regions were tooth root which near the working surfaces. The maximum stress of the failed flexspline calculated by FEA was 162.683 Mpa.

By comparing the microstructure of the material, it was found that there are cracks at the tooth root surface, where the stress concentration and the alternating stress are the root causes of the failure of the flexspline. In order to better analyze the stress field of the failed flexspline, the influence of different fillet radii at bending part on the maximum stress of the flexspline under no load was studied by taking the failed flexspline as an analysis model. The fillet radius is 0~2 mm, and the other parameters are unchanged. The FEA result of stress distribution is shown in Fig. 8.

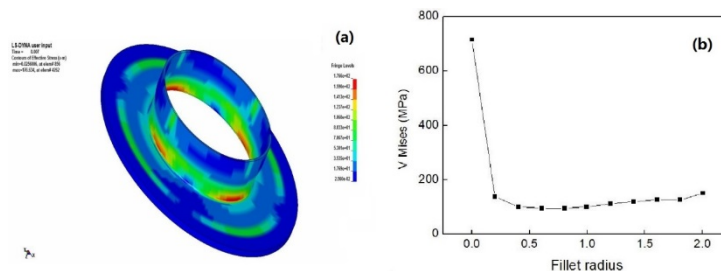
**Figure 8.** The influence of different fillet radii on the flexspline.

Fig. 8a shows that, when the flexspline is running, the force at bending part is the largest, and the radii of the fillet here directly affect the maximum stress of the flexspline.

Fig. 8b shows the maximum stress of the flexspline corresponding to different fillet radii: 1) when the radius is 0 mm, the maximum stress of the flexspline is the largest, reaching 714.7 Mpa; 2) when the radius is 0.2 mm, the maximum stress of the flexspline is 137.9 Mpa, and as the radius increases, the maximum stress of the flexspline decreases; 3) when the radius is about 0.8 mm, the maximum stress of the flexspline reaches the minimum, 94.2 Mpa, with the radius increasing, the maximum stress of the flexspline increases; 4) when the radius is 2 mm, the maximum stress of the flexspline is 149.3 Mpa. Taken together, when the fillet radius is about 0.8 mm, the stress is minimum at bending part. By changing the fillet radius, the stress distribution of the flexspline, in a manner, can be improved.
