## Failure Analysis of the Leaf Spring of Truck Colt Diesel Using Finite Element Method

## ***Failure Analysis of the Leaf Spring of Truck Colt Diesel Using Finite Element Method***

**Husaini<sup>1</sup>, Rizki Riantoni, Nurdin Ali and Teuku Edisah Putra**

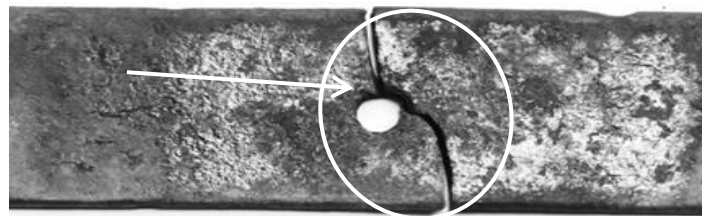
**Figure 1.** Material for research object

The material used in this study is a fracture leaf springs of colt diesel truck. The springs experience fracture at the usage of 572 km operating as shown in Fig. 1. This Material was supplied by a mechanical workshop, then it was identified the vehicle types and the loads capacity allowable using the name plate. The arrows in Fig. 1 shows the fracture part of the leaf springs near the bolt hole.

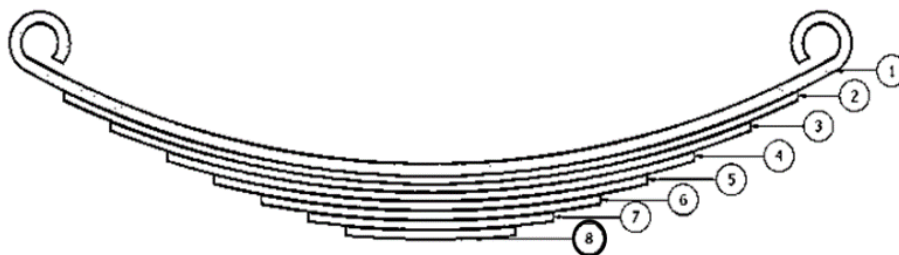
**Figure 2.** Failures leaf spring occurred at number eight

The fracture surface was visually evaluated as shown in Fig. 2. The figure shows the spring number eight experienced the fracture on the bolt hole.

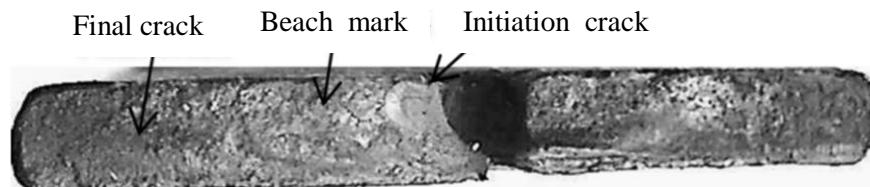
**Figure 3.** Image of fracture surface of leaf spring

Visual evaluation of the leaf spring failure was focused in the area of bolt hole. Image of the failure surface was taken for showing the historical failure data of failure. The image of surface marked initial crack, beach mark and final crack as shown in Fig. 3.

The surface of the fracture spring identified as a fatigue fracture, characterized by a crack initiation area, which subsequently occurs crack propagation in line with fluctuating loading and final fracture [7,8]. The loads led by springs on the vehicle are known as fatigue loads because of their dynamic nature. The leaf springs fracture surface was evaluated using scanning electron microscopy (SEM) image. Through SEM image, failure region can be evaluated whether there is a preliminary defect in the leaf springs as shown in Fig. 3.

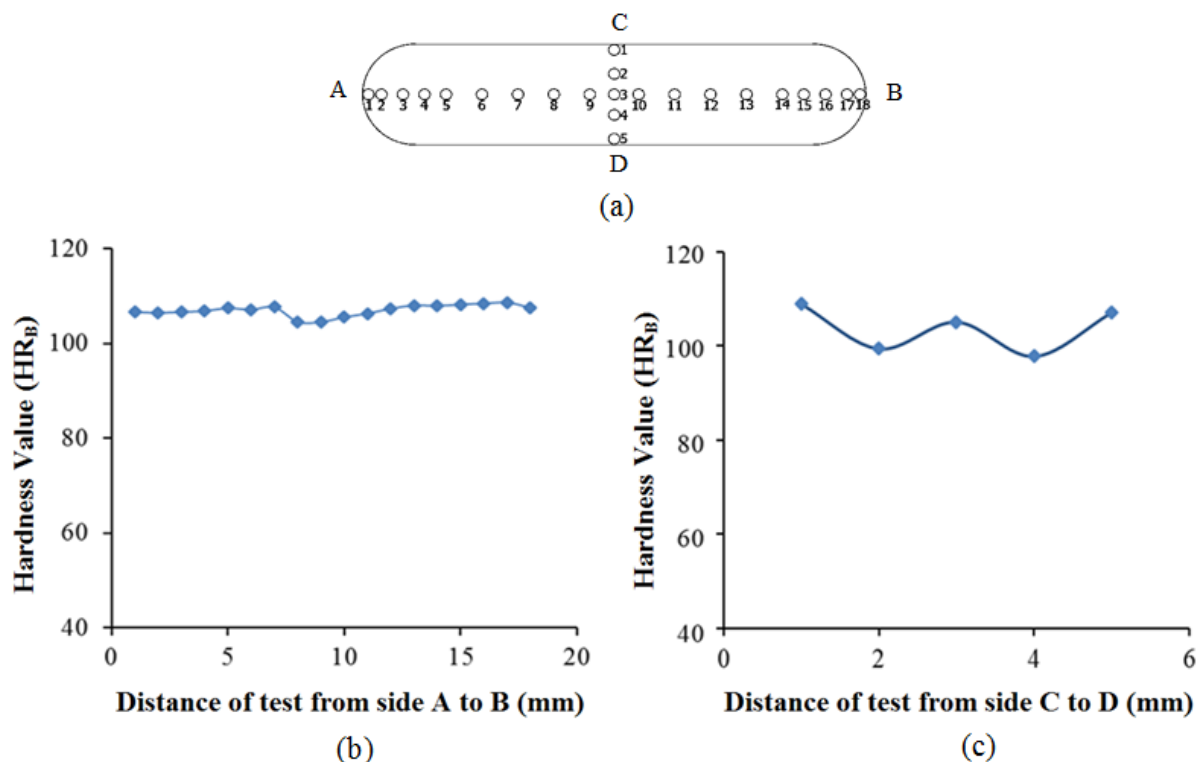
**Figure 7.** Material hardness testing. (a) Hardness test point at the spring. (b) Inner surface hardness graph from A to B side (see Figure 10.a). (c) Surface hardness graph from side C to D (see Figure 10.a)

The results of hardness test are shown in Fig. 7 horizontal axis from point A to B and vertical axis from C to D in the sum of 22 points. The distance between point approximately 2 to 5 mm (ref. to Figure 7.a). The hardness in the area close to the bolts hole or in middle of the spring is lower than of the ends of leaf spring. It shows that, the materials toughness on the center of the leaf spring higher than of the spring ends. This result is in agreed well with the result reported by previous researchers [2].

The sample of leaf spring surface hardness yields different values between the center and the edges. Hardness test results show that, in the horizontal directions of A to B are 104.6 HR<sub>B</sub>

minimum and 108.5 HR<sub>B</sub> maximum. The difference in hardness value is insignificant only 3.6 %. The same results are encountered in directions of C to D are 97.8 HR<sub>B</sub> minimum and 107.1 HR<sub>B</sub> maximum remain under 10 % namely 8.7 %. The mean hardness was 106.5 HR<sub>B</sub> in the A to B direction and 102.5 HR<sub>B</sub> for the C side to D direction. The mean of the overall hardness value is 104.5 HR<sub>B</sub>. It can be concluded that no hardening of the damaged leaf springs as seen from hardness is not much different between the points around the fracture and outside the point.

After testing the hardness depth reaches 22 mm from the outer surface of leaf springs. Hardness of the AISI 5150 material according ASTM standard is 92 HRB, while the hardness value of leaf springs of the results is 106.9 HRB. This hardness value indicates that the spring had undergone heat treatment and shot peening as surface treatment for residual stress regenerating. The high hardness difference between the value of the standard and the test results can decrease the ductility or tinkering occurs during the spring operation. This may cause the spring elasticity function to tend to decrease and when the maximum spring loading will be easy to crack [16,17].

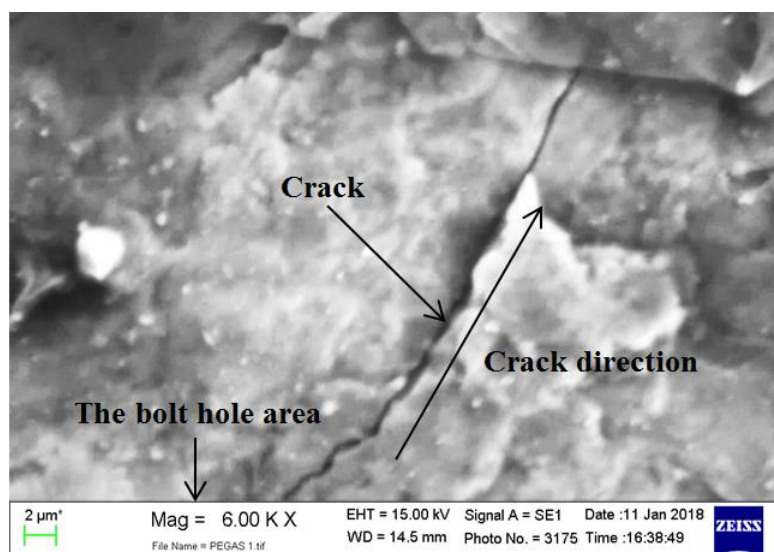
Microscopic observations with magnitudes of 6000 on the fracture surface of the spring identified that the crack occur around the bolt hole. The crack starts on the bolt portion then propagate to the cross section of the spring. Figure 8 shows the image of crack area.

**Figure 8.** Fracture surface spring shows crack area marked with initiation crack

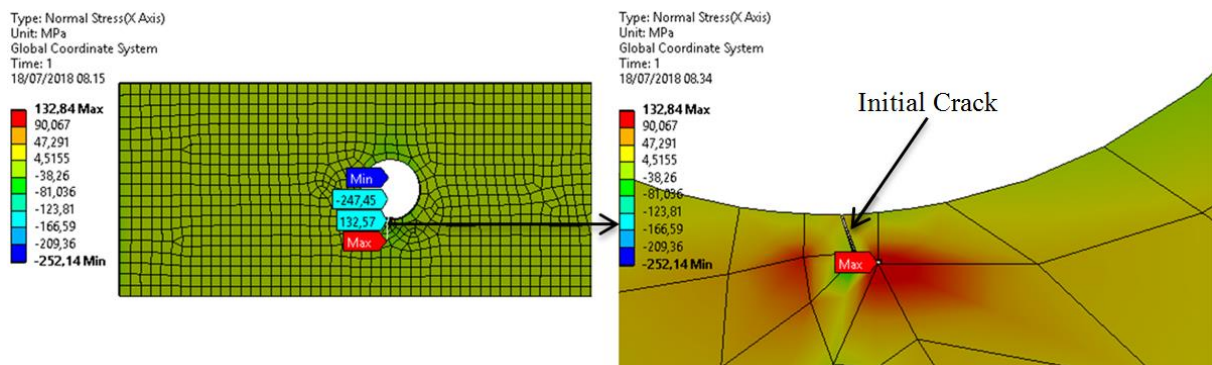
**Figure 10.** The normal stress of leaf spring

Where  $a$  is the crack length. The crack length is obtained from the visual observation with the value is 4.9 mm,  $\sigma$  is the stress that occurs in the spring (specimen). Stress occurring at the spring is calculated using finite element analysis. From finite element analysis as shown in Fig. 10 with a given load of 26950 N, the maximum value of 132.84 (MPa) is obtained.  $F_{hs}$  is a limiting correction factor calculated by referencing to previous research methods [19]. The results of boundary correction factor analysis obtained value of 2.49.

The maximum stress value received by spring is smaller than the yield strength of AISI 5150 material equal to 218 MPa, so it does not cause the spring number eight deformed and the mean stress on the spring number eight is well distributed.

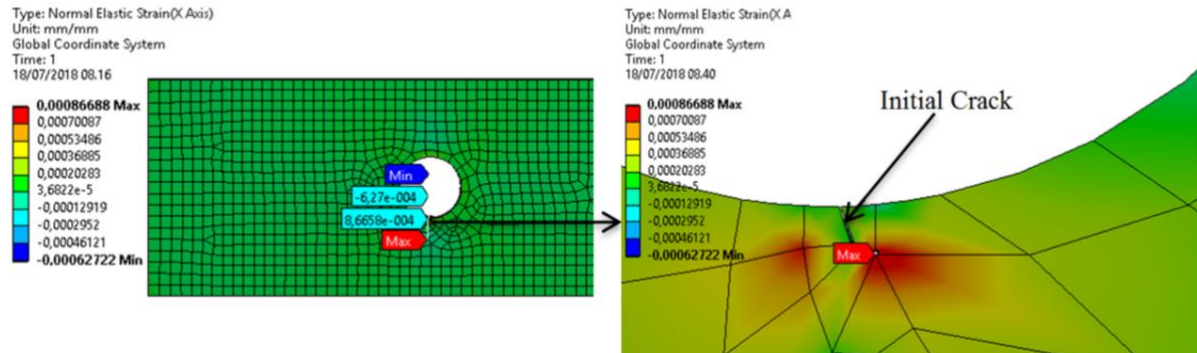
**Figure 11.** The normal strain of leaf spring

The result of strain occurring on leaf spring number eighth with load of 26950 N shown in Fig. 11. The value of maximum strain resulted by simulation was  $8.67 \times 10^{-4}$  at bolt hole area and minimum was  $-6.27 \times 10^{-4}$ . The largest shape change was on the eight spring bolt holes.

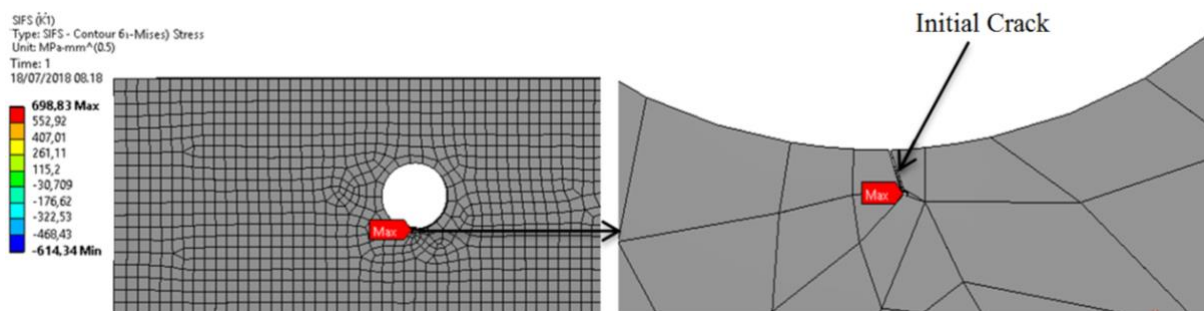
**Figure 12.** Stress Intensity Factor ( $K_I$ )

The results of finite element method analysis for obtaining the stress intensity factor ( $K_I$ ) on leaf springs by modelling the crack length of 4.9 mm in the bolt edge crack are shown in Fig. 12.

The stress intensity factor analysis yielded a value of  $22.09 \text{ MPa}\sqrt{m}$  with a load of 26950 N. The analysis results show that the value intensity factor is close to the fracture toughness ( $K_I \approx K_{IC}$ ). Therefore, this can cause crack propagation due to dynamic loads [9,10]. This fact states that this is one of the causes of leaf spring failure.
