# A case study of urban road subsidence induced by the underground connection of the shield tunnelling method

**Abstract.** A case study of the road subsidence hazard that occurred during the construction of a cable tunnel was conducted. The cable tunnel was built 30 m below the ground surface by using the shield tunnelling method, parallel to a sewage pipe with a diameter of 2000 mm. During shield docking, the bolt of the seal plate in the shield segment ruptured. This rupture led to water flooding into tunnel and the settlement of the ground surface. The causes of the subsidence hazard were analysed and discussed. The results of this case study indicate that risk assessment and hazard analysis of shield tunnels should be conducted separately in the planning, design, and construction phases for ensuring disaster mitigation. To avoid the occurrence of a subsidence hazard, sensors should be embedded 30 m below the ground surface and near the shield machine. Using monitoring sensors and increasing the number of observed frequency are effective in enhancing the settlement sensitivity so as to provide early warning information. Ground improvement is suggested even while using the conc

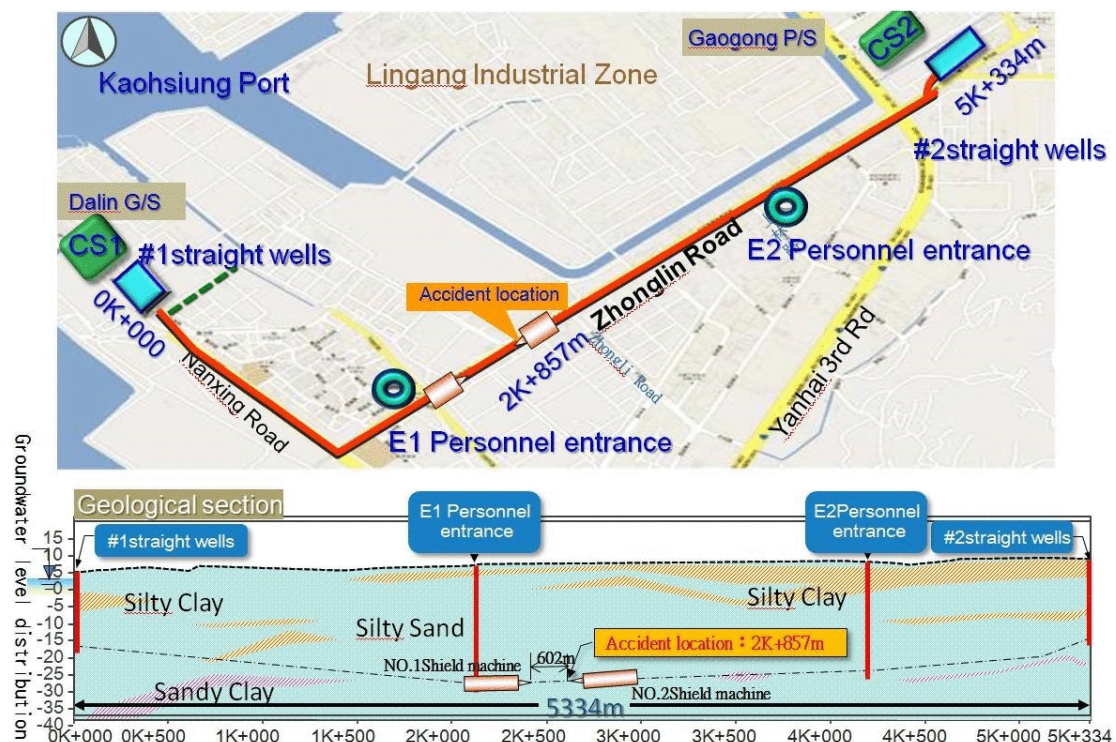
**Figure 1.** Plan illustration and stratigraphic section of the accident location.

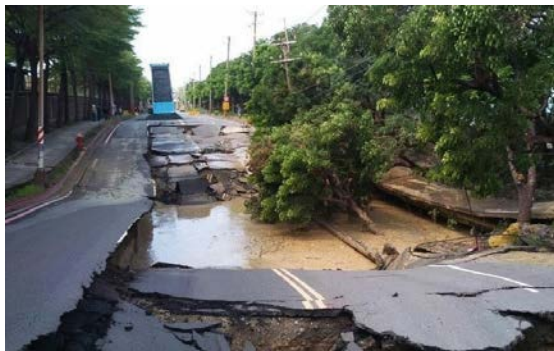
**Figure 2.** Road subsidence due to subsurface settlement.

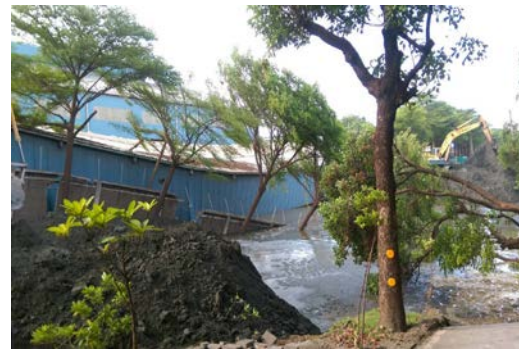
**Figure 3.** Warehouse subsidence due to subsurface settlement.

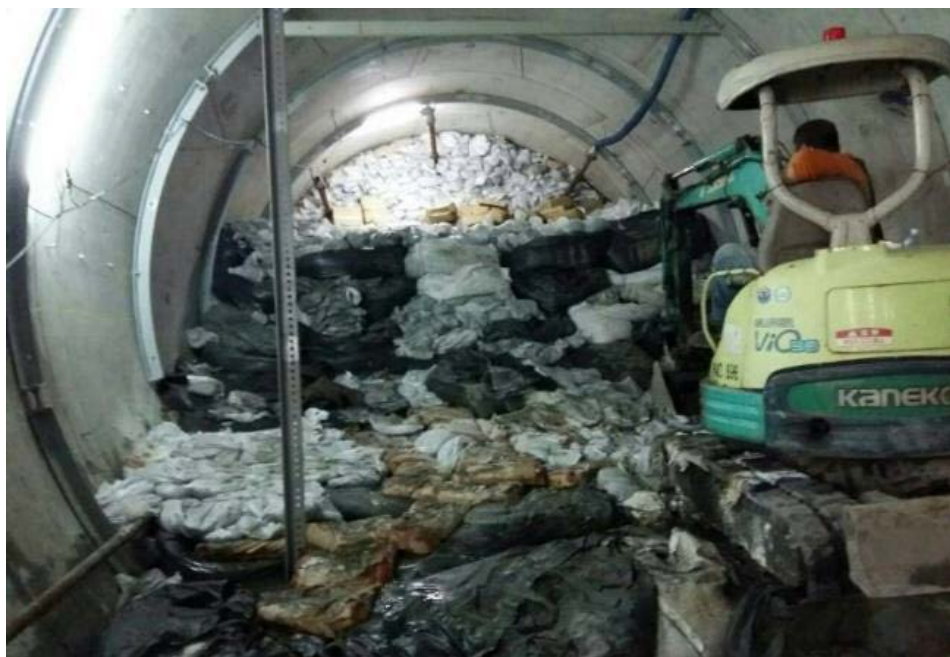
However, mass water and soil continued to flood into the tunnel. Additional emergency measures were taken: 1) sandbags were stacked to stop the water inrush, shown in figure 4, and 2) the hydraulic jacks applied loads to slow down slurry. As large quantity of water gushed out, the local soil under the front shield hollowed. This effect caused the head of shield machine to have a 200 mm subsidence. Then, the back of the connecting shield segment was dragged and began to deform, thus inducing a successive water leakage near the segment joints.

**Figure 4.** Stacking sandbags to stop water inrush in the tunnel.

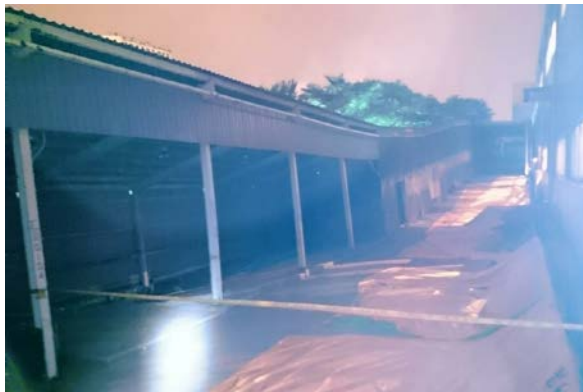
The land subsidence hazard caused a 10-m long and 75-m wide road collapse. Many factory buildings tilted due to the occurrence of alligator cracking on the road, as shown in figures 5 and 6. Moreover, underground pipelines, including telecommunications line, power line, water pipe, sewage pipe, oil pipes, and gas pipes, were damaged. The hazard influenced 4000 power users and 300 water users, and the total loss based on the preliminary estimate was approximately 17 million US dollars.

**Figure 5.** The CPC warehouse subsided due to the land subsidence hazard.

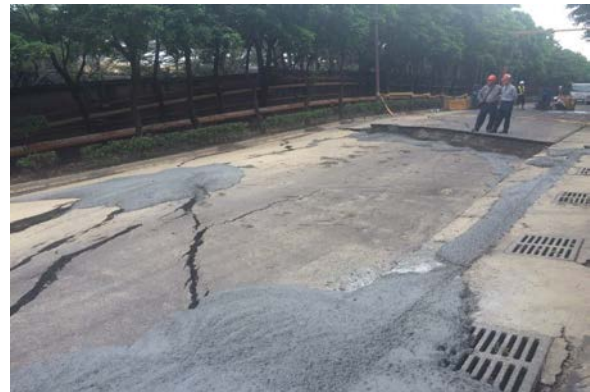
**Figure 6.** Alligator cracking of the road that occurred due to the land subsidence hazard.

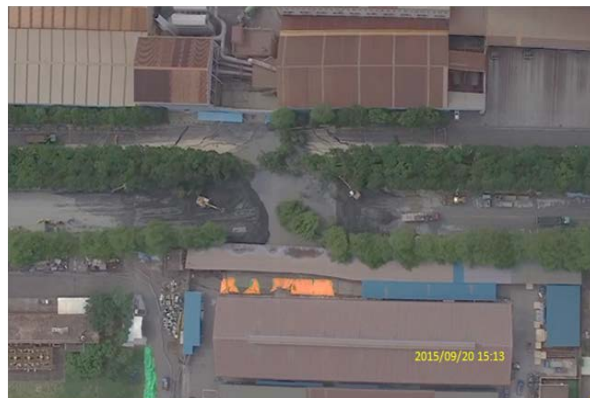
During the period of recovery rescue, aerial photography was used twice a day to manage the hazard-impacted area, and 36 monitoring points were installed at the warehouse of China Steel Corporation (CSC) and Chinese Petroleum Corporation (CPC) near the hazard zone to monitor the change in land subsidence every 2–4 h, as shown in figures 7 and 8.

**Figure 7.** Aerial photo of the hazard-impacted area of the disaster.

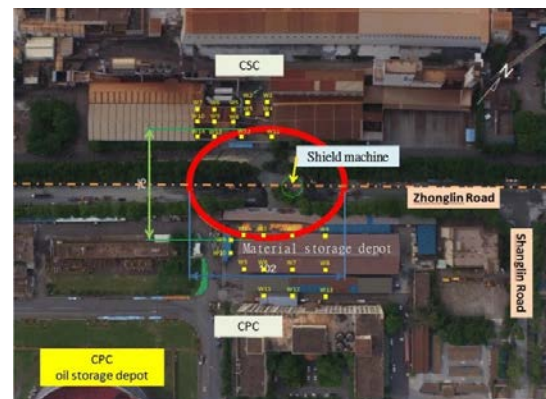
**Figure 8.** Hazard-impacted area and 36 monitoring points nearby, which include 14 points at the CSC warehouse and 22 points at the CPC warehouse.

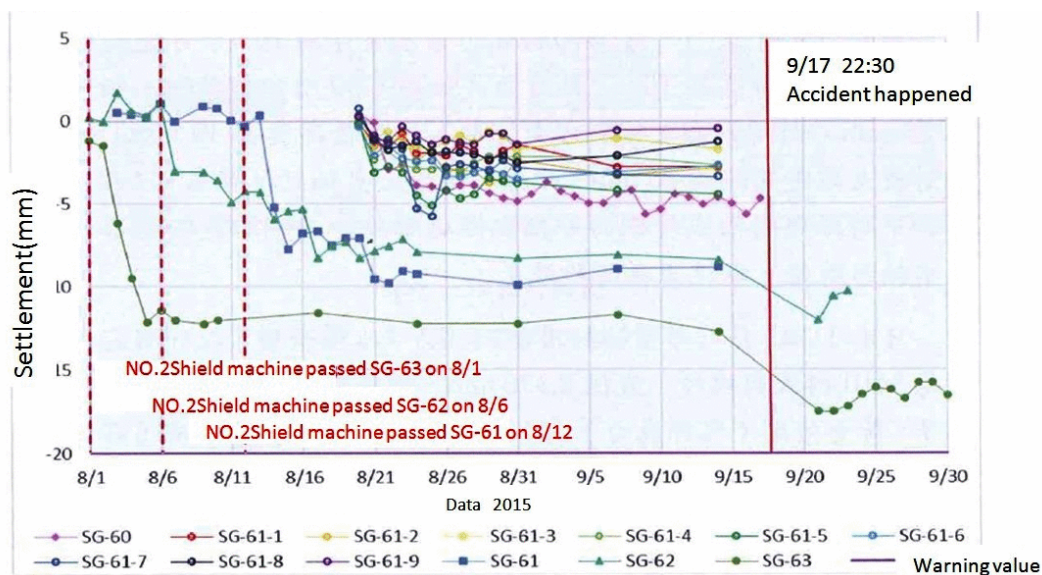
Moreover, in this case, the sensors for subsidence monitoring were installed 2–3 m below the ground surface because there were many pipelines along the construction route. Thus, the monitoring sensors were not installed in the deep soil layer to avoid any harm to the pipes. Only the surface subsidence data in the neighboring area of the accident location (2k + 857 m) were recorded. Figure 9 presents the records of the subsidence near the accident location and 2.2 m below the ground surface during August and September, 2015. Head #2 of the shield machine passed through the settlement monitoring points SG-63, SG-62, and SG-61 on August 1, August 6, and August 12, respectively. Obvious settlements were observed on August 2–5 (at SG-63), 7 (at SG-62) and 13–15 (at SG-61) respectively when head #2 of the shield machine passed through the settlement monitoring points, as shown in figure 9. The settlement of monitoring points at SG-61 and SG-60-1 to SG-60-9 were recorded manually and the last monitoring data were recorded the day before the occurrence of the accident, that is, on September 15. Figure 9 indicates that the maximum settlement value was approximately -10 mm, and all the monitoring values were lower than the warning value of -20 mm. All observed monitoring data of subsidence were normal (less than the warning value) on September 15. This implies that the surface subsidence data showed no abnormal subsidence until the hazard occurred. No subsidence warning signal was provided by the sensors before the hazard because the sensors were embedded 2–3 m below the ground surface and were not 30 m below the ground surface, that is, near head #2 of the shield machine. Therefore, the monitoring sensors were located near the ground surface and far away from the construction site. Thus, they could not present any deep subsidence data which we needed.

**Figure 9.** Subsidence data acquired by the monitoring sensor embedded in 2.2 m below the ground surface, near the accident location.

While using the CID method, a proper soil improvement or freezing method should be used to reduce the hazard of soil sinking. To ensure effective settlement monitoring, the sensors should be installed near the shield machine, for instance, 30 m below the ground surface in this case. The sensors should be spaced more densely, and the settlement monitoring frequency should be modified to once a day instead of once in 5 days to enhance the monitoring sensitivity. Such an enhancement can effectively identify a deformation in the soil layer to achieve early warning of subsidence during shield construction.
