## Analysis of manhole structure Safety of draft tubes in hydropower plant

# Analysis of manhole structure Safety of draft tubes in hydropower plant

**Abstract.** The fault of the manhole on draft tube in a hydropower plant was investigated and analyzed. The results showed that the main reason for the cracking and leakage of the manhole on draft tube was that: the four corners of the manhole were not rounded, so fatigue cracks appeared under the effect of long-term alternating loads, which caused the leakage at the four corners of the manhole on draft tube during unit operation.

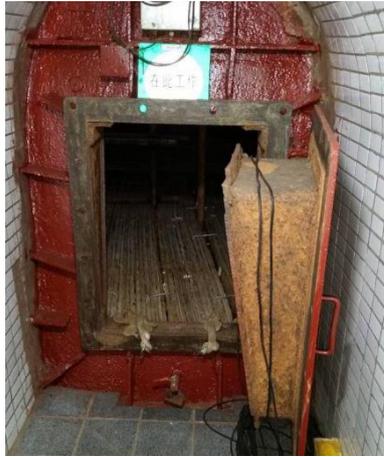
The manhole at tailwater of this unit was a square hole, as shown in Fig. 1. During the inspection, a severe cavitation area with a length of 150mm was found on the surface of the tailwater manhole liner; After the original cavitation site was repaired by welding, the cavitation of different degrees began to appear around the repaired area, as shown in Fig. 2. The fillet welds connecting the liner and the draft tube were detected, one of which had serious cavitation and developed into a crack with a crack length of about 50mm, and the reinforcing plate and the draft tube cracked.

Fig. 1 External appearance of the tailwater manhole

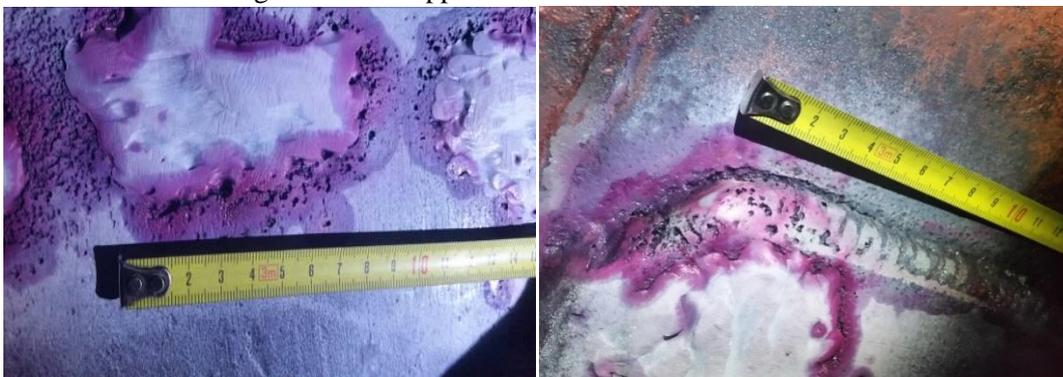
Fig. 2 Cavitation and cracking of tailwater manholes

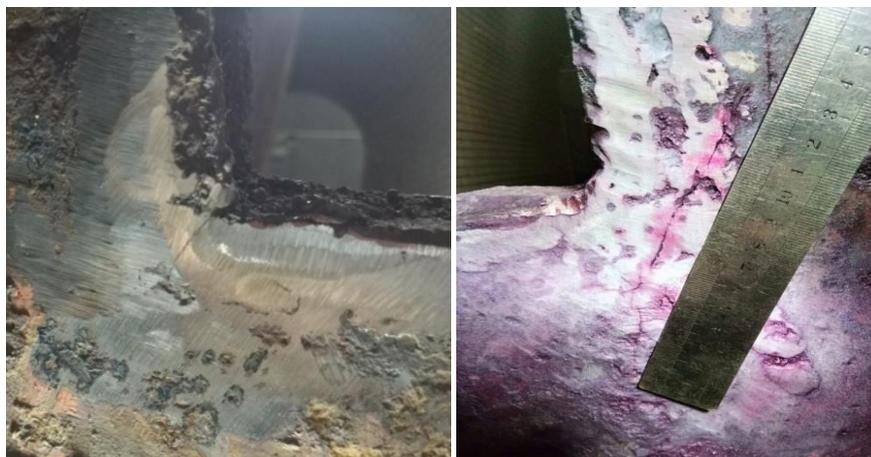
After removing the manhole reinforcement liner, the tailwater manhole was detected, focusing on the four corners of the tailwater manhole. Cracks were detected in three of the four right angles, one of which was a crack in the lower left corner of the tailwater manhole, with a length of about 30mm; There was a crack in the lower right corner of the manhole with a length of about 130mm (Fig. 3). The tailwater manholes of the same type of unit were inspected and similar defects were found. The four corners of the tailwater manholes had different degrees of cracks which caused different degrees of water leakage (Fig. 4).

Fig. 3 Cracks on the tailwater manhole

Troubleshooting revealed that the cracks were mainly concentrated in the four corners of the manhole. The tailwater manhole was a square hole, and there was obvious stress concentration on the square hole at right angles. According to the clause 4.2.1.17 of GB/T 15468-2006 “Basic Technical Conditions of Hydraulic Turbines”, when the square manhole door is used for the draft tube, the four corners should be rounded. The four corners of the tailwater manhole were right-angled, not rounded, so they did not meet the standard requirements. Under long-term cavitation and welding repair cycles, the four corners of the tailwater manholes were rough and uneven, easy to cause local stress concentration.

When the operation conditions of the unit were poor, such as when the unit was being operated in the vibration zone, the draft tube of the unit would vibrate obviously. The draft tube, including the tailwater manhole, was under the alternating load. The unit was put into operation in 1987 and has been in operation for more than 30 years. The alternating stress had been acting on the tailwater manhole for many years. Because the four angles of the manhole were right angles, the stress concentration was obvious compared with other parts, and long-term alternating load effects led to fatigue cracks there.

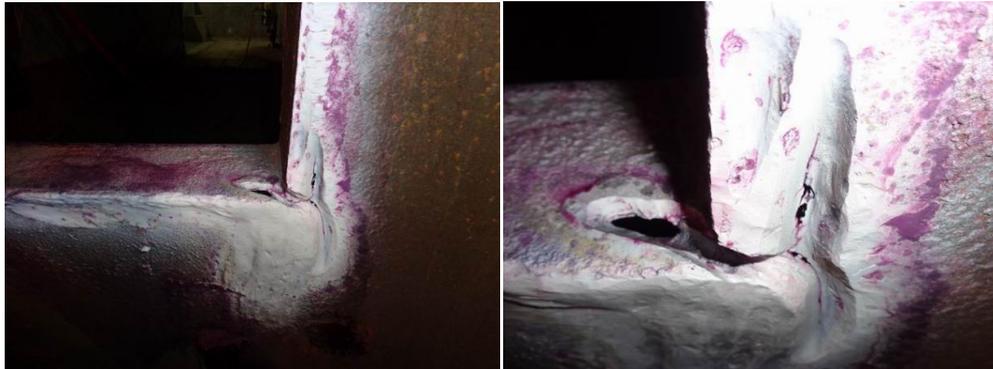
Fig. 4 Cracks on the four corners of other tailwater manholes

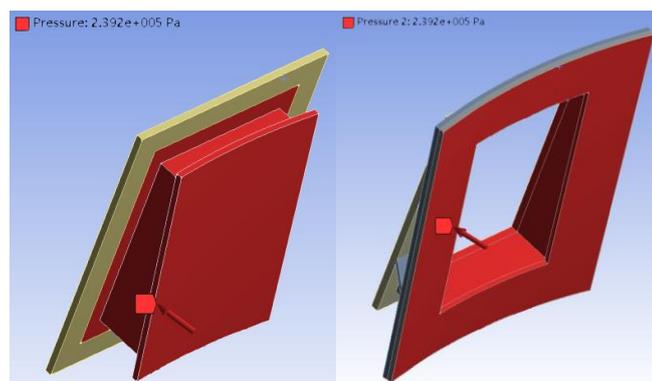
Fig. 5 Hydraulic load applied surface of the tailgate

The stress situation of the tailwater manhole was simulated and analyzed. The element solid185 was used to divide the finite element mesh, with a set internal pressure load  $P_e=0.2392\text{MPa}$ . The constraint condition was that the top surface around the tailgate was fixed. The hydraulic load surface is as follows:

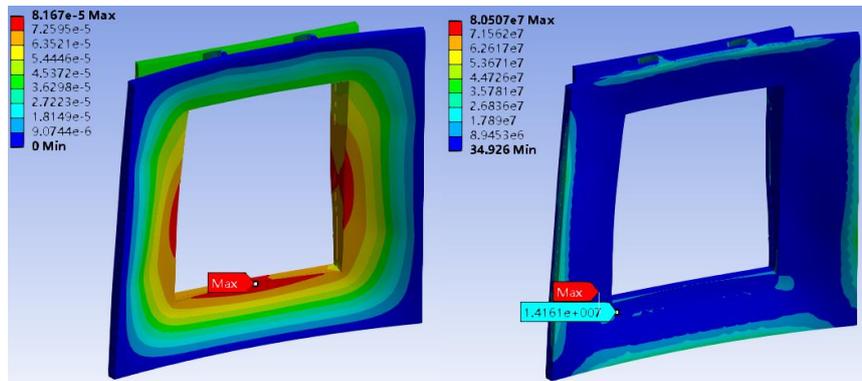
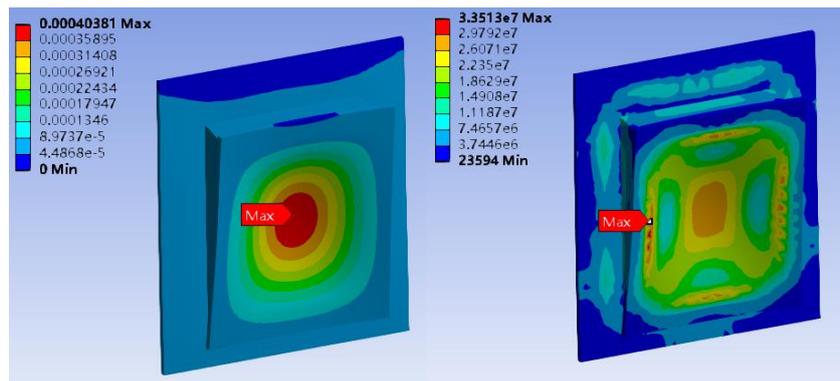
Fig. 6 Finite element calculation results of manhole cover and base of the draft tube

By calculation, the maximum deformation of the structure was 0.4mm, appearing in the middle of the inner panel of the door cover, where the middle of the inner panel was empty, so the deformation was relatively large under the effect of water pressure. The maximum stress was at the contact between the support plate of the manhole seat and the reinforcement liner of the draft cone tube. The results are shown in Fig. 6 and Table 1.

(a) Deformation of the manhole base (b) Stress on the manhole base

(c) Deformation of the manhole cover (d) Stress on the manhole cover

The calculation results showed that the stresses of the entrance door and the entrance seat of the tailwater spinal canal met the requirements of GB / T15468-2006 and ASME. At the right angle of the entrance seat, the stress is small and the safety is high. The rounded corners will further reduce the stress, but the impact on the safety of the entrance door is small [4,5].
