Conservation purpose material testing of corrosion products on outdoor bronze statues

Abstract. A detailed material testing was carried out before the conservation project of the János Arany statues of Garden of Hungarian National Museum. The scope of the testing to analyse the corrosion products on the surface and help to develop the best cleaning and protection practice. Samples were taken from more areas and the samples were analysed by SEM-EDS, XRD, FT-IR methods. This article introduces the results of the testing and the relevant effect to the conservation process.

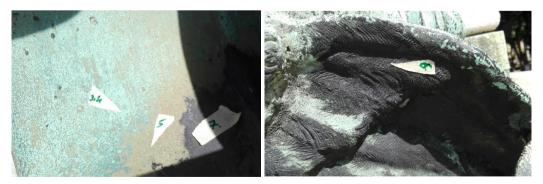
Figure 2. The different type of corrosion products on the surfaces of status. Right image shows a black and porous green layer, left image shows the continuous green and yellow-brown layer with a black covered area.

Field portable X-ray fluorescence (pXRF) analysis was performed on the statues in several regions. The aim of this examination was to determine the elements and assumed chemical composition. Basically, four different corrosion product were identified on the surface: i, surface areas covered by black layer; ii, vellow-brown layer; iii, porous green layer on the surface; iv, continuous ductile green layer. The documentation wrote a bronze bas material. Measurements in different areas has been confirmed the documentation's copper and tin content. Silicon, aluminium and iron content also was detected in these areas. However, silicon and aluminium content were significantly higher in the black layer. Phosphorus was detected in the yellow-brown areas, which could be dangerous in terms of cleaning. Higher sulphur content was detected at the green layers, which originated to the patina first. Oxford XMET 8000 type pXRF analyser was used for the measurements. Powder samples were taken from the mentioned areas from more positions and statues. First energy dispersive X-ray spectroscopy (SEM EDS) were made with a Hitachi -S4300 CFE to study the structure and the chemical composition of the different materials. XRD measurement were made with a Bruker D8 Advance to identify the different compounds. Only a small amount of samples could be collected, so the identification was hard. FTIR analysis was performed to find possible remains of a prior treatment with organic or polymeric materials. Samples were taken from the continuous green sample; which brittleness was tested by microhardness tests.

The results suggest that it was necessary to remove the black and the yellow-brown layer from the surface of the statue. The green layers could be left over the surface and could be used a patinating process to equalize the outlook of the surface. The black and yellow-brown layers are brittle layers and easily detached from the statue, so a mechanical cleaning process (blasting) can be used. Neither polymeric nor other organic substances were found which makes necessary a special chemical treating during the cleaning. Chlorine or other substances also did not find which could cause problem during the patinating process.

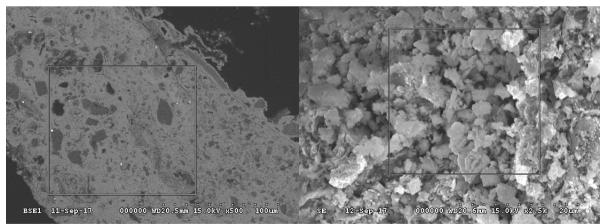
Just small amount of powder, and small parts were possible to collect from the different layers. So, a detailed SEM-EDS study was made to see the microstructure of the layer, and the local chemical compositions. SEM-EDS analysis show the structure of the different layers. The black and yellow-brown layer built-up from particle agglomerates, where different particles, dust sticked together (Figure 3. right) The green layer is really a continuous one, where particles are integrated to a matrix. It was observed during the sampling, the black and yellow-brown layers are brittle, and these are easily detached from the surface. It was suggested to remove it during the conservation process due to this property. Additionally, in the case of yellow-brown layer EDS analysis showed high iron content, the colour of thin layer originates to the iron-oxide content.

Figure 3. The structure of the continuous green layer (left micrograph) and the yellow-brown layer (rignt micrograph).

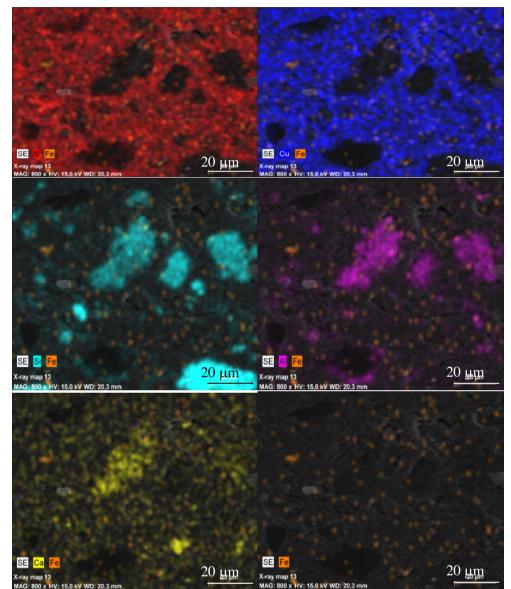
Figure 4. Element distribution map of the surface of the continuous green layer. The matrix is the patina the particles are from dust.

The green layer seems compact and it was hard to remove from the surface during the sampling. It was also analyzed, and high copper and sulfur content were measured, so this assumed as the patina layer. Figure 4 shows the distribution of different elements in a typical cross section of this layer. It reveals that the particles have a high aluminum and silicon content. These elements clearly distinguish the particles and the matrix. Calcium content detected in the particles only, which did not contain sulfur. This shows that the layer either contains calcium, but not in gypsum form, it come from the dust. An interesting observation is that the iron distribution is nearly uniform, and small particles can be seen mainly in the matrix material. Chlorine did not detect, so chlorides or other substances which contains chlorine did not exists on the surface of the statutes.

These results show that the particles are also from dust, which deposited to the surface. The matrix is the real corrosion product, the patina which growth continuously during the corrosion process. The patina layer involved the dust particles with its growth process. The results of the EDS analysis and the suggestions will compare to an XRD phase analysis later.

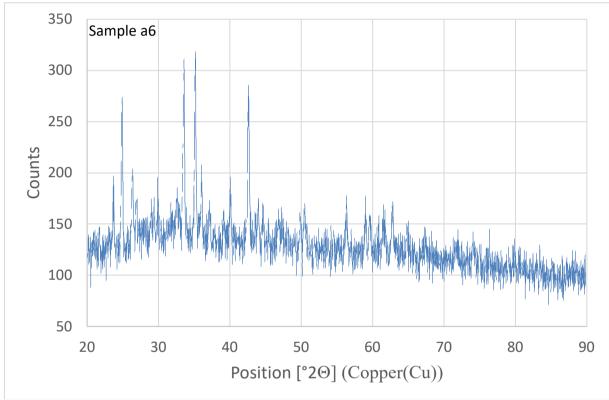
Figure 5. The XRD spectrum of the green layer.

The XRD analysis of the green layers were performed (Figure 5. sample a3). The intensity in the XRD spectra was low due to the small amount of samples but $CuSO_4 \cdot 2Cu(OH)_2$ and $CuSO_4 \cdot Cu(OH)_2$ were clearly identified as the components of the patina layer. The SEM-EDS observations helped to identify the different compounds. Al₃Fe₅O₁₂+SiO₂ identified as dust particles. Next to these SnO, CuO₂ and Fe₂O₃ oxides were found in the sample. Tin and copper oxides are also a corrosion product of the raw material. The SEM micrograph revealed the distribution of the iron-oxide particles. The XRD analysis told nothing about the status of calcium due it's small concentration.

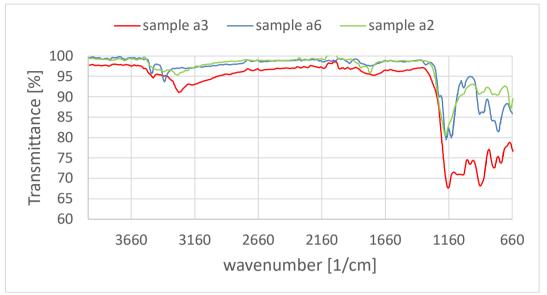
FTIR analysis of the samples performed to look for organic material or polymers from a possible previous treatment. Without any treatment the samples examined and neither organic nor polymeric materials were found (Figure 6.). The curves on Figure 6 cannot show any radicals or organic substances. Three samples were tested: a2, a3 and a6. Samples a2 and a3 are taken from green layer. Sample a2 was taken from Toldi's sword, sample a3 take from Toldi's helmet. sample a6 is a sample from the black layer and it was taken from Toldi's helmet. There is no significant difference in the FTIR spectra. Just a small amount of carbonates could be identify.

Figure 6. The FTIR spectra of three different samples of green layer.

The FTIR spectra identified only carbonates which either could be a copper compound in the patina layer or calcium-carbonate content of the dust particles. These results show another evidence the absence of gypsum in the layer.
