Health assessment of large and old trees in Ragunan Zoo, Jakarta

**D Nandika^{1*}, H Kusuma¹, D T Kusumawardhani¹, E Rumiati², Tata²,
L Karlinasari¹, and I Z Siregar³**

²Taman Margasatwa Ragunan (TMR)- Ragunan Zoo, Jakarta Selatan 12550, Indonesia

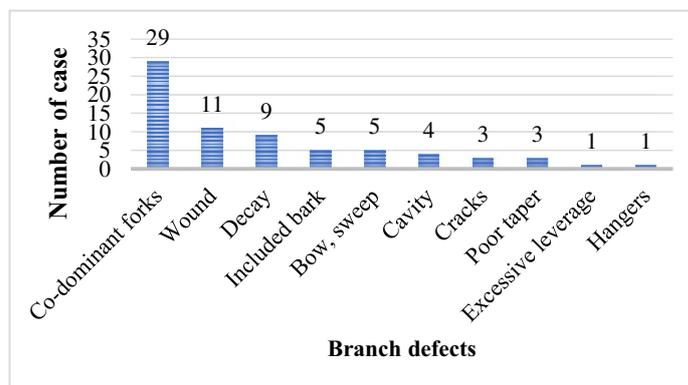
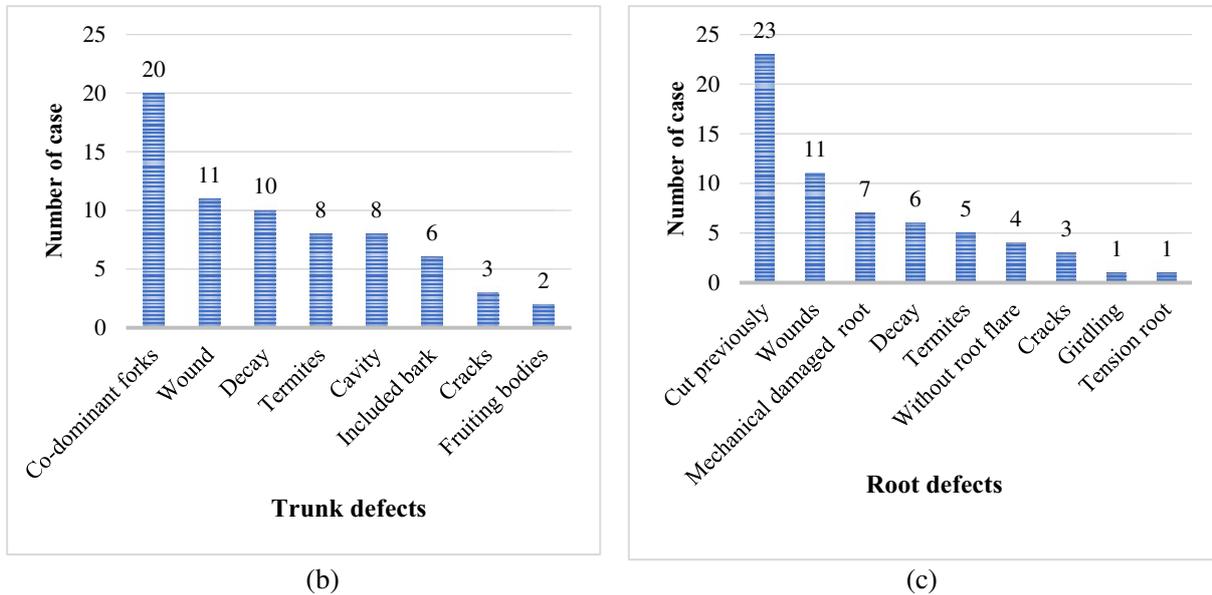
Every damage to every part of the targeted tree was observed (Figure 7). The most common defect on the roots was mechanical damage, such as cut off roots, wounds, and others caused by the surrounding's construction and buildings. Weathering and decay that occurs in trees can be caused by many factors, such as termite attack, fungus, or water infiltration. According to Tainter and Baker [23], decay usually starts from the middle (heart decay), but it can also start from the outside (tree bark). If decay occurs from the middle, it will reduce more than double the wood volume. Economically, trees that experience decay will have low value [24]. In terms of security, trees with large diameter and are located in human-accessible locations are considered dangerous, especially if the stems are weathered and porous. Therefore, they need regular maintenance so as not to endanger the tree structure.

The symptom defects, such as subterranean termite tunnels, and the fungus fruiting bodies on the targeted tree must be anticipated because they can endanger the condition of the tree. The presence of subterranean termites was marked by soil traces in the tree. According to Zulkaidhah *et al.* [25], subterranean termites always come in contact with the soil because they live there. Meanwhile, the pests absorb food sources from the host tree so its health will be affected. The higher the attack frequency, the higher the aggressiveness, which means more damages to the host tree [26]. The wound, cavity, and cracks of the stem need to be anticipated so that they will not interfere with the tree structure. If not, they will trigger infection from various pathogens (fungi, bacteria, viruses, microplasma, nematodes) into plant tissue [27].

Figure 7. (a) Branch defects distribution and (b) Trunk defects distribution of targeted tree (c) Root defects distribution of targeted tree

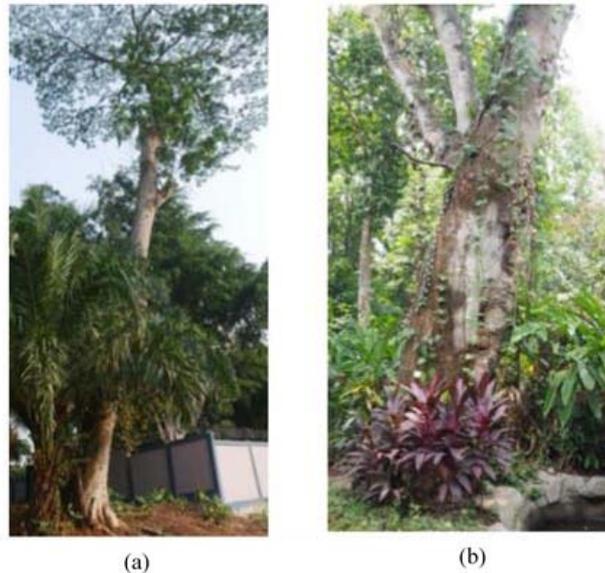
Figure 11. Targeted tree number 37 (Sengon, a) and number 49 (Sengon, b)

The result showed 31 trees were only fairly safe, while 5 of them were classified as safe. The dangerous and very dangerous trees have one tree each (Figure 10). Number 37, which is classified as dangerous, is a Sengon tree whose trunks are damaged due to a subterranean termite attack. Meanwhile, number 49 (Sengon) is categorized as very dangerous because it also has some heavily damaged trunks and was located on a puddle that causes heavy weathering. The LCR of both trees is at <45%.

of failure are fairly dangerous to make similar observations no later than 6 months after the previous one. Meanwhile, trees with a risk of very dangerous failure are recommended to be cut down. Most of them are Sengon a species which are not historical tree.

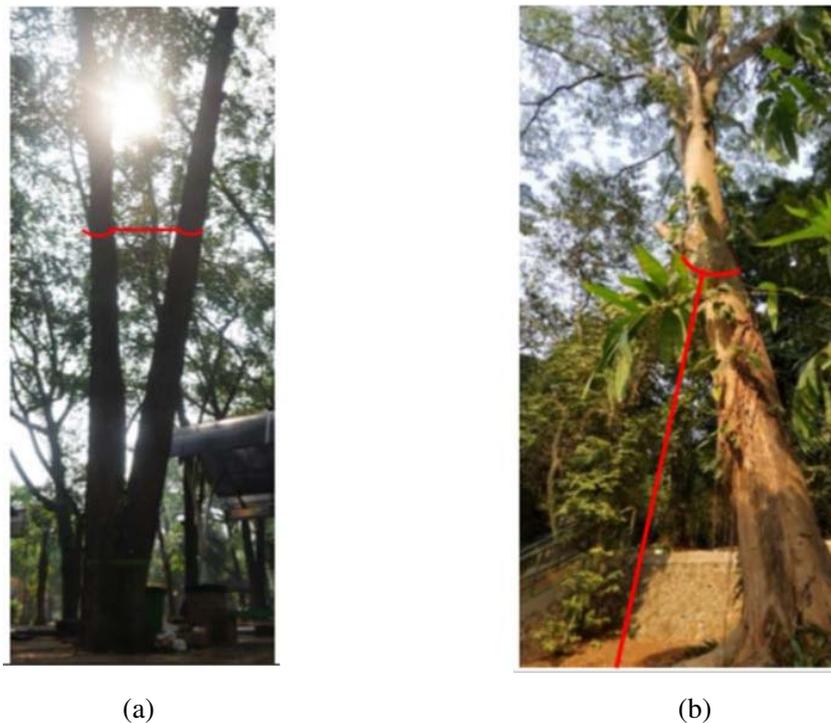
Figure 13. Simple lines for (a) Application technique of dynamic “sling” (b) Tree stand for leaning targeted tree

Several target trees have a tree trunk with a slope of $>20^\circ$ that requires treatment with the support of a certain height using reinforced construction made from two intersected galvanized iron trunks (10 cm in diameter). For some of the trees with codominant branches, dynamic slings can be made (Figure 13). Trees with a risk
