# Earthquake damage of self-built reinforced concrete frame structures in $M_S$ 8.1 Nepal Earthquake

#### Peilei Yan and Baitao Sun

**Abstract.** An earthquake measured Ms 8.1 occurred near the Nepal Pokhara on April 25, 2015(Beijing time). As a member of China to Nepal disaster assessment team, the author conducted thorough investigation about the earthquake damage of all kinds of engineering structure in Nepal. Self-built reinforced concrete frame structure which is widely accepted by the people at all levels in Nepal and is one of the building structure forms which are widely built suffered damage by varying degrees in the strong earthquake and aftershocks. Based on the seismic damage investigation date of the earthquake and its aftershocks, the characteristics of aseismic construction are summed up, the damage characteristics and the reasons of its destruction are analyzed. The main problems in the design and construction of the structure are pointed out. The advices on the existing problem of self-built reinforced concrete frame structures are given.

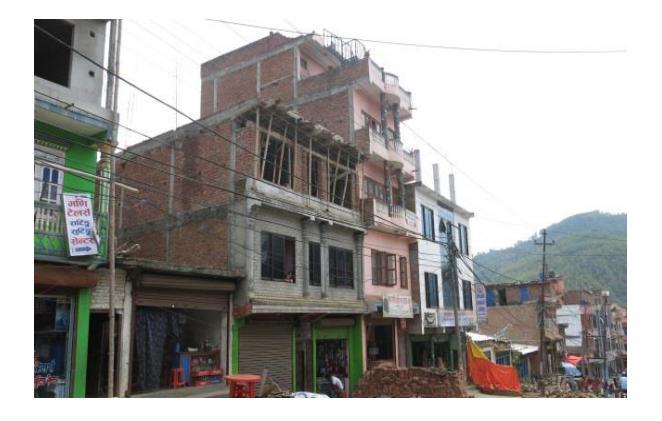
Self-built reinforced concrete frame structure are mainly 3-5 layers (Fig. 1). The top of general structure are ready to be followed by half layer of reinforced concrete columns and exposed steel cage(Fig. 2). Storey height is 3.0m. Layout is symmetric regularly. Column space is from 3m to 3.9m.

Fig.1 Overall picture of self-built reinforced concrete frame structure

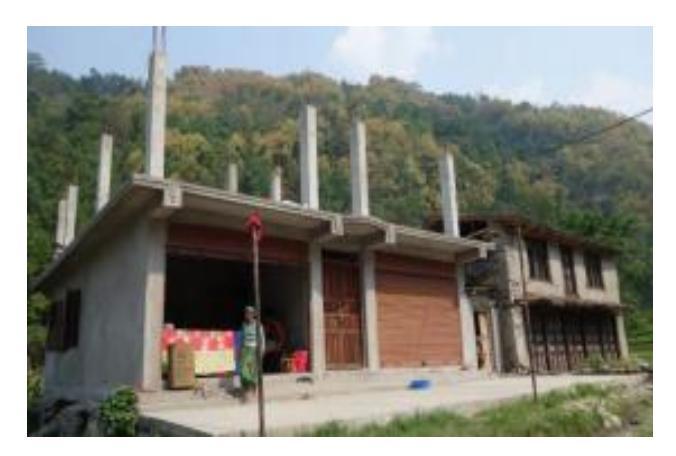
Fig.2 Reserved reinforced concrete column and steel cage on the top floor

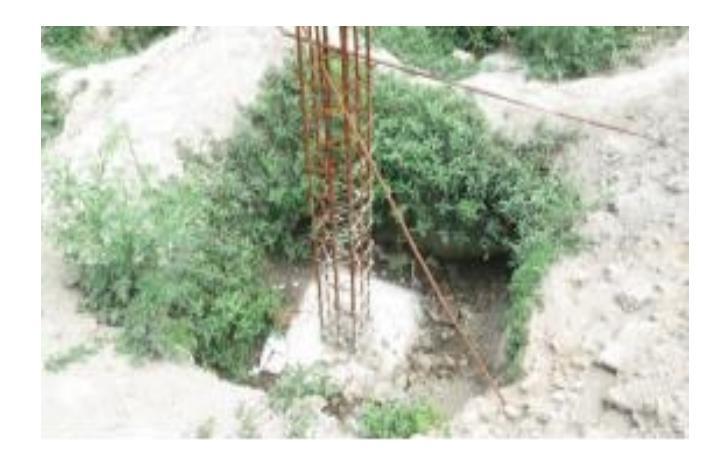
The structure use independent column foundation; the size of frame column section is  $230 \text{ mm} \times 230 \text{ mm}$ ; longitudinal bar is 6A12 and stirrup is A6@120, without reinforcement of stirrup encryption in frame columns (Figure 3); the size of frame beam section is  $300 \text{ mm} \times 230 \text{ mm}$ ; the majority of beam section's size is greater than the column section's size, violating the specification requires for a "strong column, weak beam"and component section with minimum size concept design principles of all countries in the world; floor and roof panels use cast-in-place reinforced concrete floor slab, of which the thickness is 100 mm; infilled walls use solid brick ( $220 \text{ mm} \times 100 \text{ mm} \times 50 \text{ mm}$ ) and mud masonry; the outer wall thickness is 220 mm, the inner wall thickness is 100 mm; the wall and the frame column (Figure 4).

Fig. 3 Reinforcement of frame column

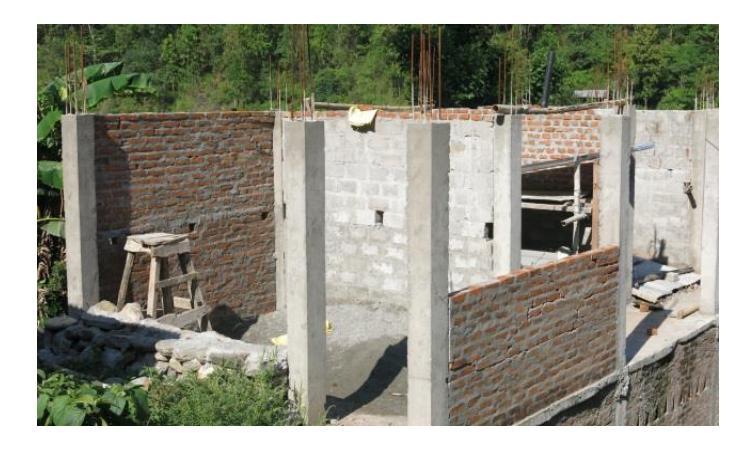
Fig.4 Structural Rachel measures between infilled walls and frame columns are not set

bottom of the beam during construction.Cement mortar masonry should be used in the infilled wall. And at the same time, enough construction rachel measures should be ensured between the infilled wall and the main structure.

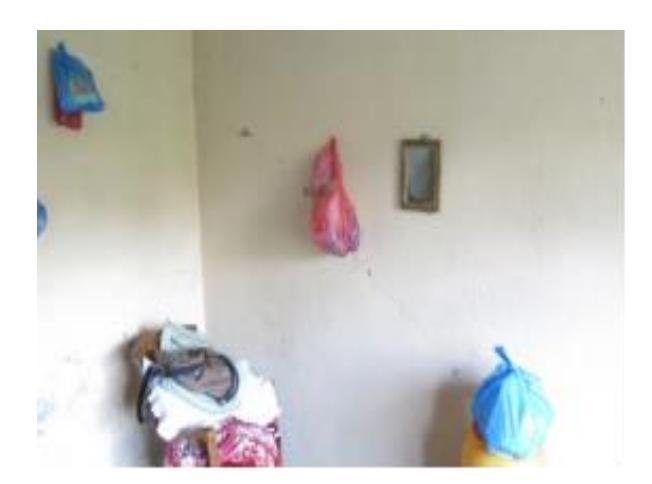
In VI zone, there were no obvious damage in infilled walls. In VII zone, the bottom infilled walls run through the inclined cracks or cross cracks (Figure 5). In VIII degree, the bottom infilled walls run through the transparently inclined cracks or cross cracks (Figure 6).In IXdegree, the bottom infilled walls collapsed partially, and were damaged heavily (Figure 7).Using mud masonry in the infilled wall lead to the low level of walls' shear strength. Under the action of reciprocating horizontal earthquake, a large number of shear cracks or cross cracks happened in the infilled walls; at the same time, the infilled walls had external flash, or even collapsed in high intensity area because there were no reinforcement structure filled between the walls and the frame columns.

Fig.5 Destruction of infilled walls in the region of VII degrees

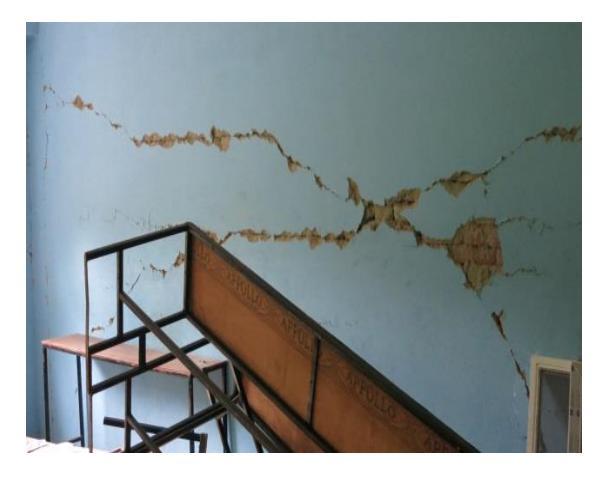
Fig.6 Destruction of infilled walls in the region of VIII degrees

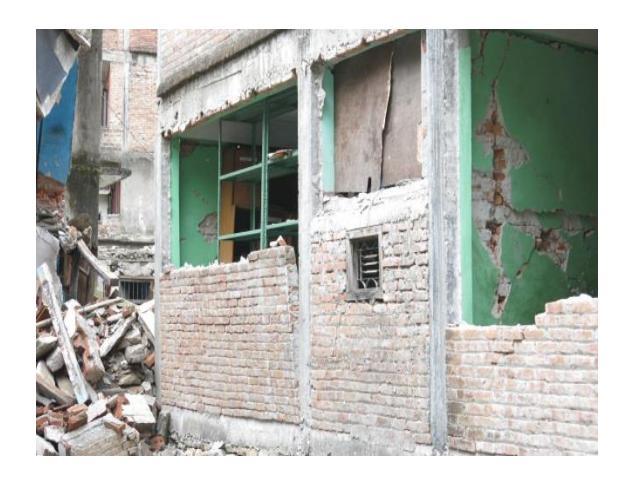
Fig.7 Destruction of infilled walls in the region of IX degrees

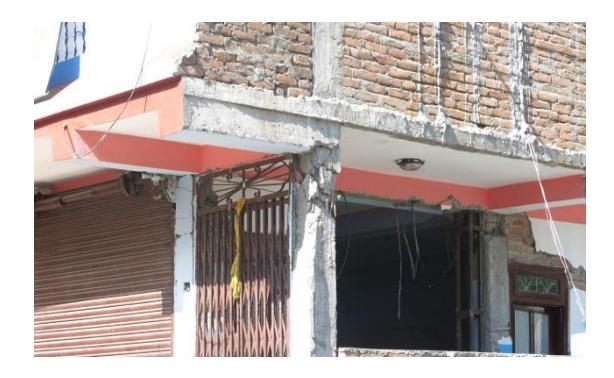
In VIII degree area, shear failure occurred at the top of a small quantity of frame bottom columns (Figure 8); In IX degree area, shear failure occurred at the top of some frame bottom columns, shear failure occurred at the middle of a small quantity of frame bottom columns (Figure 9). In self-built

reinforced concrete frame structure, the size of beam section is generally greater than that of the column section and the reinforcement of reinforced beams are often stronger than the column, resulting in the formation of "strong beam weak column" mode in the structure <sup>[1-3]</sup>. At the same time, the lack of joint hoop reinforcement near the beam and column node area <sup>[4-6]</sup> lead to less reinforcement brittle damage on the top of column more easily. At the same time, there is an inherent weak link in the top of the column because most of the frame columns were poured directly to the bottom of the beam during construction. It increased the destruction of the top of the column under the horizontal earthquake reciprocating action, eventually leading to shear failure occurred on the top of the column.

Fig.8 Destruction of the top of the underlying columns in the region of VIII degrees

(5) In view of the existing problems of self-built reinforced concrete frame structure, it is proposed to strengthen the supervision and review of the new reinforced concrete frame structure by the government departments of Nepal.The cross-sectional area of the frame column should be strictly ensured in the structural design, and enough stirrups encryption area should be set up in the beam - column joint area at the same time. We should ensure that the self-built frame structure is a "strong column and weak beam" ductile structure, and the frame column should not be poured directly to the

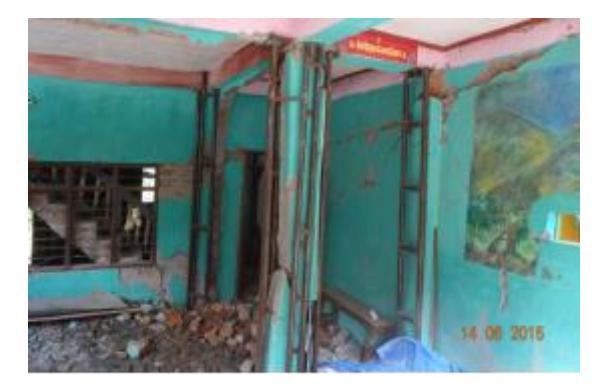
Fig.9 Destruction in the middle of the bottom frame columns

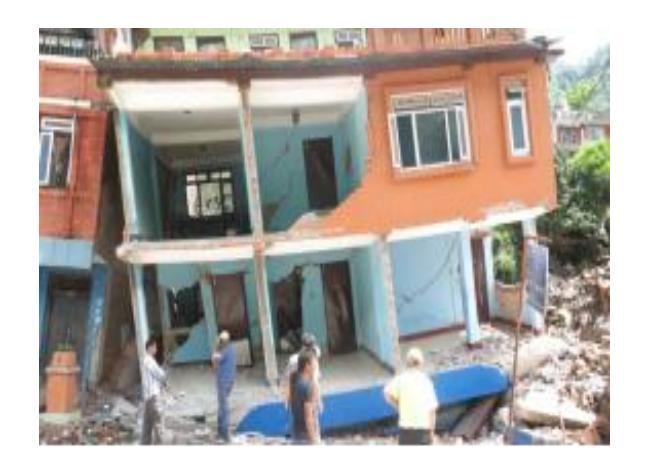
In IXdegree, the disappearance of bottom layer occurred on parts of self-built reinforced concrete frame structure. The research found that most of the bottom columns suffered severe shear failure in the main shock. In the following 3larger aftershocks, the damage on the top of columns continued to increase until the underlying structure disappeared (Figure 10).

#### Fig.10 Collapse of the self-built reinforced concrete frame structure

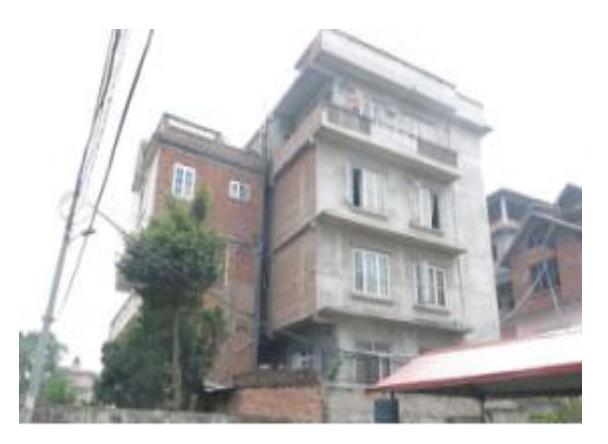
Due to the limited land resources, the density of buildings in Nepal's towns is extremely high and the spacing between adjacent buildings is extremely small. And the design and construction of self-built reinforced concrete frame structure has not been effectively supervised by the government. The above two reasons lead to obvious differences of dynamic performance of adjacent structures, adjacent buildings collide and the structure is damaged in the earthquake. (Figure 11)

Fig.11 Collision damage to adjacent structures

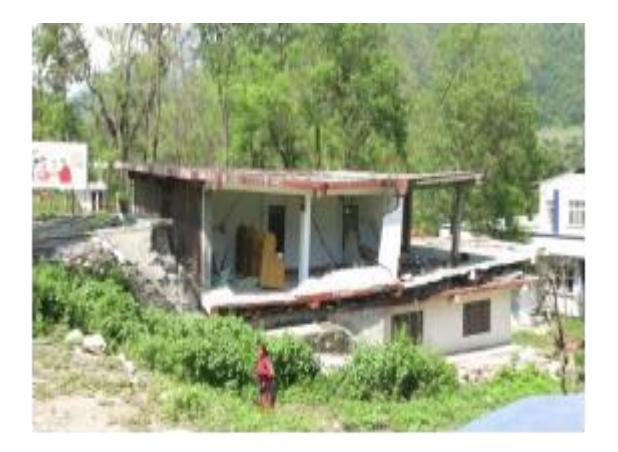
Parts of the self-built reinforced concrete structure were built along the road. Structure were close to the road subgrade or connected by rigid connection with the road subgrade. Because the dynamic performance of the structure and subgrade is different, the two collide with each other in the earthquake, resulting in serious structural damage and even collapse. (Figure 12).

Fig.12 Collision damage between self-built reinforced concrete frame structure and highway roadbed
