To cite this article: Etienne Godin *et al* 2014 *Environ. Res. Lett.* **9** 105010

# Effects of thermo-erosion gullying on hydrologic flow networks, discharge and soil loss

Etienne Godin<sup>1,2</sup>, Daniel Fortier<sup>1,2</sup> and Stéphanie Coulombe<sup>1,2</sup>

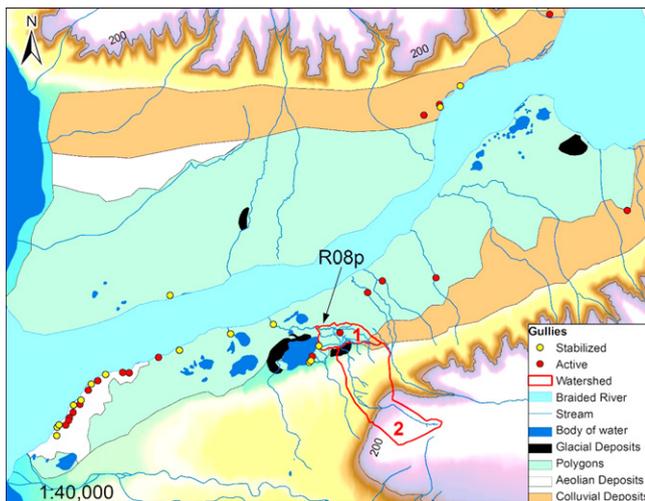
**Figure 1.** The valley of glacier C-79. Red and yellow dots indicate the location of active gullies and stabilized gullies, respectively. Intensively studied gully R08p is indicated on the map along with its watershed and sub-sections.

In the valley of glacier C-79 on Bylot Island, 35 thermo-erosion gullies were identified and mapped since 1999 (figure 1). The gullies covered in this paper consist of a contiguous network of thawed polygon troughs and edges resulting from the partial erosion of numerous low-center polygons. One of these gullies was closely monitored since its inception in 1999 (Fortier *et al* 2007). Water tracks existing on the terrace before the formation of the gully were visible at the current gully location on aerial photography from 1972. Water tracks and stream flow were captured by headward gully thermo-erosion, increasing connectivity (Pringle 2003) and further enabling transport of sediments and nutrients (Bowden *et al* 2008).

A 1.74 km<sup>2</sup> watershed encompassed the gully R08p (figure 1). About 81% (or 1.41 km<sup>2</sup>) of the watershed occupied by a sequence of plateau, slope and lateral moraines generally characterizing the southern wall of the valley, south of the gully. Few changes were observed between the 1972 and 2010 observations in this contributing area of the watershed. Since the focus of this research is the gullying of polygons on the terrace, the watershed was divided in two contributing area: sub-unit 1 (0.33 km<sup>2</sup>) on the terrace and sub-unit 2 on the slope and plateau (figures 5(a), (b) in yellow).

The gully R08p (figure 1, figure 5) was measured during summer 2013 for its eroded area and volume. The eroded volume of the gully R08p was estimated at 32 093 m<sup>3</sup> for 22 574 m<sup>2</sup> in channelled area. When taking into account the whole gully network, including partially eroded polygons, baydzhherakhii and local ground subsidence caused by gully-ing the area in 2013 was 28 891 m<sup>2</sup>. The mean depth for the gully channel was 1.42 m. Nevertheless the typical cross-sections geometry of R08p varied tremendously along the

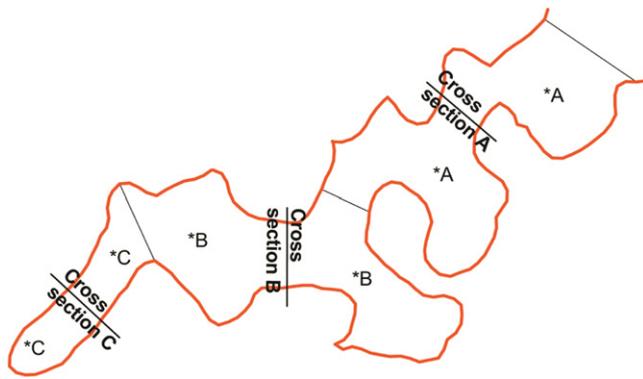
**Figure 2.** Cross sections were measured in the gully as indicated by the black lines labeled ‘Cross section A, B, and C’. Average depth was calculated for each cross section and multiplied by its proximally similar area \*A, \*B and \*C.

Gully R08p was monitored with precision for linear erosion rates of gully branches, and total eroded volumes of permafrost. Gully margins were mapped with a GNSS in 2013. Gully topographical cross-sections were measured with a Trimble VX Station at 29 emplacements distributed across the whole gully, including shallow retrogressive thaw slumps, stabilized sections and recent, deeper sections. 20 to 40 tri-dimensional measurements were obtained for each cross sections. Each cross-section profile was simplified from 3d to 2d by summing vectors from point to point. Each profile line was fitted (using a 3rd to 10th degree equation depending on the complexity of the profile). Depth values were obtained using the resulting equation at intervals of 20 cm, and thereafter averaged. The average depth of a given cross section was multiplied with a section’s area to obtain an eroded volume (figure 2). The volumes of all the sections of the gully were summed to obtain the total eroded volume. Only the channels were taken into account for volume calculation, which excluded non-collapsed polygon centers for instance.

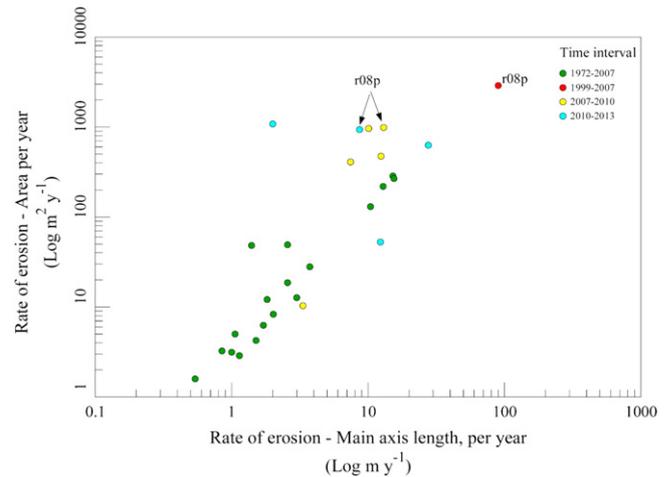
**Figure 3.** Rate of erosion for active gullies in the valley, per interval. Log scale was used for clarity. R08p as indicated on the figure had the fastest development in recent years.

The group of four yellow dots (figure 3) representing active gullies during 2007–2010 were all within the same range for development rates, suggesting a relatively recent initiation (1990 to early 2000)—following the aforementioned model of evolution.

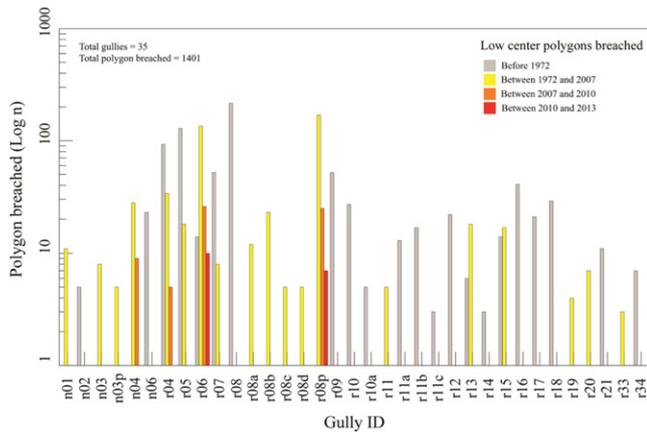
**Figure 4.** Frequency histogram counting the breached polygons on site either existing before 1972 (gray) breached between 1972 and 2007 (yellow), 2007 and 2010 (orange) 2010 and 2013 (red). Y-axis is log scaled. Total count of breached polygons in the valley was 1401 in 2013.

As gullies evolved through time, polygons ridges, troughs and even polygon centers were eroded or breached. Figure 4 display, per individual gully, the count of breached polygons in the valley, per interval. Gray bars indicate the quantity of polygons which were already eroded on the 1972 image mosaic, totalling 803, with a mean of 37 polygons per gully, count varying between three and 216 per gullies. Between 1972 and 2007, 516 polygons eroded over 35 years, resulting in a rate of 15 new polygon breached per year during that interval (yellow bars). Between 2007 and 2010, only 4 gully enlarged enough to breach new polygons, for a total of 65 (orange bars) with an average of 21 per year during that interval. 17 were breached between 2010 and 2013 within two gullies (red bars). The total accounted polygons breached in the valley was 1401 as of 2013.

Apart from polygon troughs and ridges forming in the 1% slope of the terrace and occasional pond located at troughs intersect, this terrain unit was relatively uniform. Between 1972 and 2013, the contributing area 1) (0.329 km<sup>2</sup>) (figure 1) saw drastic changes. In 1972 there was 4.4 km of water tracks and distinct drainage channels were absent, but by 2013 the channelized flow was 1.53 km in length. While channels shapes varied widely, from less than 1 m to more than 4 m deep and up to 20 m wide, the gully formation was morphing the flat terrace toward a dissected, incised surface. Gully heads were evolving at the rate of the gully erosion, generally toward water sources to the south and east (figure 5(b)), while simultaneously eroding polygons ridges and breaching low-center polygons along the way. Thus, the partially breached polygons had their water conservation capacity reduced and the progression of the gullyhead further prevents any eventual recharge of the polygon as the feeding source is captured headward or rapidly drained away during snowmelt. Several breached polygons were observed and resulted in concentrations of dried out *Eriophorum angustifolium* and *Carex aquatilis* as a consequence of a rapid drop in moisture conditions. Since 1999 around gully R08p, 202 polygons at least were either breached or partially to completely eroded (figure 4).

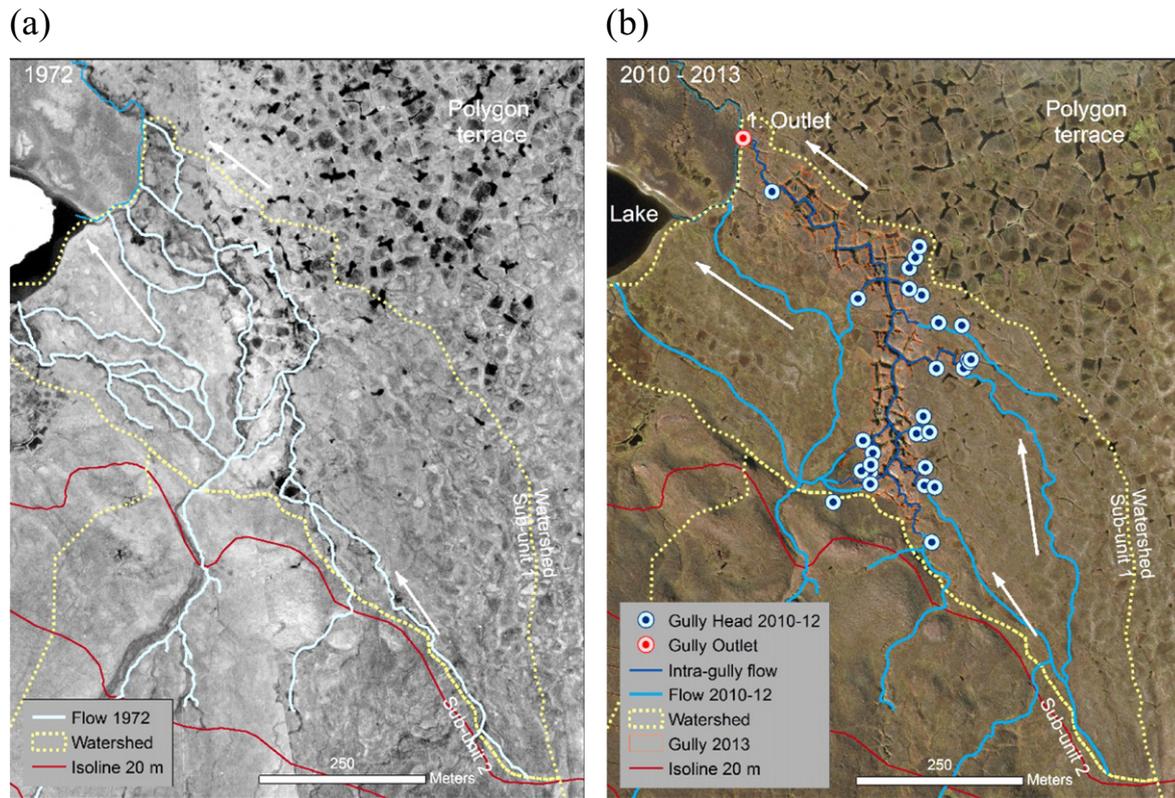
**Figure 5.** shows the emplacement and the main geomorphological features of the landscape at the location of the gully R08p before its formation (1972, 5a) and following its initiation (2010–2013 5b). Watershed is delineated in a dotted yellow line and sub-units are labeled. White arrows show the general direction of water flow. The light blue lines show stream paths and water tracks. On figure 5(b), the gully contours are delineated in orange while the current flow in the channelized network inside the gully is indicated by a dark blue line. Blue dots indicate the emplacement of gully heads and sinkholes observed on the field soon after the seasonal hydrologic peak in late spring 2010–12. The red dot indicates the gully outlet where hydrologic measurements were obtained. The background is a colored GeoEYE satellite image (2010).

the gully, one located 100 m to the south flowing through a lateral moraine from a nearby secondary valley. The second one was the result of water track concentration from the upper slope to the terrace, south-east of the gully head. Both are ephemeral and were often observed to not be flowing during late July, depending on the antecedent moisture conditions. A mesh of water tracks were identifiable on figure 5(a) (1972).

**Entry points and discharge.** During mid-June 2010 and 2012, 29 water entry points (sinkholes and gully heads, figure 5(b)) position and discharge were obtained for the gully. Each blue dot represents a water track or stream entry point in the gully. Discharge at any of those points varied between less than 0.01 m<sup>3</sup> s<sup>-1</sup> up to 0.1 m<sup>3</sup> s<sup>-1</sup>. Four gully head and sinkholes had discharge of 0.1 m<sup>3</sup> s<sup>-1</sup>.

Discharge and precipitation were recorded from June to August 2013 (figure 6) at gully outlet (red dot, figure 5(b)). Stream flow in the gully following the final snow bank collapse near the red dot (figure 5(b) initiated on 10 June 2013. The yearly peak flow followed the dam collapse by a few hours and lasted until 16 June 2013 (E1) with a cumulative flow of 134 600 m<sup>3</sup> in 6 days (59% of the total flow for the year, figure 6). On site, 45 mm of rain were

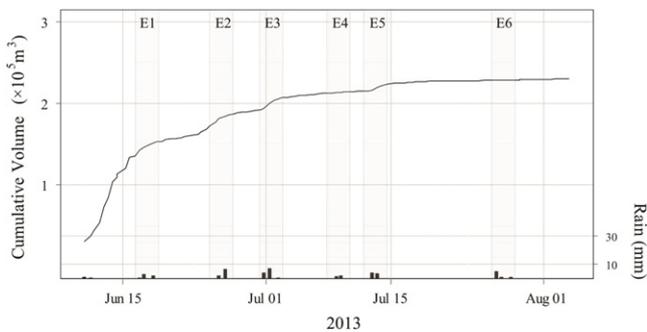
**Figure 6.** Cumulative flow volume at the gully outlet and rain during the summer of 2013 at the emplacement identified by the red dot on figure 5(b). Left y-axis refers to the cumulative volume of water through the outlet. Rain events are shown on the x-axis and the right y-axis refers to the amount of rain (mm). Each rain event and related hydrologic response are identified by E1 through E6, and has its duration interval delineated by a light gray box. Flat line indicates the absence of flow (standing water to dry). Total rain for the 54 days period was 45 mm and the volume of water 229 662 m<sup>3</sup>.

recorded during 2013, which was considered a dry year (CEN 2013). Effects of each rain event were evident on the cumulative curve except for E4 and E6. Events duration varied between 48 h and 72 h. Between E5 and E6, very low or no flow was common at the outlet. Cumulative volume of

It is generally assumed that the water volume measured at the outlet should increase when it rains, which was the case here, the figure indicating a flashy discharge at each event. The event E1, while featuring the highest estimated flow, was induced by a small rain event (5.5 mm in 72 h) and a smaller input in precipitation. The reason is there was still a high flow from snowmelt at mid-June (figure 6—E1) and a very shallow active layer (less than 5 cm). We infer that by eliminating the snowmelt partition of the flow, the point would be much nearer the trendline (figure 7—E1). Similarly for E4, a very small rain event (3.5 mm in 48 h) occurred at mid-July when the active layer was generally deeper (20 cm deep) in the polygons surrounding the gully. The event barely showed on the cumulative discharge graph (figure 6—E4). The active layer as a reservoir was possibly depleted or had an important potential for recharge following a dozen days without precipitation, between E3 and E4 (figure 6) as displayed by the

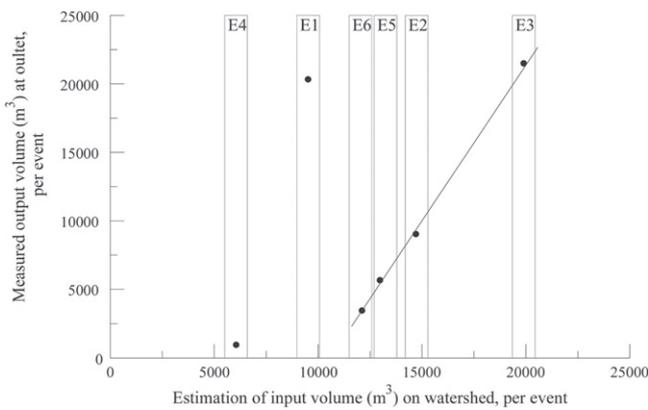
**Figure 7.** Estimated water volume input at the watershed scale related to the measured output volume transiting through the outlet (in m<sup>3</sup>), per rainfall event (figure 6, E1-E6). Estimated input was modeled by multiplying the watershed area (1.74 km<sup>2</sup>) with the amount of rainfall (in mm). The duration of each events varied between 48 h and 72 h.

To assess the efficiency of the gully as a drainage vector at watershed scale, input volume of rain were related to the overall volume output measured at gully outlet, per event (figure 7).

The input was calculated by multiplying the watershed area (1.74 km<sup>2</sup>) with the amount of rainfall (in mm) which resulted in a total volume for each event. Output volume was strongly influenced by antecedent conditions and amount of precipitation. Apart from E1 and E4, the relation between input and output corresponded well and is thoroughly interpreted in the discussion.

difference between precipitation input against actual discharge at outlet (figure 7).

The remaining four events (E2, E3, E5 and E6) fitted the drawn trendline with a  $R^2$  of 0.96 (figure 7) and clearly a relation could be drawn between the amount of rain for a given event, the input at the watershed level and the output at the outlet. The slope of the predicted input on the watershed should be corrected by obtaining more precise rainfall data, as there was only one station deployed at the site. Further, one-third of the watershed had a high plateau (up to 300 m), which could potentially increase rainfall measurements variability. Nevertheless, it was possible to assume that the flashiness increased when precipitation increased, suggesting a saturation of the storage with a larger input. The depth of the active layer which should deepen progressively, did not seem to be a factor for those 4 events.

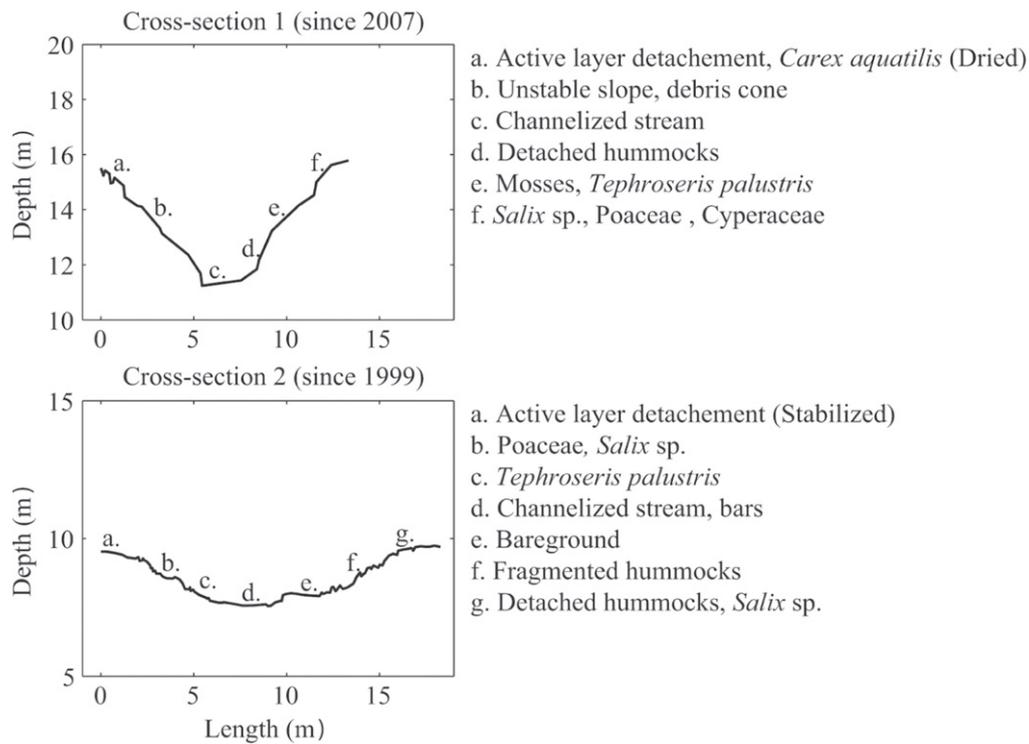
**Figure 8.** Two gullies cross section located in a section eroded since six years (cross-section 1) and 14 years (cross-section 2). The y-axis indicate the altitude above sea level.

Cross-section 1 (figure 8), gullied in 2007, was in 2013 12.8 m wide and 4.54 m at maximum depth, with an average depth of 2.26 m. While gullying at this emplacement initiated in 2007, one side of channel (figure 8, cross-section 1, a., b.) had still recent (2013) evidence of ground perturbation and slopes in transition as the section was not yet stabilized. *Carex aquatilis* was spreading in the previously wet polygon and following its breaching by gullying, the polygon was drained, therefore inducing a transition in plants locally. A 1 m wide channelized stream flowed at the floor level of the gully (figure 8, cross-section 1, c.). The other side of the gully (figure 8, cross-section 1, e.) indicate a transition toward stabilization, where pioneer species such as *Tephrosieris palustris* were colonizing the bare ground, while plants typical of the wetland environment were present over the edge of the cross-section as a remnant of pre-gullying (figure 8, cross-section 1, f.).

Cross-section 2 (figure 8) initiated erosion by gullying in 1999. In 2013, the section was mostly stabilized. Dimensions were 17.2 m wide and 2.19 m at maximum depth with an average depth of 1.21 m. On the left side of the cross-section 2 (a. b.) *Salix* sp. and Poaceae were colonizing directly on the slope inside the gully. Alluvial bars were common on the floor of the gully near this section.

Cross-section 1 was much more incised than cross-section 2: recent gully channels were not stabilized and therefore may not have slopes in equilibrium. Another factor explaining the difference in incision for the two cross-sections is the base level of the large glacial river located in the center of the valley, which is estimated at 7–8 m above sea level (NRCan 2004). More than 400 m separate the cross-section from one another; there is also a difference of 5 m in altitude of the terrace between the two emplacements, which could further explain the differences in incision.
