Analysis of Debris Flow Kuranji River in Padang City Using Rainfall Data, Remote Sensing and Geographic Information System

Z Umar¹, W A A Wan Mohd Akib² and A Ahmad³

Faculty of Geoinformation & Real Estate, Universiti Teknologi Malaysia
81310 UTM Johor Bahru, Johor, Malaysia.

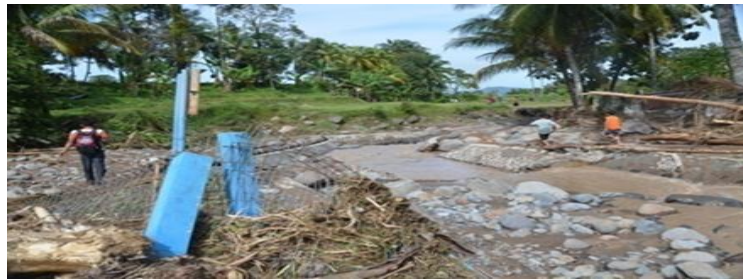
West Sumatra Provincial Government with the details of damaged houses of 878 units, mosque 15 units, irrigation 12 units, bridges 6 units, schools 2 units, and health posts damaged 1 unit (Figure 1). Irrigation network damage affected an average of ± 3000 hectares which eventually disrupt the food security of Padang. The aims of this paper to determine the cause of the flash floods that occurred in Kuranji River in Padang city on Tuesday, July 24, 2012 at 18:00 pm.

Figure 1. Image infrastructures by Debris flows.

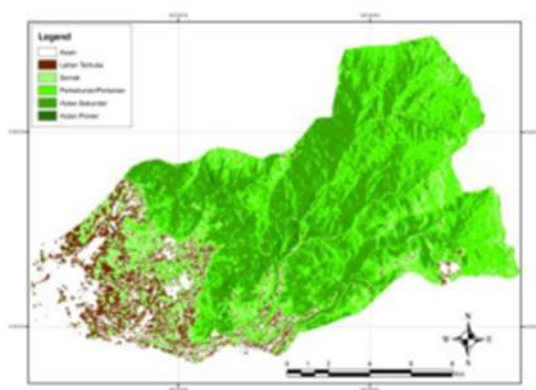
The results of the level of greenness of vegetation indicate that there has been a decrease in the level of greenness in Kuranji River basin. It is presented with impairment of quality NDVI moderate in 2009 of 92.55 km² (Figure 2) to 73.68 km² in 2012 (Figure 3). Decrease in NDVI values show that the vegetation in the watershed Kuranji River suffered a significant reduction.

Figure 2. NDVI in year 2009

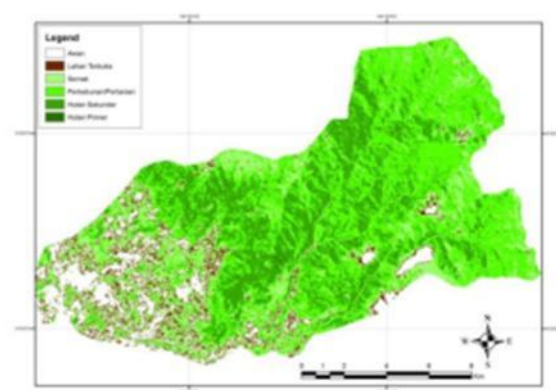
Figure 3 NDVI in year 2012.

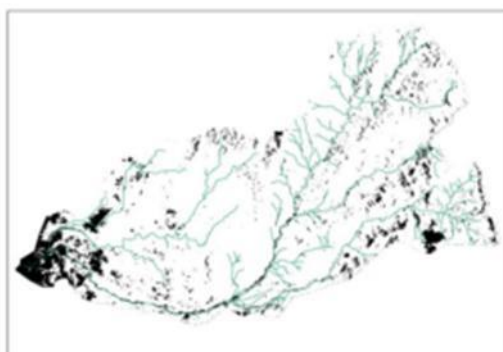
The results also showed that many puddles that occurred in the Kuranji River. In 2009, a water body covering an area of 14 km², and in 2012, it increases to 20 km². This water body may be standing water in the fields and can also be reservoir formed naturally. Because the location of inundation are very far in the upstream of the Kuranji River, there is possibility of formation of very large natural reservoirs. Figure 4 and 5 show the water bodies in 2009 and 2012 respectively.

Figure 4. Water Bodies in 2009.

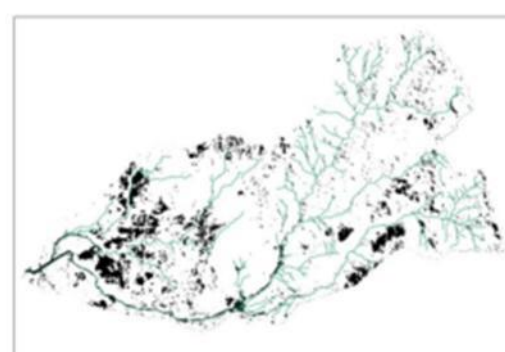
Figure 5. Water bodies in 2012.
