Application of Structure Monitoring Systems to the Assessment of the Behaviour of Bridges in Mining Areas

To cite this article: Beata Parkasiewicz *et al* 2017 *IOP Conf. Ser.: Mater. Sci. Eng.* **245** 032018

Beata Parkasiewicz¹, Marta Kadela¹, Piotr Bętkowski², Rafał Sieńko³,
Łukasz Bednarski⁴

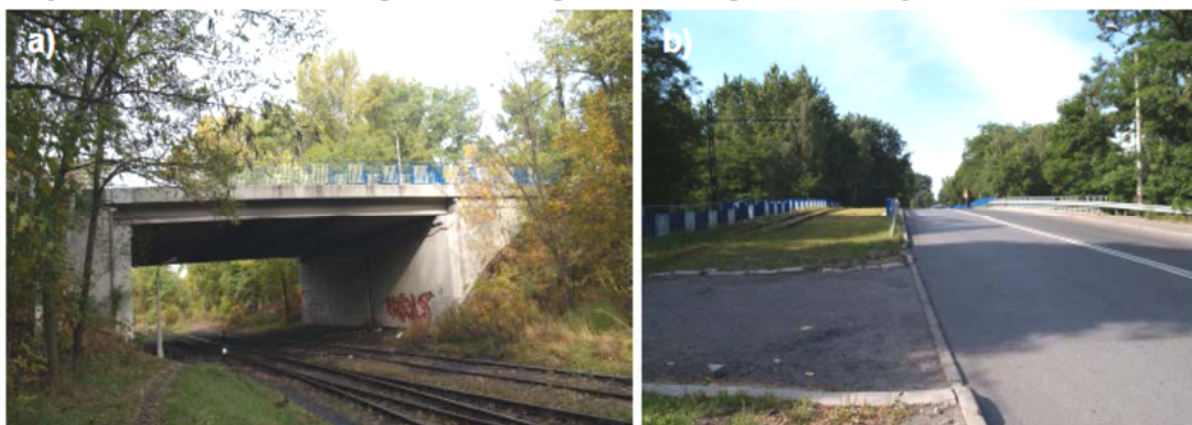
The road and tram bridge is located on the road and tramway line and creates a passage above the obstacle formed by a railway tracks, ensuring the continuity of road and rail traffic – figure 1. The structure was built in 1970s, then modernised and repaired in 2010 and 2013 in order to adapt the bridge's structure to the safe adoption of the impacts from the planned mining activities.

Figure 1. Road and tram bridge: a). view from south-west, b). view from north-east [5]

The bridge is formed by two independent spans of slab-and-beam structure and overall dimensions of $\sim 13.5 \times 18.1$ m and $\sim 9.8 \times 18.0$ m respectively, separated by an expansion joint with a design width of approx. 40 mm.

Each of the bridge's spans is supported by massive reinforced concrete abutments with direct foundations, separated by an expansion joint of a design width of approx. 0.30 m. Spans are supported on abutments via elastomer and elastomer-slide bearings. The planned width of expansion joints between the deck slabs and abutments is 80 mm in the case of northern supports and 140 mm for southern supports.

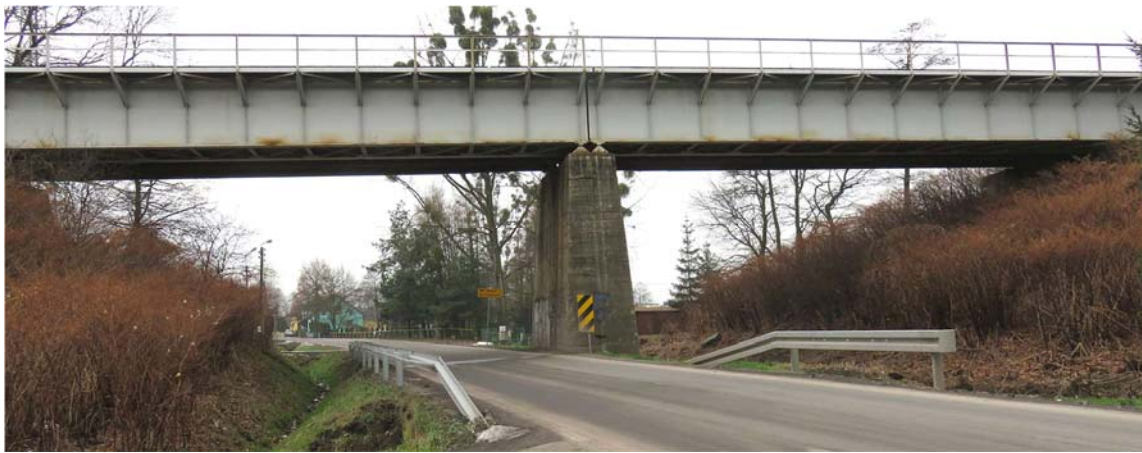
- a riveted steel structure (western bridge) under track no 1.
- a welded steel structure (eastern bridge) under track no 2 (Figure 4).

Figure 4. View of the eastern (monitored) bridge under track no 2

Each part consists of two steel spans, and each of them works statically as a simply supported beam. Spans are made of two plate girders that form an open deck.

The (monitored) eastern bridge was built in 1973. Steel structural components are welded. Girder flanges have constant thickness.

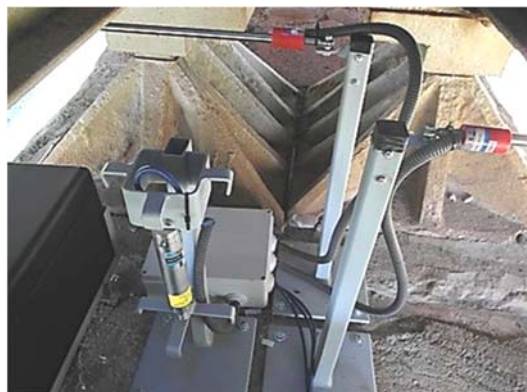
The selected physical quantities whose change significantly affects the technical condition of the structure include displacements of spans in relation to the supports along the structure's axis and angular displacements of supports (tilts) in two perpendicular vertical planes – figure 6.

Figure 6. Support structures for mounting angle sensors and displacement sensors at the intermediate support (view on the west side)

The system's structure uses string potentiometers of displacement with a measuring range of 200 mm and angular displacement string potentiometers. The system is supplied by batteries replaced during periodic inspections of the facility. The readings from the sensors are taken every 15 minutes and once in every 24 hours sent via GSM network to the measurement server, where they are processed and automatically analyzed. The system generates daily reports of the structure's behaviour and sends them to people responsible for its safety. It is worth noting that as yet no emergency situation has occurred.
