# Study on Physical and Mechanical Properties of Soil in a Loess Landslide

**Abstract.** This article takes a landslide in Zhidan County as the research object. Based on the field survey before and after the landslide occurred, the engineering geological conditions of the landslide were obtained, the landslide deformation characteristics were mastered, and then the landslide development process was divided into the early stable stage, the creeping deformation stage, the severe sliding stage and the stage after violent sliding. Soil samples of the landslide were taken before and after the landslide occurred, and the physical parameters were measured to analyze the physical properties of the slide zone soil. At the same time, direct shear, triaxial, and ring shear tests were used to obtain the mechanical properties of the landslide soil under different test conditions, and the shear strength index value of the slide zone soil was analyzed. The main conclusions are as follows: After the landslide slides fiercely, the water content increases, the plasticity and compressibility increase, the properties of the slip zone soil deteriorate, and the relevant physical parameters such as the

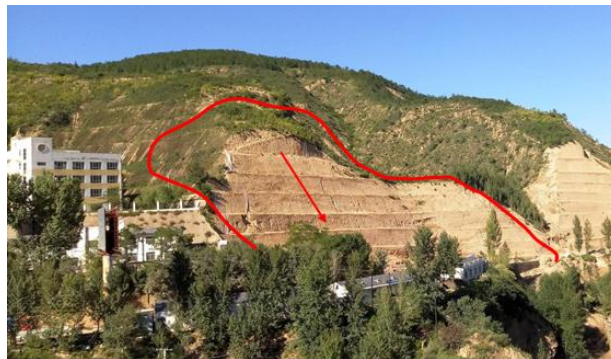
The on-site investigation showed that the trailing edge of the landslide was steep, the tension cracks were clear, the scratches and the marks of dislocation were visible, the perimeter of the landslide was obvious, the leading edge exposed the slip surface, and the sliding belt with a certain thickness was presented, the feather cracks were dislocated, the extrusion and crumpling were obvious, there were obvious mirror scratches, and the position of the shear outlet was determined. The full view before and after the violent sliding of the landslide can be seen in figure 1 and figure 2.

**Figure 1.** Landslide panorama

(iii) The vigorous sliding phase. The trailing edge of the slope is completely penetrated with the cracks in the side wall, and the whole movement occurs, the roadbed cracks, and the mountain collapses in a large area (figure 2). After on-site investigation, the trailing edge of the landslide sits downward, forming a steep ridge 2~8m high, the back wall is dry and smooth, and multiple longitudinal cracks are formed on the side wall. The upper part of the slope is wavy from top to bottom, the structure is loose, forming a number of step-like arrangement of through cracks, the original roadbed of the leading edge is arched 4.5-7.0m, the slip zone soil layer is obvious, the moisture content is high, and it is present a blocky structure. The upper part of the slope is wavy from top to bottom, the structure is loose, forming a number of terrace arrangement of through cracks, the original roadbed of the leading edge is arched 4.5-7.0m, the landslide soil layer is obvious, the moisture content is high, and it is present a blocky structure. In addition, the leading edge slides of the landslide forward into the stream channel, causing serious blockage of the stream channel.
