To cite this article: M Yu Drygin and N P Kuryshkin 2018 *J. Phys.: Conf. Ser.* **944** 012029

# Raising quality of maintenance and control of metallic structures in large-load technological machines

**Abstract.** Active growth of coal extraction and underinvestment of coal mining in Russia lead to the fact that technical state of more than 86% of technological machines at opencast coal mines is unacceptable. One of the most significant problems is unacceptable state of supporting metallic structures of excavators and mine dump trucks. The analysis has shown that defects in these metallic structures had been accumulated for a long time. Their removal by the existing method of repair welding was not effective – the flaws reappeared in 2–6 months of technological machines' service. The authors detected the prime causes that did not allow to make a good repair welding joint. A new technology of repair welding had been tested and endorsed, and this allowed to reduce the number of welded joints' flaws by 85% without additional raising welders' qualification. As a result the number of flaws in metallic structures of the equipment had been reduced by 35 % as early as in the first year o

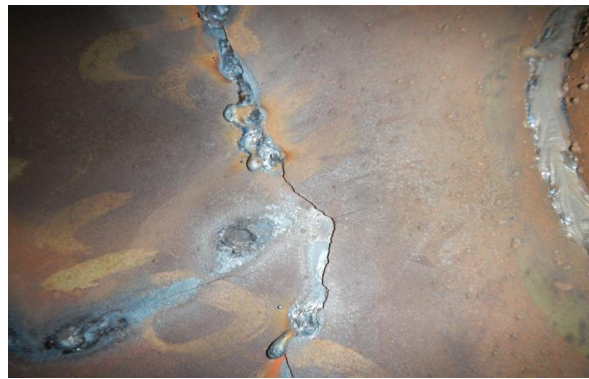
More than 90 % of flaws detected in metallic structures were removed several times but reappeared. Along with this ultrasonic testing showed that in more than 98 % their was a lack of penetration in the welded joint. Figure 1 shows the photo of a typical repair welded joint from backside. As it can be seen a lack of penetration extends through the whole length of the joint.

**Figure 1.** Lack of root penetration in the repair welding joint.

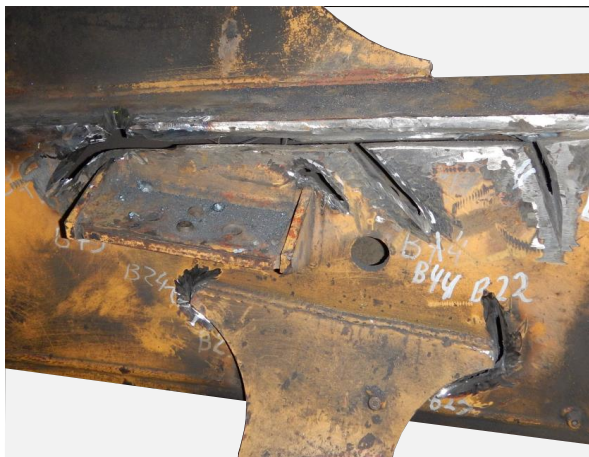
**Figure 2.** Opening of break on the mine dump truck frame.

- curvature of the flaw and, as follows, non-linear required groove;
- different position of the flaw;
- meeting of several parallel flaws (Figure 2);
- the necessity to remove totally the welded metal and the heat-affected zone of the fractured welded joint, leading to double or triple extension of the groove area (Figure 3);
- varying thickness of the metal down the line of the flaw extension;
- absence of information about the thickness of the welded metal.

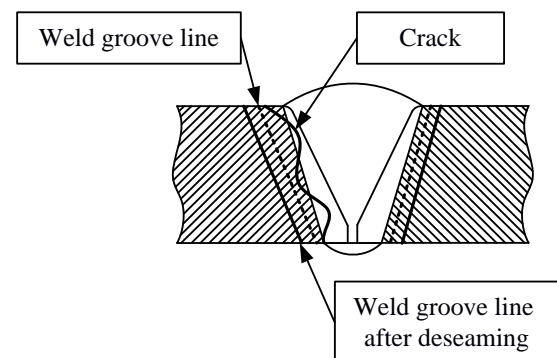
**Figure 3.** Groove of the fractured welded connection.

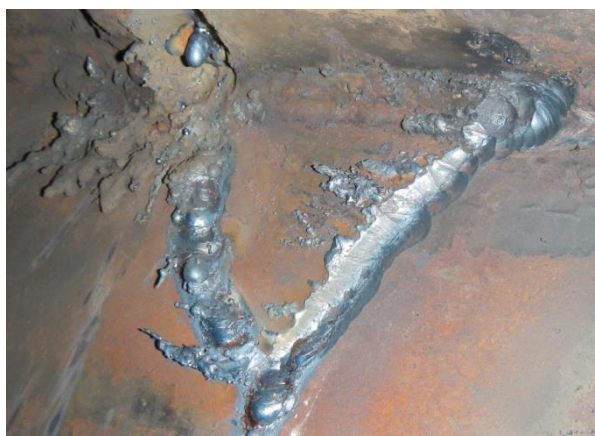
All this, complicating the work of the welder who is not familiar with the groove, leads to a typical mistake – narrow groove with leaving some metal for fusion (Figure 4), and it does not allow complete root penetration with a temper bead.

**Figure 4.** Improper opening of break for making a welding joint.

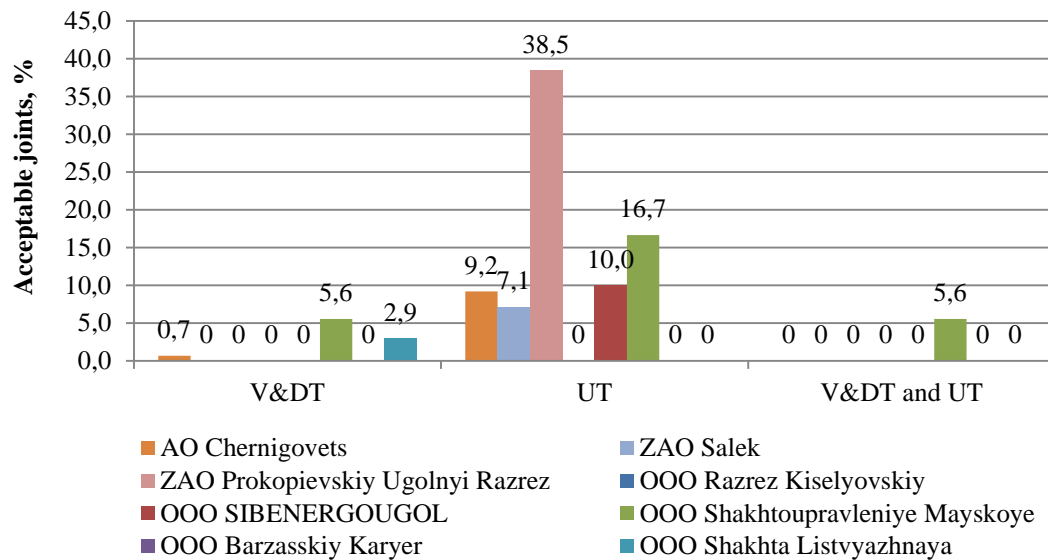
The chart presented on Figure 5 shows the results of the assessment of the welded joints quality. The welded joints were done by the workers of AO HK SDS-Ugol enterprises.

**Figure 5.** Results of the control of the specimens produced by the welders at the enterprises of AO HK SDS-Ugol.

The number of specimens of the required quality according to visual and dimensional test done only by the welders of OOO Shakhtoupravleniye Mayskoye was 5.6 %. All other enterprises showed practically zero result. The specimens of ZAO Prokopievskiy Ugolnyi Razrez welders had passed visual and dimensional test and made 38.5% of their total amount. Only 5.6 % of specimens done by the welders of OOO Shakhtoupravleniye Mayskoye met the joint requirements of V&DT and UT.

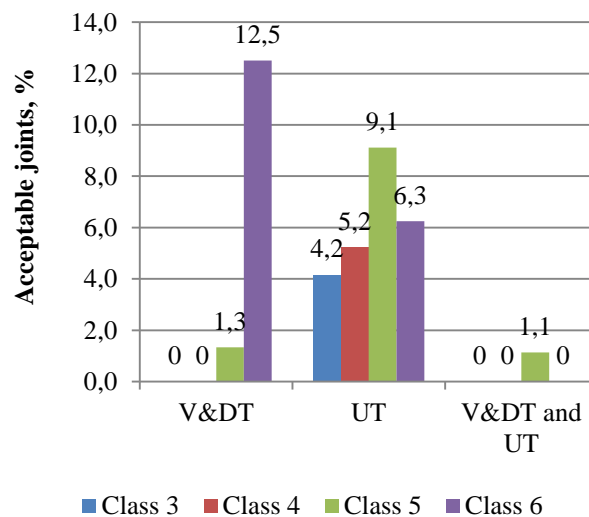
The results of analysis of flaws' distributions according to the welders' categories shown on Figure 6 show that the quality of the welded joints does not depend on the welders' qualification. Thus on the one hand welders of the 6<sup>th</sup> category had expectedly more specimens meeting the norms of V&DT (11.2 % more than the welders of the 5<sup>th</sup> category), on the other hand they had less (2.8 % less) welded joints meeting the norms of UT than welders of the 5<sup>th</sup> category. And only 1.1% of specimens done by the welders of the 5<sup>th</sup> category had met the joint norms of V&DT and UT.

**Figure 6.** Influence of the welder's job class on the quality of welding joints at AO HK SDS-Ugol.

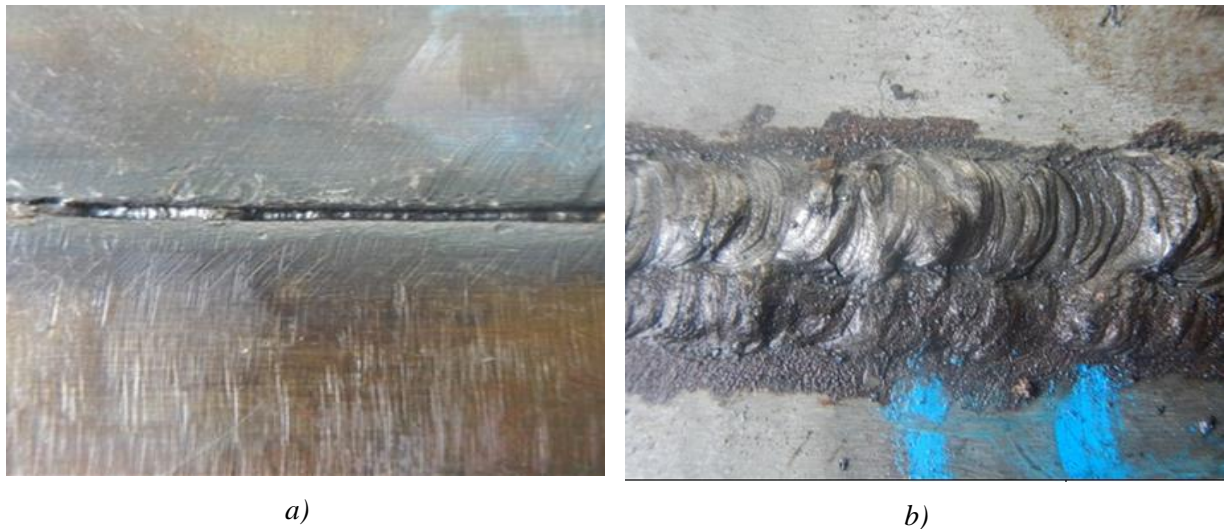
The results of the experiment with welding specimens evaluation had therefore shown that there were no specimens meeting the norms set by documentary standards. The most occurring flaws were those connected with lack of root penetration (Figure 7, *a*) and form deviations of the welded joint surface (Figure 7, *b*).

**Figure 7.** Typical root defects *a)* and the surface of *b)* repair welding joint.

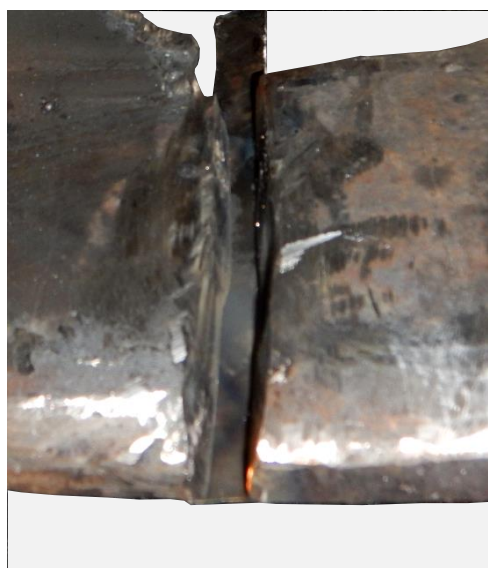
More than 91 % of flaws detected by V&DT are removed by deseaming of the weld face (if necessary with backing weld and subsequent deseaming). This method allows to remove such flaws as irregular ripples, beadings tough transition to the base metal, excessive height of the crests step structure of the welded joints and undercuts. It does not require expensive raising of welders' qualification and increases solidity of welded joints due to removal of macro- and micro acceptable flaws where welding stresses are concentrated. In the conditions of alternating strains (where welded joints usually function) it leads to the loss of their operational life due to appearing and extension of fatigue cracks. Removal of the flaws detected by UT is no less significant problem. The analysis of welded specimens' ultrasonic testing allowed to conclude that 85 % of flaws are flaws of groove (preparation for welding). They are not directly caused by the qualification of the welder making a joint, but to a greater extent they are flaws of a specialist preparing for the welding works. The solution of this problem lies in the area of repair conducting technology. Thus introduction of the method of slotted groove with installing a background plate allows to solve the problem (Figure 8).

**Figure 8.** Slotted groove of fractured welded connection with installing a background plate.

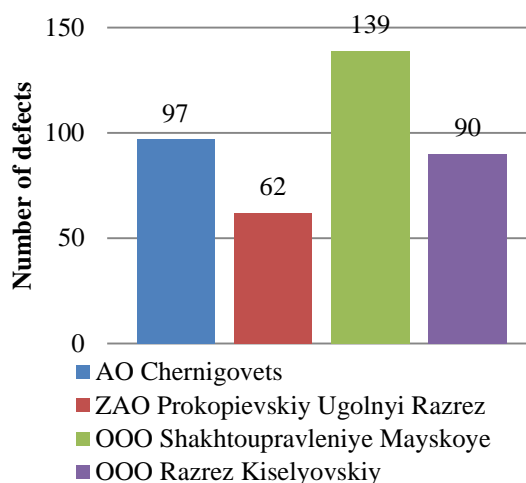
For practical approval and introduction of this technology there was an order for the whole enterprise at ZAO Prokopievskiy Ugolnyi Razrez: during the repair works on metallic structures welding joints' groove with installing a background plate is obligatory. This allowed as early as in the first year of functioning to reduce the number of detectable flaws in metallic structures of the technological machines on average by 35 % in comparison with other enterprises of AO HK SDS-Ugol (Figure 9).

**Figure 9.** Average number of defects in metallic structures detected during each examination.
