Rapid site assessment in a small island of the Philippines contaminated with mine tailings using ground and areal technique: The environmental quality after twenty years

To cite this article: D B Senoro *et al* 2019 *IOP Conf. Ser.: Earth Environ. Sci.* **351** 012022

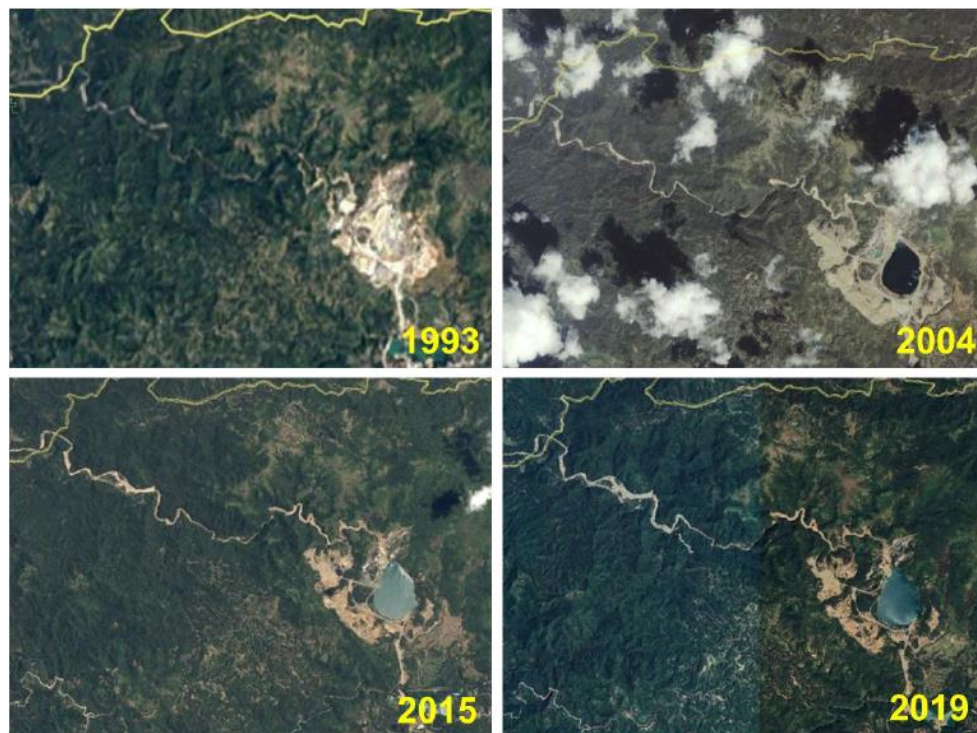
Figure 3. Historical aerial photos of Mogpog River Basin [10].

Below images demonstrates the historical areal-aerial images of Mogpog (figure 3) and Boac River (figure 4), the San Antonio photographs (figure 5) and current state of Mogpog and Boac River (figure 6). Figures 3 and 4 were captured by Google Earth 2019, while figure 5 was captured by the UAV Mavic Air. The historical images helped in the comparative analysis of the areal conditions of the Mogpog-Boac River Basin right after the disaster until the present condition. The UAV aided the team to determine potential sampling locations and choose appropriate routes. Further, it provides

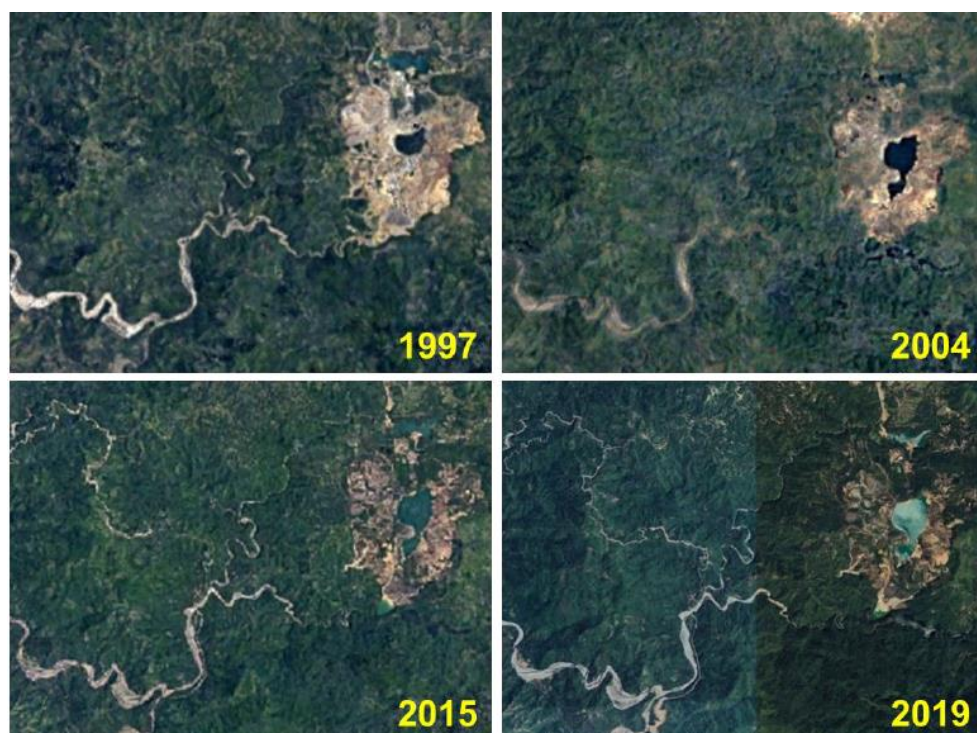
Figure 4. Historical aerial photos of Boac River Basin [10].

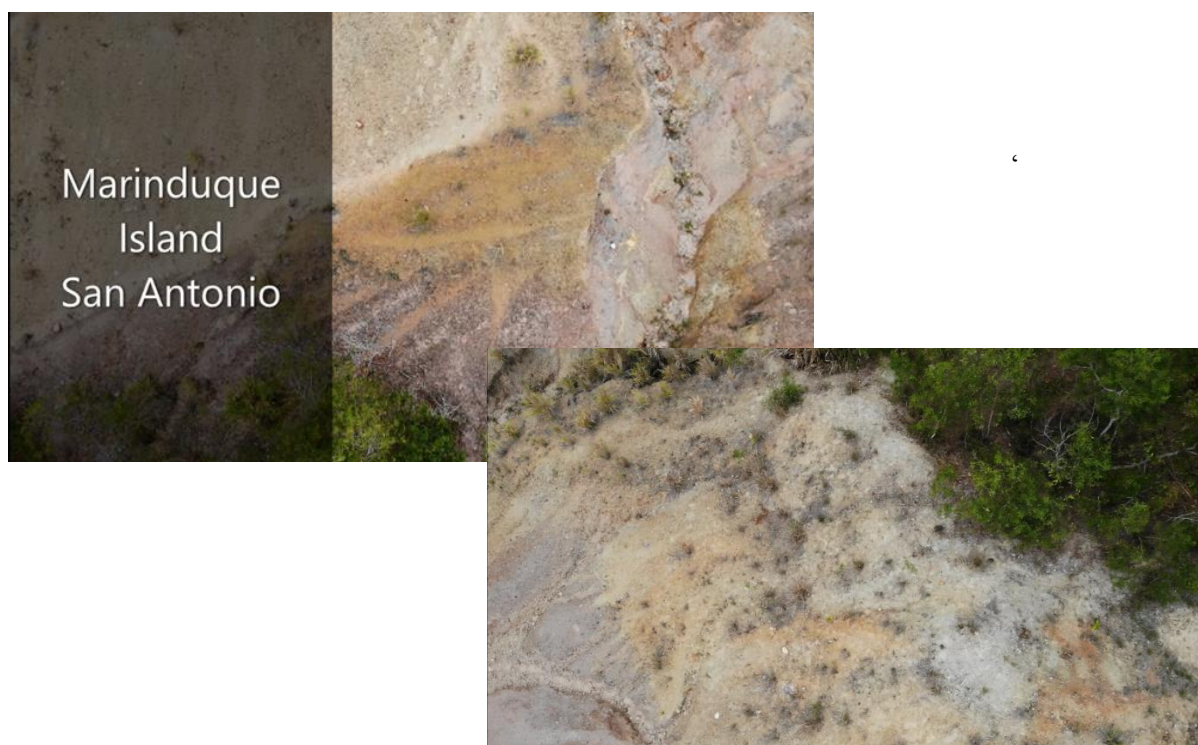
Figure 5. Aerial photograph captured by the UAV in Brgy. San Antonio.

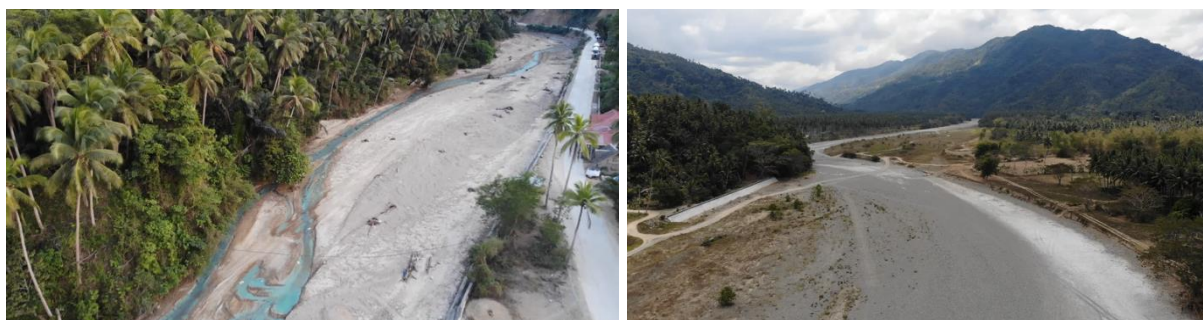
Figure 6. Aerial photograph taken by the UAV – Mogpog and Boac River.
