# Investigation and Analysis of Old Houses' Aseismic Capability in Rural Areas of Jiangxi Province

Qiang Zhou\*, Wenyang Zhao, Lingyu Yang and Guquan Song

School of Civil Engineering and Architecture, Nanchang University, 999 Xuefu Avenue, Honggutan new district, Nanchang city, Jiangxi province, China  
Email: zhouqiang@ncu.edu.cn

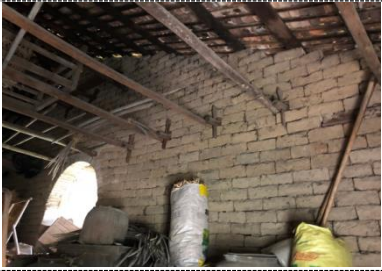
The main defects of raw-soil structure houses are as follows: 1) There is no drainage system built around the house and the external walls are easy to be washed and soaked by the rain. 2) The roof frame purlin was placed on the gable with no pad, which made the gable force uneven and easy to produce vertical cracks in the wall. 3) There is no reliable tying between longitudinal wall and transverse wall; the gables are easy to be damaged with the form of out-of-plane failure. 4) The wooden roof is affected by biological and climate factor, the state of corrosion is severe.

| <b>Figure 9.</b> No pads under the purlins. | <b>Figure 10.</b> Column foot cracks and offset. |

properties of raw-soil block, the test results showed that mechanical properties and water resistance of improved raw-soil blocks were enhanced. Chang Weihua et al. [13] discussed various reinforcement methods for raw-soil masonry walls, and carried out quasi-static tests, it was found that the wall reinforced by wood frame can also be greatly improved, considering the factors of reinforcement cost, the raw-soil structure houses in rural areas can give priority to the reinforcement of wood frame.

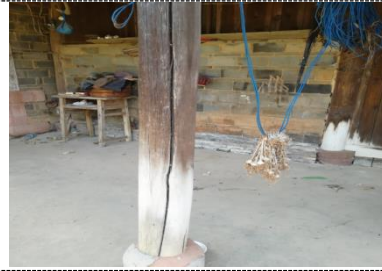
The main defects of timber structure houses are as follows: 1) The column foot is prone to offset, which makes the column base stone under the stress state of eccentric compression. 2) Wood columns commonly have vertical cracks, which seriously weaken the bearing capacity of the wood columns. 3) The wooden component nodes have looseness or even invalid connections, which reduces the integrity of the bearing system. 4) Wood components are severely affected by biological factor, a large number of wood components show signs of being eroded by termites.

In the case of wood structure houses, Zhou Tiegang et al. [14] proposed that the wood columns and joists could be strengthened with angle steel, the wood column, purlins and eaves should be reinforced with thin steel sheets, and the joists and purlins could be strengthened with flat iron. As for the reinforcement of retaining wall, the method of setting mortar steel bar in horizontally caved groove of wall was adopted. The shaking table test results showed that these measures can effectively improve the aseismic capability of the reinforced object while ensuring the lower reinforcement cost.

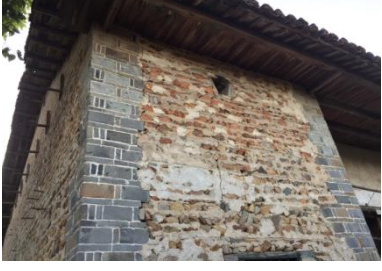
The main defects of brick-wood structure houses are as follows: 1) The foundation bearing capacity is insufficient, the foundation is directly built on the weak soil layer. 2) The foundation is poorly integrated; the foundation was built by gravel instead of sintered brick or concrete. 3) The quality of building materials is poor, and the masonry mortar is not produced according to the specified mortar mix ratio. 4) The walls of many brick-wood houses were constructed by sintered bricks and gravel, which greatly reduces the integrity of the walls.

| <b>Figure 11.</b> The wall built by different materials. | <b>Figure 12.</b> Shallow depth of foundation. |

For the problem of poor aseismic capability of brick-wood structure houses, Wang Mansheng et al. [9] verified through the shaking table test that adding reinforced concrete window frames to the doors and windows of unreinforced brick-wood structure houses can significantly reduce the number of cracks in the door and window openings of walls. Yang Wei et al. [10] proposed that reinforced polymer mortar ring beam could be added on the gable wall of brick-wood structure houses to improve the integrity of the house, the effectiveness of this method was verified by the shaking table test.
