## Seismic performance assessment based on displacement capacity of unreinforced masonry structures

A Scupin<sup>1</sup>, R Văcăreanu<sup>1</sup> and F Pavel<sup>1</sup>

**Abstract.** The National Geological Museum is a representative building for the typology of historic unreinforced masonry structures built in Romania at the beginning of the XX century. The seismic behaviour was studied with respect to the displacement capacity, by comparing the initial structural configuration of the building with the retrofitted one. Taking into account the irregularities of the structure and the localized reinforced concrete jacketing works done in the 80s', global results were proven to be misleading. Thus, relative floor displacements were used to study the behaviour of individual walls involved in local failures. Limit state thresholds based on relative displacements were used in order to calibrate the initial model with the post-earthquake damage assessment and then they were compared to the results obtained for the retrofitted model to establish the effectiveness of the strengthening works.

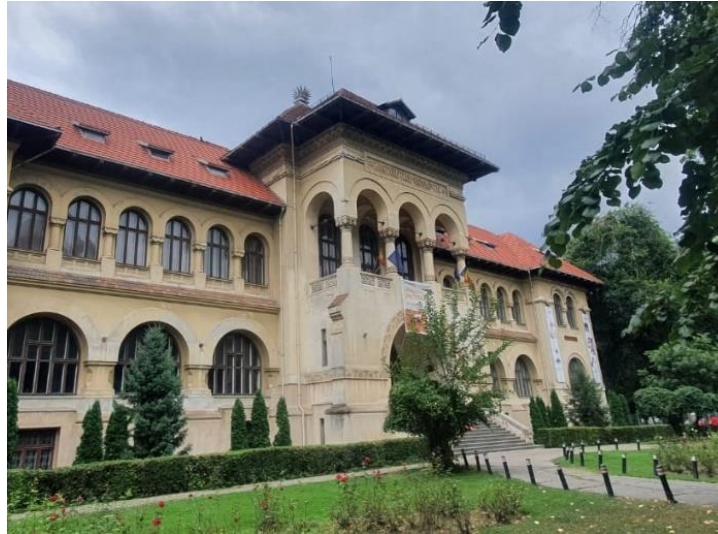
The National Geological Museum from Bucharest shown in Figure 1 is a historic unreinforced masonry structure built in 1906, following the typical layout of massive palaces. It is composed of two wings with different layouts and storey heights. The secondary wing hosts the exhibition hall with more than

10 m height that is connected to the main wing through an impressive stair case, without having a proper seismic joint in between.

**Figure 1.** National Geological Museum

Even though the placement of vertical structural elements allows for a regular load path, several discontinuities are also present. Firstly, the thickness of the masonry walls gradually decreases along the height, leading to 55% reductions of the total wall area, when comparing the semi-basement level to the attic level. Secondly, the openings placement on the front façade vary from one floor to another, both in terms of size and location. One of the most vulnerable structural parts is the front portico above the main entrance, where stone pillars support the attic walls. According to the damage assessment which followed the 1977 earthquake, fractures and excessive fissures were encountered for this part, causing the partial detachment of the portico.

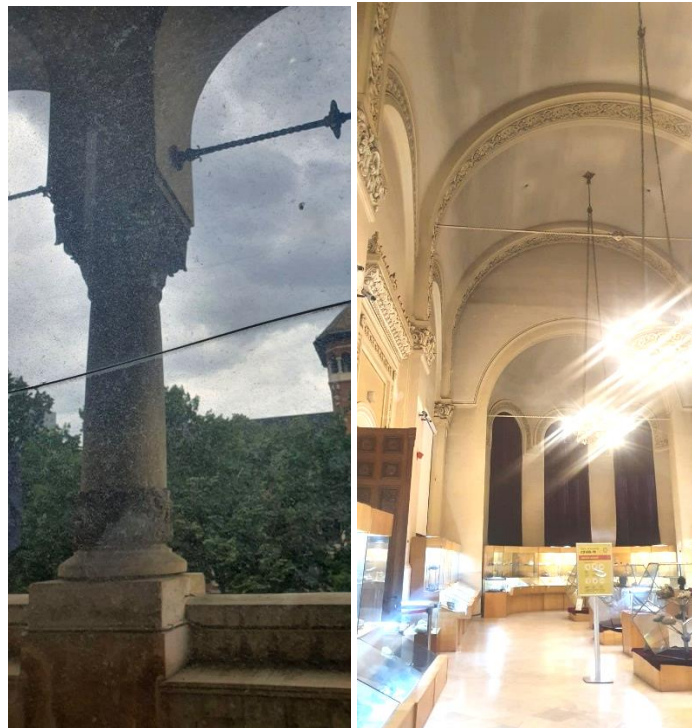
**Figure 3.** Steel tie rods

In order to ensure the structural safety of the building, retrofitting works were carried out in 1984, according to the knowledge and the practices of that time. For creating proper connections between orthogonal walls, all the original flexible floors were replaced by reinforced concrete slabs. Some of the masonry walls were retrofitted by reinforced concrete jacketing to increase their in-plane strength. The walls strengthened with 20cm layers of reinforced concrete and 4 cm of reinforced mortar are marked on Figure 2 with dark green, respectively light green. Apart from these works, other local repairs were done using grout injections, partial reconstructions and also steel tie rods were added in the secondary wing, as illustrated in Figure 3.
