# Study of the durability of ferritic - austenitic steel samples after cyclical fatigue impact

Georgi Georgiev<sup>1</sup>, Yaroslav Argirov<sup>1</sup>, Tatyana Mechkarova<sup>1</sup>, Daniela Spasova<sup>1</sup>, Aneliya Stoyanova<sup>1</sup>

**Abstract.** The purpose of this article is to investigate the fatigue strength of corrosion resistant ferritic austenitic steels used in marine equipment. Two groups of sheet steel samples were prepared: the first group were reference parts and the second group of samples were welded. The fatigue tests were performed with specially developed vibrating equipment. The destroyed surfaces were examined by optical microscopy, and the phase composition by X-ray diffraction analysis. Fatigue strength was evaluated by the number of cycles needed for a crack at a certain alternating load. Fatigue tests show how multi-cyclical fatigue affects the formation and development of a fatigue crack, and metallographic and X-ray diffraction analysis shows the phase changes occurring in the structure of SAF 2507 steel.

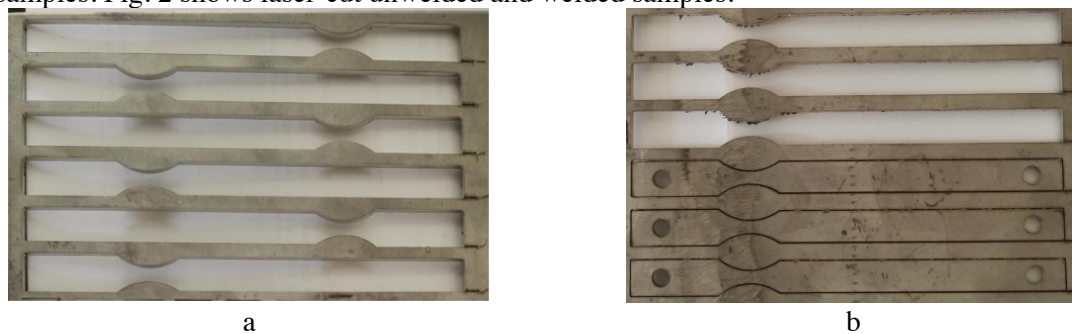
**Figure 2.** Laser cut samples  
a) unwelded; b) welded

In order to reduce the temperature effect influencing the structural changes, a laser is used to cut the test samples. Fig. 2 shows laser-cut unwelded and welded samples.

The unwelded samples (fig. 2-a) are laser cut from a plate with dimensions 350mm by 200mm and thickness 3mm. Welded samples (fig.2-b) are made of two plates measuring 150mm by 350mm with a thickness of 3mm. The two plates are welded unilaterally to each other by manual Shielded Metal Arc Welding (SMAW). ESAB OK 68.82 electrodes were used. The plates are pressed at the four corners to avoid distortion. They are roughly ground so that they can be laser cut. The welded plate is rapidly cooled with water.

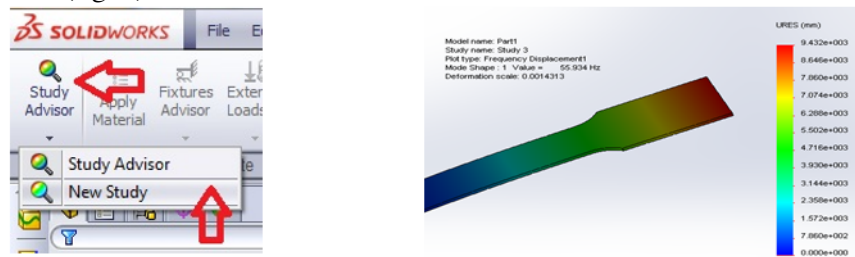
**Figure 4.** Determination of natural frequency in a 3D model of the test sample

**The first step** of the simulation analysis is to select "New study" from the "Study Advisor" menu. Of the types of analyses, "frequency" is the one chose on this occasion, which searches the natural frequencies, as well as visually showing their shape and displacement in case of vibrations from the resulting resonance (fig. 4).

The study obtained a result of 55.9Hz, and with the increase of the 3D model length, the operating frequency decreases.
