# Leakage Current Analysis of Bushing with Water-cut Sheds in Heavy Rain Test

**Abstract:** In this article, heavy rain tests under two rainfall intensities are introduced. Three kinds of bushings with different water-cut-sheds were used in these tests. Then leakage currents monitored during tests are analysed and contrasted to obtain characteristics and tendency. The results show that maximum value of leakage current is affected by voltage applied, profile of water-cut sheds, and the rainfall intensity. Higher AC voltage applied on bushing leads to higher peak of leakage current. More and larger water-cut sheds makes bushing able to withstand higher leakage current. Heavier rain may cause leakage current rise totally. These results may be helpful in online monitoring of insulation.

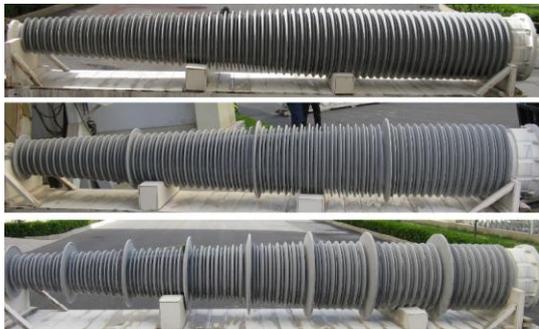
**Figure 1.** Profiles of tested specimens.

Three types of 500 kV porcelain bushing with different water-cut shed configurations were used in this test. Their insulation height are all 4.7 m. One of them is common bushing with no water-cut shed, the others are with four and eight water-cut sheds, respectively. Table 1 gives parameters of those tested porcelain bushings, and figure 1 shows the pictures of three porcelain bushings.

Number	Leakage Distance (mm)	Number of Water-cut Sheds	Spacing of Water-cut Sheds (mm)	Overhang of Water-cut Sheds (mm)
1	18775	0	-	-
2	18775	4	1165	50
3	19200	8	580	95

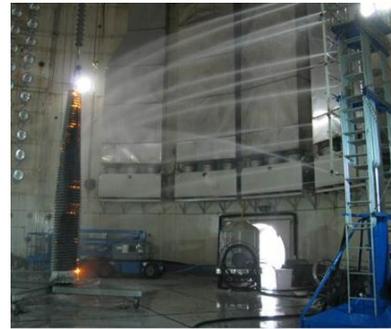
**Figure 2.** Set-up of artificial rain test.

Artificial heavy rain flashover tests were carried out at the Pollution and Environment Laboratory in State Grid UHV DC Test Base, which is located in Changping, Beijing. Tested bushings were installed vertically in the artificial environmental chamber which has a test space of 20 m in diameter and 25 m in height. It is capable for environmental tests such as icing, raining and fogging. Figure 2 shows the set-up of artificial rain test in the chamber.
