Use of UAVs for Technical Inspection of Buildings within the BRAIN Massive Inspection Platform

To cite this article: Carles Serrat *et al* 2019 *IOP Conf. Ser.: Mater. Sci. Eng.* **471** 022008

Carles Serrat ¹, Anna Banaszek ², Anna Cellmer ³ and Vicenc Gibert ⁴

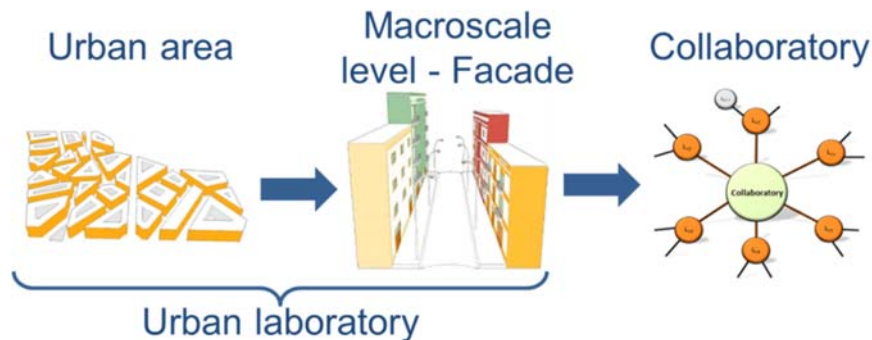
The methodology focuses on a massive prospecting campaign of the facades at a multiscale level. Indeed, it concentrates on the concept of the urban laboratory that collects the envelope of the buildings and constitutes the urban front. Gibert (2016) [3] defines the urban canyon as the U-shape location where the facades are exposed. In the urban canyon the ageing of the building stock population takes place. Territorial and environmental covariates occur and determine the facades durability over time. Figure 1 illustrates the urban laboratory and the urban canyon.

Figure 1. Urban laboratory network and Collaboratory for the BRAIN project

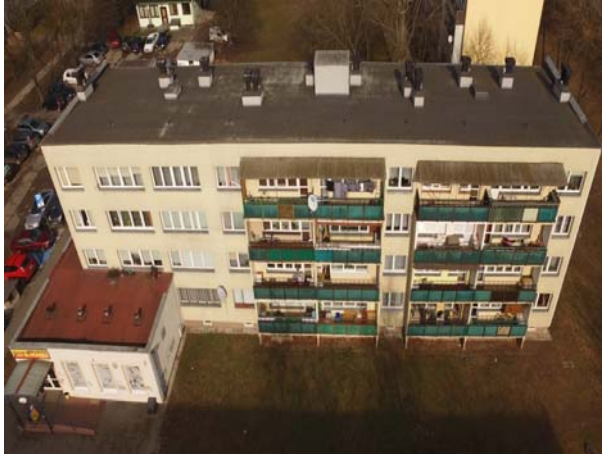
Unit 1 (balconies, slightly damaged)

A sample of six facades was selected in Poland, located in Warsaw (4 units) and Olsztyn (2 units). Facades were identified as units 1 to 6, respectively. The sample was chosen based on criteria of morphology and deterioration level. In figure 3 general views and characteristics of the sample under study are shown.

**Figure 3.** General views of the facades in the sample. In parentheses (morphology, deterioration level)

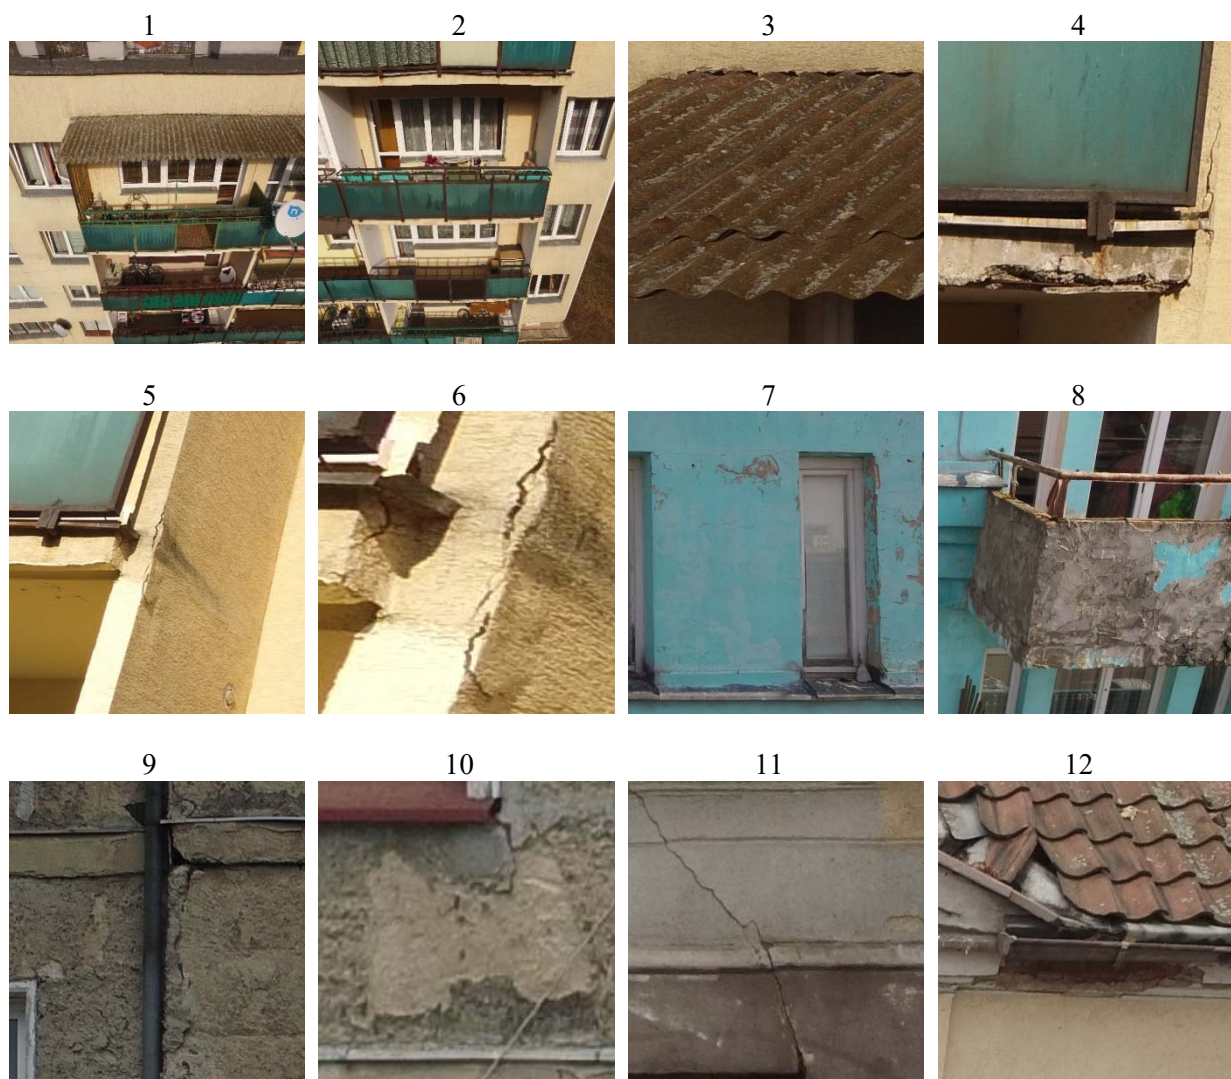
After the flights the images were processed and analyzed, facade by facade, by the technical inspector in the Collaboratory. Figure 4 displays a set of selected images that give support to the main contributions that can be derived from the analysis. It is important to notice that, in essence, all the results are positive. Main advantages and possibilities are listed in what follows.

Figure 4. Selected images to illustrate different views of the facades and several injuries, extents and severities.

- Sweeping of the camera from top to bottom, which cannot be replicated by the inspector from the public way, allows making visible parts and elements of the façade which were not visible till now (figures 4.1, 4.2, 4.3 and 4.12).

- To zoom the images, when it is necessary, allows the inspector to detect the extent of the injuries (figures 4.4, 4.5 and 4.6).
- To accurately diagnose the injury and its severity. (cracks and wear of material, figure 4.7; interim interventions, corrosion of railing and type of wall anchor, figure 4.8; breaks of work elements fastened by downpipes, figure 4.9; detachment with lack of lateral adhesions, figure 4.10; fissure with movement and detail of detachment of plaster, figure 4.11 and eave break with channel detail with tile joint and break state, figure 4.12).

- UAV strengths include high mobility in data acquisition and the ability to fly at different heights
- To observe any area of the facade with sufficiently precise approaches to detect any type of existing injury. In addition, the results of the images are sufficiently explicit as to enable an expert to identify the existing architectural elements and their construction techniques (figure 4).
