Application of TLS Intensity Data for Detection of Brick Walls Defects

Czesław Suchocki ¹, Jacek Katzer ², Carles Serrat ³, Marcin Jagoda ⁴

^{1,2,4} Koszalin University of Technology, Faculty of Civil Engineering Environmental and Geodetic Sciences, Śniadeckich 2, 75-453 Koszalin, Poland

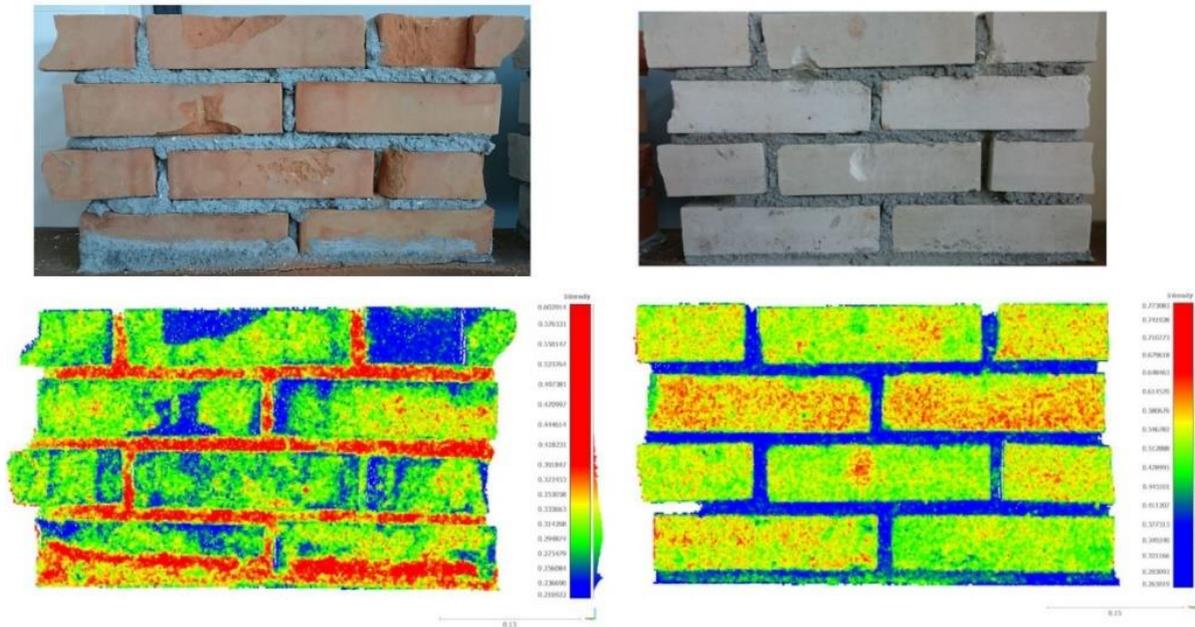
The research programme was carried out in both laboratory and field conditions. In the laboratory, the measurements were carried out on two specially prepared specimens. The first specimen was made of traditional red ceramic bricks and cement mortar. The second specimen was made of silicate white bricks and cement mortar (see Fig. 1). Before the tests, the specimens were intentionally damaged in multiple places to simulate real old brick walls. The specimens were remotely scanned by a TLS Leica ScanStation C10 from the distance of 10m. The Leica ScanStation C10 scanner uses time-of-flight principles of distance measurement. This scanner is characterized by high scan speed of approximately 50,000 pts/sec and the maximum range of 300m @ 90%. Laser wavelength is equal to 532 nm (visible green).

Figure 1. Real photo and point clouds of the tested specimens

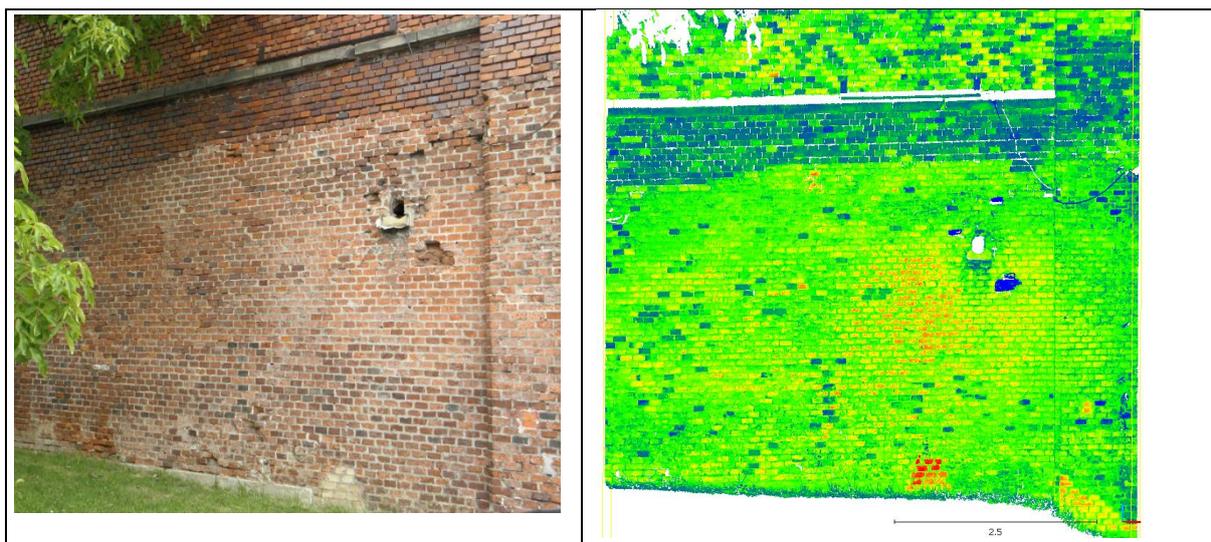
In the field conditions, the measurements were carried out on a 19th century brickwork (citadel located on the Kościuszko Mountain in Cracow, Poland). The brick wall in question was chosen for tests due to its poor technical condition (see Fig. 2). The brickwork was renovated multiple times in the past and currently consists of different types of ceramic bricks in varied technical state. For the second phase of the research a time-of-flight TLS Riegl VZ-400i was used. A narrow infrared laser was used in the Riegl VZ-400i scanner. The maximum measurement range and maximum measurement rate of this TLS depends on used laser pulse repetition e.g. 100 KHz (800 m, 42,000 pts/sec), 1200 KHz (250 m, 500,000 pts/sec) respectively.

Figure 2. Tested historic brickwork (left) and point clouds of this wall

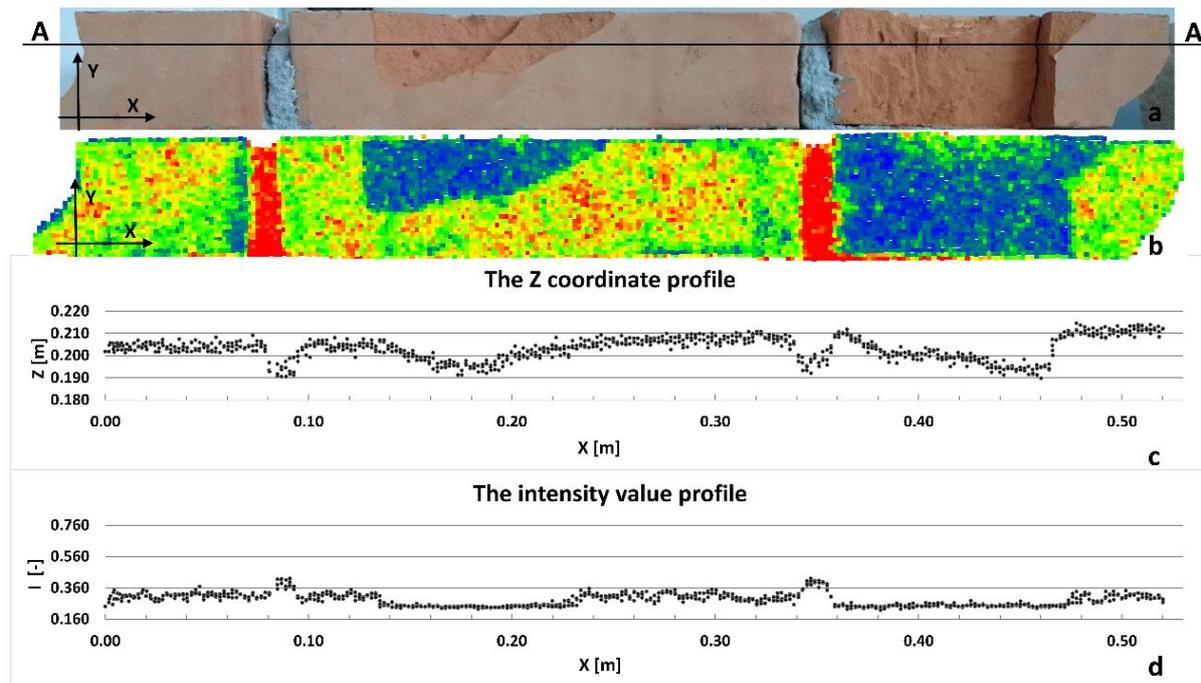
The CloudCompare software was used for the processing of the datasets. Two AA profiles were made for the ceramic brick wall specimen in order to carefully analyse the cavities in the context of changing the intensity value. The profiles present a strip of 0.01m width. The first profile shows the distribution of points in the OXZ coordinate system (see Fig. 3c). The second profile shows the distribution of points in the OXI coordinate system (where I - *intensity* value of each points), see Fig. 3d.

Figure 3. Profiles of the ceramic brick wall specimen

The analysis of a profile the ceramic brick wall specimen is graphically represented in Figure 3c. One can locate defects in the wall in relation to the assumed reference plane. The analysis of Figure 3d profile allows to track changes in the *intensity* value in the research area. One can easily notice that there is a change in the *intensity* value of the laser beam reflectance at the places of defects and in areas of material change (cement mortar in comparison to the brick). In areas of defects, the *intensity* value slightly decreases in comparison to the areas without defects. The *intensity* value increases on the cement mortar surface in relation to the ceramic brick surface. Thus the proper analysis of *intensity* value of point clouds may be useful information for detecting cavities in the ceramic brick wall. In addition, the intensity value can be used for segmentation of dataset e.g. separation of points on a cement mortar.

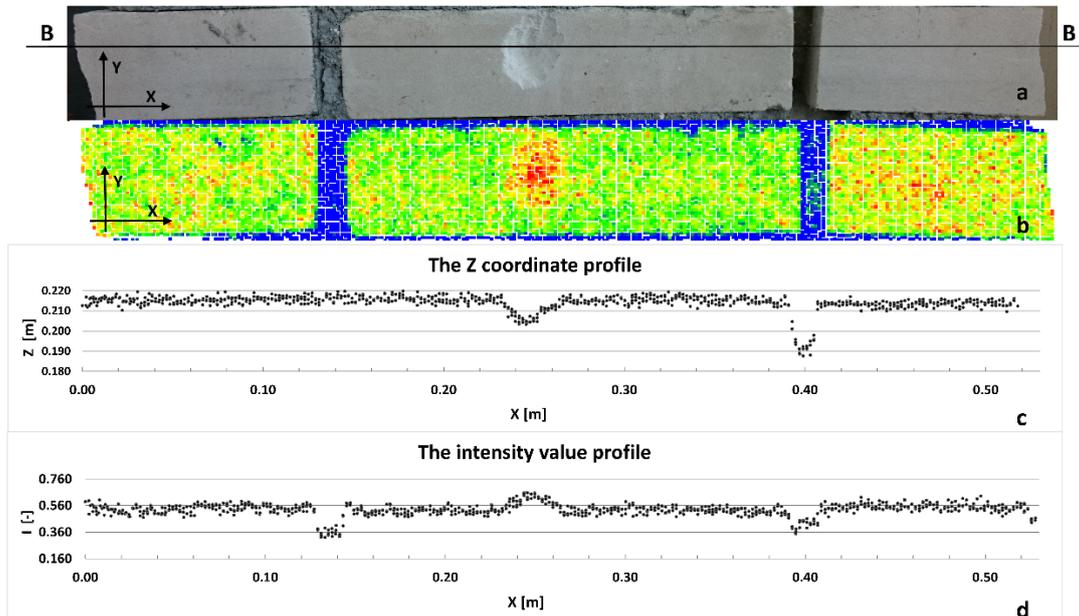
The analyses of datasets from the TLS measurement of the silicate white brick wall specimen were carried out in the same way as for the ceramic brick wall specimen. Fig. 4 presents profiles made on the basis of the silicate brick wall specimen.

Figure 4. Profile of the silicate brick wall specimen

As in the previous example, the *intensity* value also changes in the places of defects and in areas of material change (cement mortar in comparison to the brick).

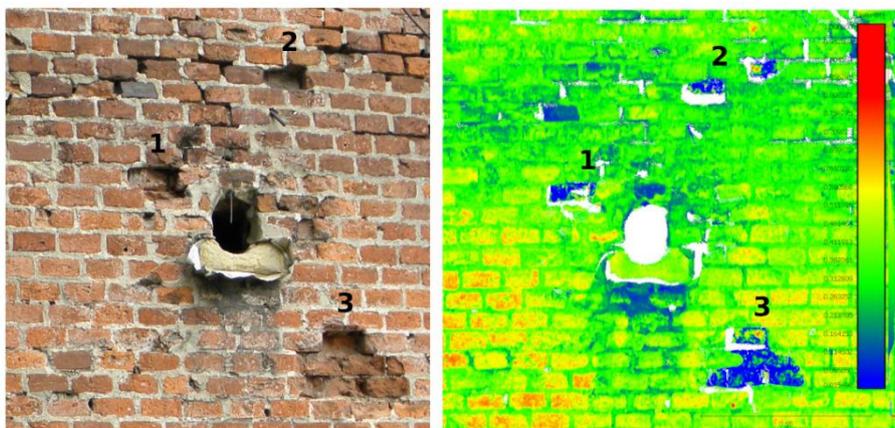
The next phase of the research was a visual analysis of the intensity value distribution on the real object: 19th century brickwork. Cavities in the wall were presented in Fig.5. These cavities were numbered (1-3) in RGB photo and intensity image created by TLS. In Fig. 6 the reconstructed part of brick wall was presented.

Figure 5. Presentation of cavities in the RGB picture and on the point cloud

Such analysis is very useful for localization of areas of walls in need of urgent repair and areas renovated using different type of bricks. In Fig. 5 areas with missing bricks and missing mortar were clearly located. In case of the wall presented in Fig. 6 old ceramic brickwork was repaired using modern bricks. The area covered by modern bricks was clearly located. Using modern bricks for restoration of old brickwork is a very serious technical mistake. Both types of bricks are characterized by a very different mechanical properties [24][25]. Modern bricks are characterized by significantly higher compressive strength and modulus of elasticity than the old bricks. Modern bricks are basically “incompatible” with old brickwork and will cause its quick degradation.

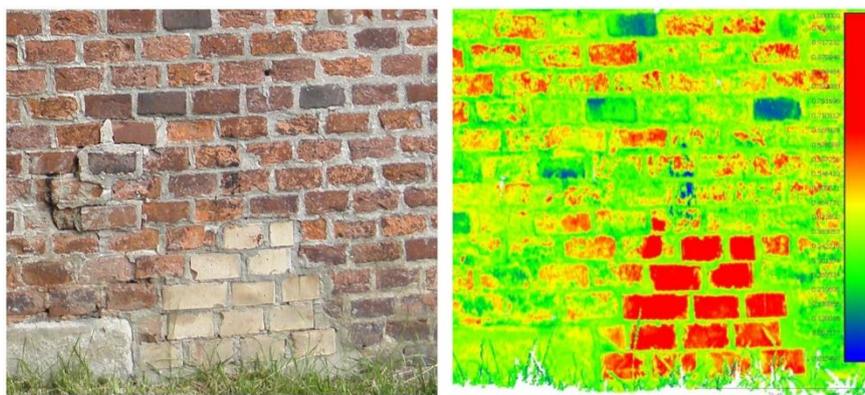
Figure 6. Presentation of reconstructed part of brick wall
