Long-term monitoring of spillway using various NDT techniques-case studies

K-T Hsu¹, C-C Cheng², C-H Chiang², Y-T Ke³ and J-S Cheng⁴

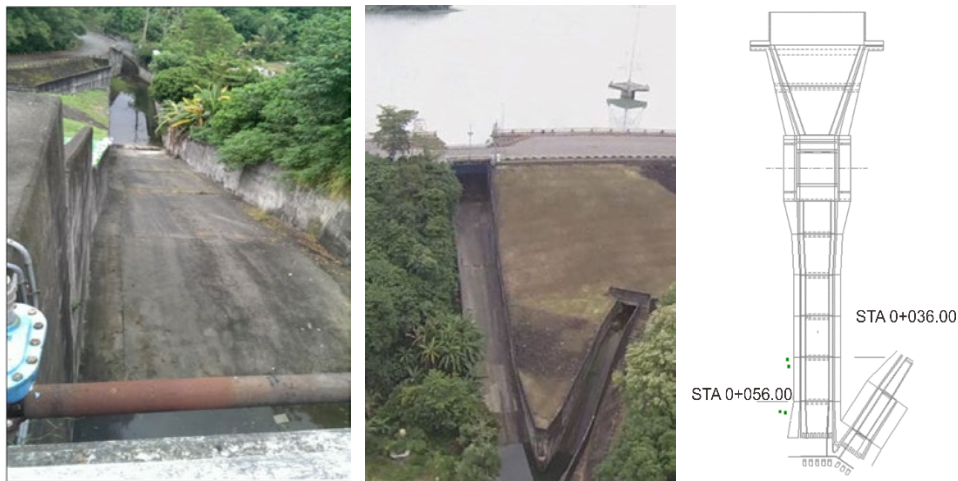
Figure 1. The picture and design diagram of spillway which had been commissioned in 1987 in Taiwan.

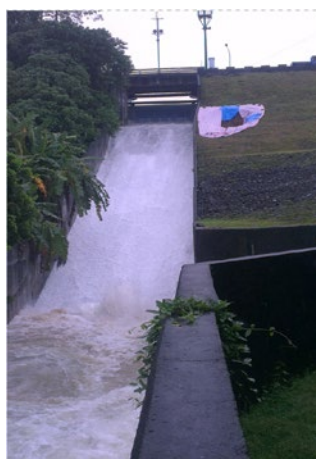
Figure 2. The picture of the spillway discharge during a heavy rainstorm.

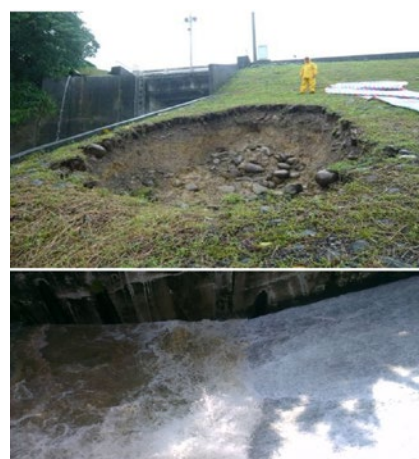
Figure 3. The piping was founded in soil slop beside the spillway after a heavy rainstorm.

After a heavy rainstorm, the piping was founded in soil slop beside the spillway. At the same time, a serious deterioration was visible under spillway which leads to explicit cracks and breaking of the external concrete layer. Thus, the key issue is going to be the evaluation of the distribution of potholes, and subsurface cavities under the spillway for the engineering team to repair the deteriorating concrete structure. NDT techniques that includes ground penetrating radar and normalized impact echo were performed for the safety assessment as shown in figure 6. Figure 7(a) is the result of impact echo waveform recorded by the transducer and normalized spectrum. Figure 7(b) is two-dimensional imaging of GPR profile from the spillway which indicated the erosion area under the spillway (the blue wireframe in the figure). Local penetration drilling test was dealing with the concrete slab of the spillway to confirm the result of two non-destructive techniques which are both indicate subsurface cavities under the spillway as shown in figure 7(c). The field test with non-destructure techniques including ground penetrating radar and normalized impact echo are explained in figure 8. Figure 8 and figure 9 show the distribution of subsurface cavities under the spillway. Therefore, based on the results of the field test, the engineering team designed and executed the repair projects based on the conclusion of the integrity assessment, as shown in figure 10.

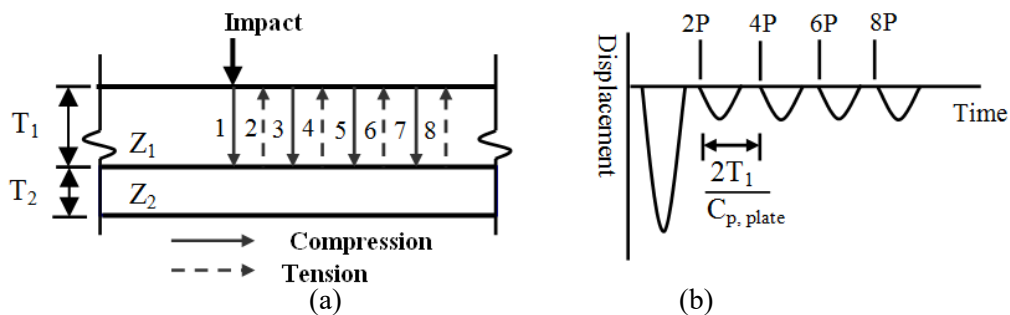
where Z_1 is the acoustic impedance of the material in which the incident wave propagates, Z_2 is the acoustic impedance of the material in which the refracted wave transmitted through, A_i is the amplitude of particle motion in the incident wave, and R is called the reflection coefficient. Figure 4(a) shows a schematic illustration of phase changes in reflected P-waves for the case that the acoustic impedance of the bottom layer is less than that of the top layer ($Z_2 - Z_1 < 0$). Figure 4(b) illustrates the displacement waveform recorded by a receiver close to the impact point.

Figure 4. The impact-echo method: (a) phase changes in reflected P-waves; (b) waveform.

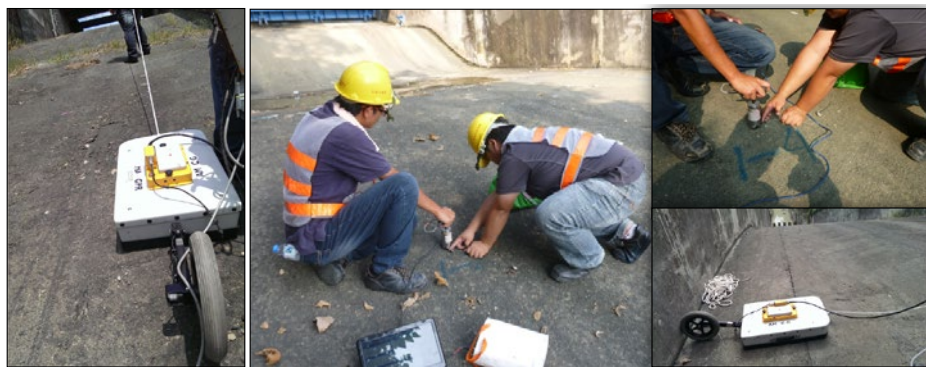
Figure 6. The picture of field test with non-destructure techniques after a heavy rainstorm on the spillway.

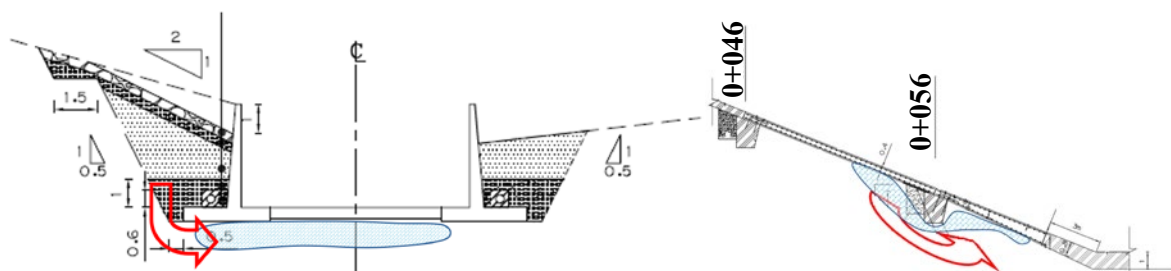
Figure 9. Potholes and subsurface cavities were confirmed in the safety assessment by using various NDT techniques.

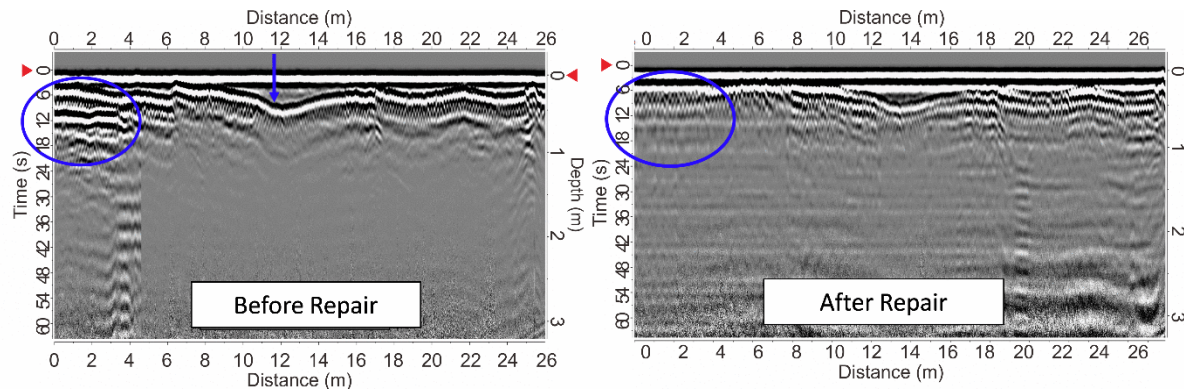
The repair project that aimed to remedy the deteriorating concrete structure of the spillway. The engineering team designed and executed the repair project based on the conclusion of the integrity assessment. Subsequent GPR inspections have been performed to monitor the integrity of the spillway in a period of 18 months following the repair project. After the completion of the repair project, repetitive GPR scans were also carried out after the rehabilitation of spillways, the integrity of the spillway can be observed in the profile of the penetrating radar as shown in figure 11. Not only the quality of repair can

Figure 11. Ground penetrating radar profile of the spillway.
