## Consideration of costs and factors of safety for landslide mitigation of the housing infrastructure in Sawahlunto

To cite this article: B Istijono *et al* 2019 *IOP Conf. Ser.: Mater. Sci. Eng.* **615** 012048

# Consideration of costs and factors of safety for landslide mitigation of the housing infrastructure in Sawahlunto

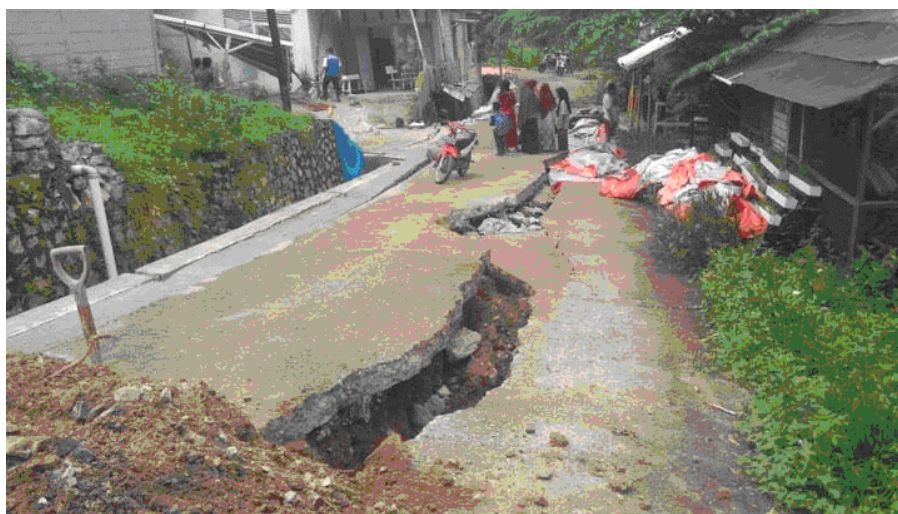
On November 2, 2018 there was land movement in a residential area in the city of Sawahlunto, West Sumatra, Indonesia. This landslide resulted in 4 houses being unable to function and 12 others damaged so that it was very uncomfortable and dangerous to be occupied, and there was road cracks (figure 1). The event of the landslide in Sawahlunto did not occur suddenly. In fact, before a major movement occurred on November 2, 2018, there had been a crack in the road since October 11, 2018 [6]. The cracks were reported following extreme rain on October 11, 2018. It is estimated that there has been infiltration of rainwater into the underneath soil through the cracks that already existed before. This infiltration resulted in saturation and reduced the strength of the soil.

**Figure 1.** Road damaged by land movement after heavy rains in Santur Village, Sawahlunto, West Sumatra, 2 November 2018. (Photo by BNPB in [6]).

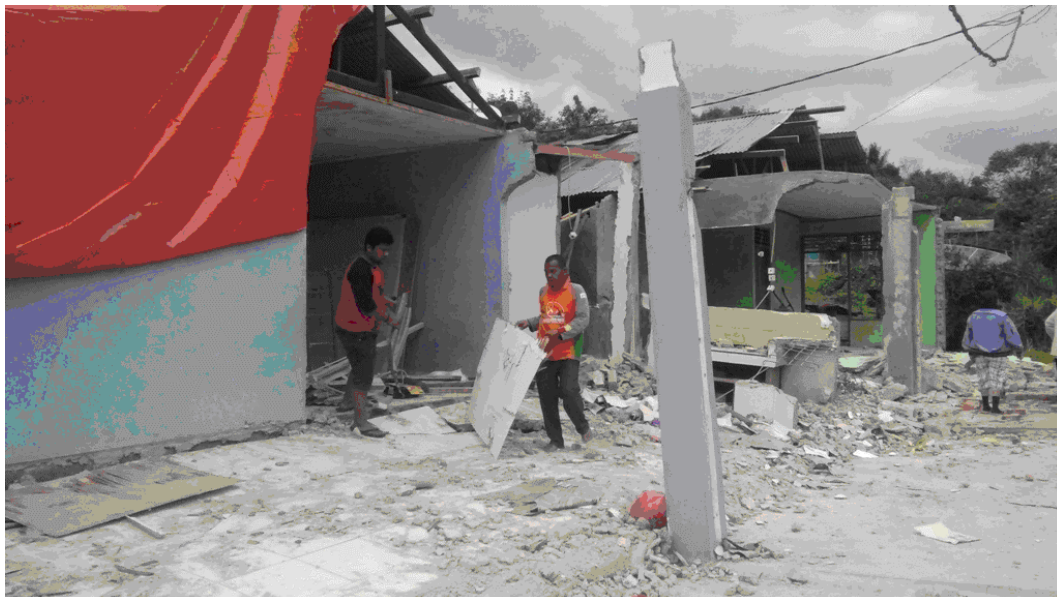
The criteria for selecting the appropriate mitigation method are based on factors of safety and the cost of construction. These criteria are adopted because the area is experiencing land movement is public housing areas and did not result in casualties. Thus, the costs needed for the constructions for this land movement must be smaller than the value of the land. If the costs incurred for disaster management are greater than the value of the housing area, then the relocation option is a wiser choice. Even from the reality in the field, the people affected by this landslide have evacuated (relocated) independently (figure 2) [7].

**Figure 2.** Residents dismantle their houses independently [7].

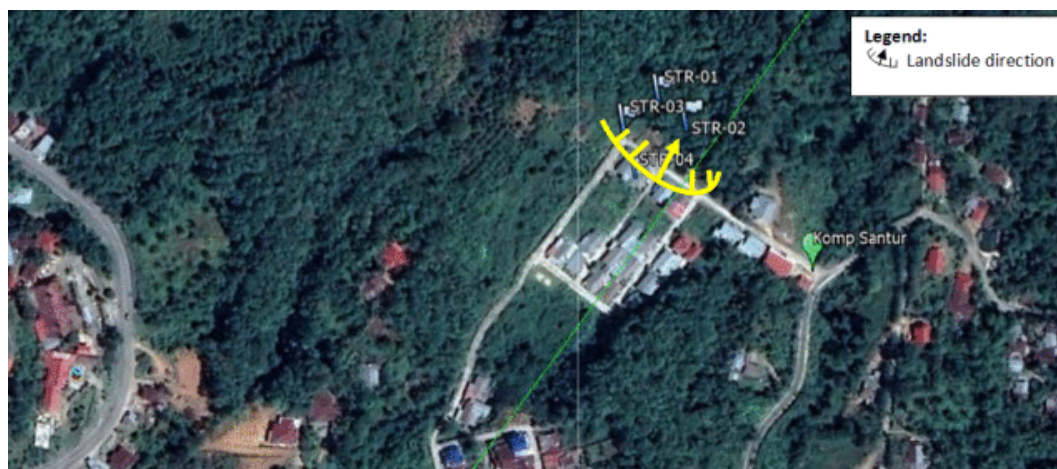
The location of this landslide is precisely in the global coordinates of E: 100° 45' 03.4", S: 0° 38' 48.0" (figure 3). The location is in the form of housing with the name "Perumnas Lembah Santur" in Karanganyar Village, Santur - Barangin District, in Sawahlunto City of West Sumatra - Indonesia. The Santur landslide has caused 4 (four) housing units to be seriously damaged, 12 (twelve) units of houses were slightly damaged and 40 meters of land cracks which damaged roads and drainage. The morphology of the Perumnas Lembah Santur area is part of the Batang Ombilin Basin, the slope is a moderate to medium steep slope (15° - 50°) and elevations range from 250 - 400 meters above sea level. The Perumnas Lembah Santur area of Barangin District and its surroundings is quite close to the fault structure with a relative north-south direction. The types of rocks in the Perumnas Lembah Santur area and surrounding areas are [8] are Lower Member Formations of Ombilin (Tmol) in the form of quartz sandstones containing archaic mica inserts, clay flakes, quartz conglomerates and coal.

**Figure 3.** Bird eye Sanur landslides.

Field observations found that the dominant type of rock was medium-strong weathered clay shale. The nature of the slab shale is impermeable so that it tends to hold water and directly reduce the shear resistance of the soil. In high rainfall a few days before the landslide, slip was created which resulted in the disaster of this land movement.

The land use for the Perumnas Lembah Santur area and its surroundings consists of settlements and plantations. The top of the slope is a highway and residential housing, while the lower part of the slope is a community-owned plantation (rubber). Hydrogeology of the Perumnas Lembah Santur area and surrounding areas includes rare groundwater zones [9] with bedrock that has a low graduation rate (porosity). On November 2, 2018 there was land movement in a residential area in the city of Sawahlunto, West Sumatra, Indonesia. This landslide resulted in 4 houses being unable to function and 12 others damaged so that it was very uncomfortable and dangerous to be occupied, and there were road cracks (figure 1). The event of the landslide in Sawahlunto did not occur suddenly. In fact, a few days before a major landslids, there was high rainfall which might create a slip line that resulted in the disaster of this landslide.

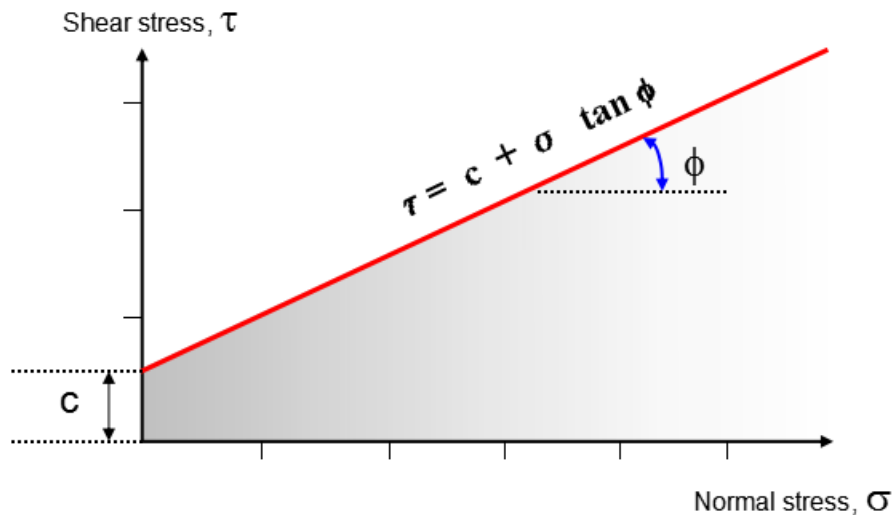
The estimation of the value of safety factors for landslides at the Santur location is carried out by following the Mohr-Coulomb equilibrium equation (figure 4) below:

$$\tau = c + \sigma \tan \phi \quad (1)$$

**Figure 4.** Soil strength for slope analysis.

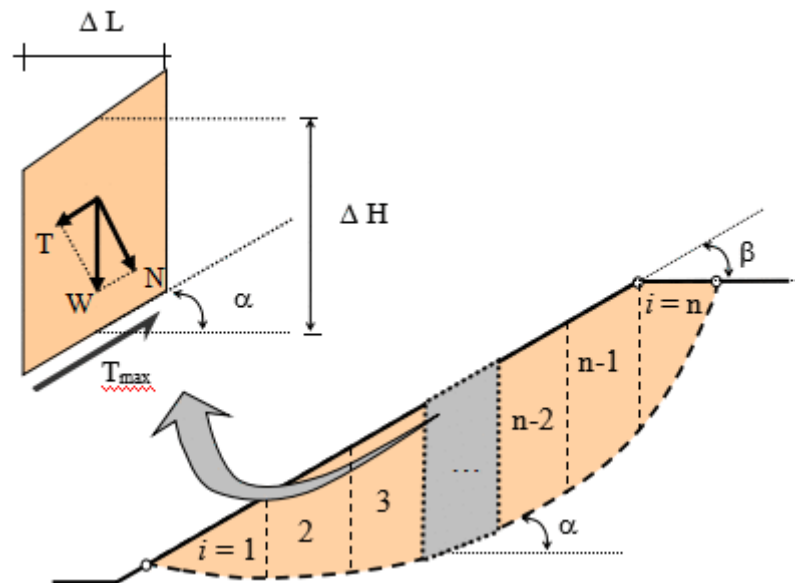
Furthermore, slope stability analysis is carried out using a generally accepted and very popular method of slices. By using numerical applications, the calculation of stability with this method is easier to be done. Stability is expressed in the form of a safety factor which compares the overall value of  $T_{\max}$  with the number of  $T$  values as follows:

$$SF = \frac{\sum T_{\max}}{\sum T} \quad (2)$$

where:  $T_{\max} = c \Delta A + N \tan \phi$  (see figure 5)

$T = W \sin \alpha$

$N = W \cos \alpha$

$\Delta A = \Delta L / \cos \alpha$

$\Delta H$  and  $\Delta L$  are the height and the length of the soil mass

$\alpha$  is the angel of the soil mass in respect to the horizontal axes

**Figure 5.** Slice Method.

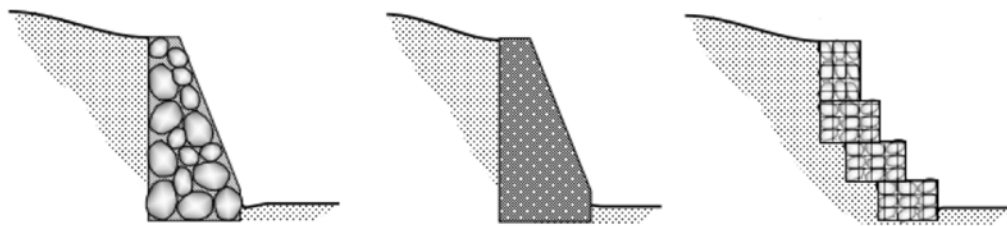
Slope stabilization is done by using several types of gravity retaining walls that are masonry retaining wall, concrete retaining wall and gabions (figure 6). This is done on the site since this type of wall is easily to be carried out in terms of materials, expertise of workers and the site conditions. Sheet pile or spun piles will be difficult to adopt by the limited area for equipment manoeuvring.

**Figure 6.** Gravity wall types for Santur Landslide.

The laboratory test results of soil gave the soil property data as follows: the moisture content of 28%, weight volume of  $1.62 \text{ t/m}^3$ ,  $S_u$  of  $1.1 \text{ kg/cm}^2$  and the sensitivity of 1,28. These values are then used in the stability analysis in terms of factors of safety. Based on the results of the slope stability analysis and chosen construction for stability countermeasure, the summarized results can be shown in Table 1 together with the cost estimation:

Based on these results, to determine the right choice based on two main factors, namely slope safety and construction costs, the cost values are compared with factor of safety (SF) (table 1). It can be seen that without using a retaining wall, the factor is zero, but this value does not actually provide security since it collapses in reality. The comparison value for the construction of concrete walls is greater than the others which means it is very expensive and does not have good economic value. Whereas the stone masonry wall has the smallest value that indicates this construction can be chosen as the right option to be used in the Sanur area.
