PAPER • OPEN ACCESS

To cite this article: R Suryanita *et al* 2019 *IOP Conf. Ser.: Mater. Sci. Eng.* **615** 012090

Experimental study and numerical analysis of flexural behaviour of post-fire reinforced concrete beam

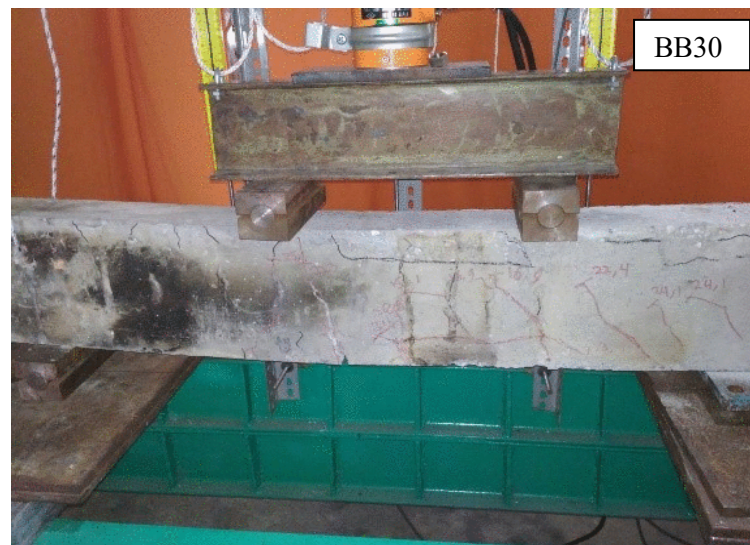
Flexural testing of BB30 beams shows that the first crack occurred at 13.1 kN loading and the ultimate load occurred at 25.4 kN. Damage to the RC beam model due to the load in the form of cracks occurs in the entire beam span. The cracks occur on the whole surface of the post-fire beam. Flexural testing on the BB30 beams can be seen in figure 4.

Figure 4. Flexural testing on RC beam BB30 model.

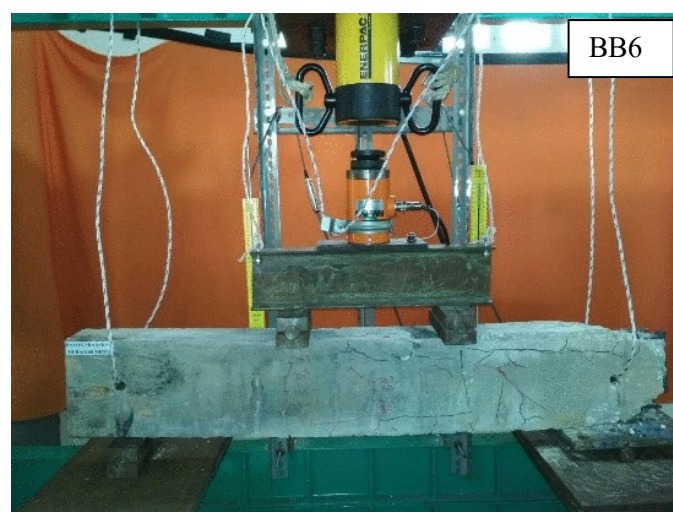
The flexural testing of the BB60 beams shows the first cracks due to load occurred at 9.8 kN and the ultimate load at 20.4 kN. The first crack is defined as a crack that first appears on the surface of the specimen when it is loaded. Meanwhile, the ultimate load is defined as the maximum load can be received before the specimen collapses. Damage to the beams due to the load occurred as cracks in the entire beam. More cracks occurred on the BB60 beams than on the BB30 beams. Flexural testing on the BB60 beams can be seen in figure 5.

Figure 5. Flexural testing on RC beam BB60 model.

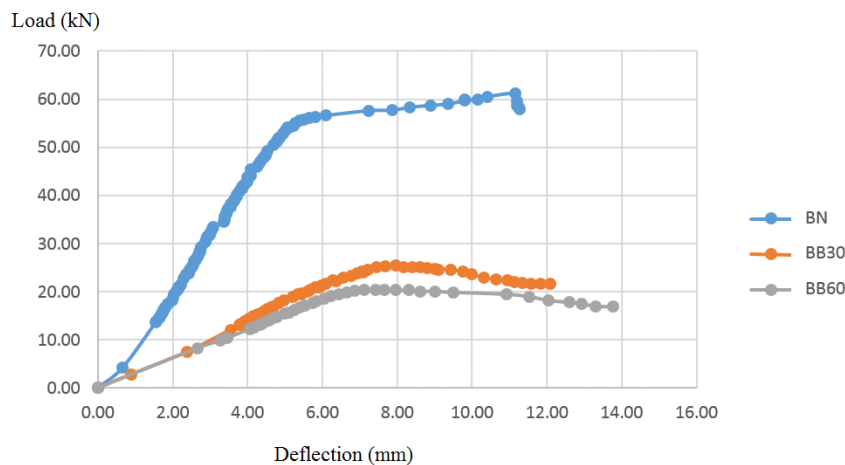
The experimental works demonstrated that there is a difference in the amount of deflection between the unburned RC beam (BN model) and the post-fire RC beam conditions. Figure 7 shows that the both stiffness and load capacity decrease with increasing duration of the fire. In the BN beam, the amount of deflection in the ultimate condition is 11.16 mm at the load of 61.2 kN. The reinforced concrete beam BB30 shows a deflection at the ultimate condition of 7.96 mm at 25.4 kN loading, whereas the BB60 beam shows a deflection in the ultimate condition of 7.12 mm at the load of 20.4 kN. The relationship between load and deflection indicates that the load energy needed to achieve a certain deflection amount decreases with increasing fire duration.

Figure 7. Relationship curves of deflection and loads.

The result of the bending strength test showed that the deflection occurring on the reinforced concrete beam that burned for 30 minutes (BB30) increased by 7% compared to the unburned concrete beam model (BN). Likewise, the 60-minute burned concrete beam model (BB60) showed a 22% increase in the beam deflection compared to the unburned concrete beam model. Moreover, the slope of the relationship curve between load and deflection (stiffness) increases after exposure to fire to 30 minutes, however, only a slight reduction in stiffness is observed for prolonged exposure (60 minutes). The pronounced difference in stiffness between the unburned beam and beams exposed to fire is related to the loss of stiffness of concrete due to heating and cooling.

- d. The results of the flexural strength test on the beams indicate that the deflection in the ultimate condition on the BN beam is 11.16 mm, on the BB30 beam is 7.96 mm, and on the BB60 beam is 7.12 mm.
