# Landslide Analysis Study and Cisewu Countermeasures in District, Garut Regency, West Java

**Abstract.** Cisewu-Garut is one of the landslide-prone areas in Indonesia which occurs almost every year, particularly in the rainy season. The landslide in this study takes place in the slope where a BTS tower is located. The peripheral fence is hanging due to ground movement, while housings stay beneath the foot of the slope. This problem could harm its surroundings and needs immediate countermeasures to prevent any hazard. At the initial stage, a survey is conducted to investigate slope condition, soil state (including soil test), and drainage. Based on available soil data, the second stage is slope stability analysis by creating a model corresponding to real condition data using the element method to Plaxis2D software. As for the third stage, a landslide disaster prevention is established by strengthening the foot of slope using gabion and retaining walls. The gabion wall cage dimension would be 5m wide and 2.5m tall. Two retaining walls by the size of 2m high to 1m wide and 1m high to 0.6m wide are build. The result of slope stability analysis is an increase of safety factor by 1.729

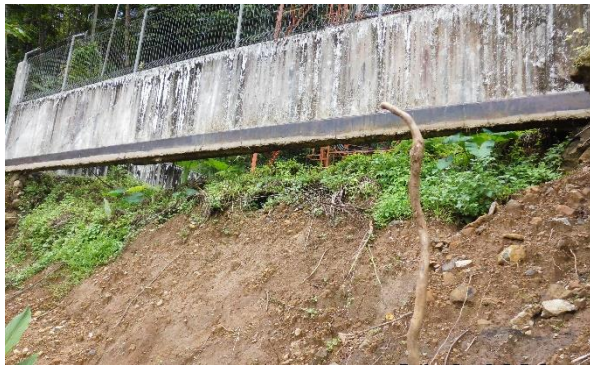
**Figure 2.** Slope failure area in the edge of fence

Based on visual observation on Figure 2, the tilt of slope is quite steep where the edge of the fence is hanging as the effect of soil movement under construction. The rainfall condition in a normal year, El Nino phase and La Nina phase are high enough [9], whereas the existing water canal in this tower building could not accommodate the rainwater stream resulting water overflow and leaked water into the soil. This condition would reduce the shear strength of soil and rock that would generate ground movement or landslide as in Figure 3.

Landslide countermeasures include; survey investigation, analysis and slope reinforcement. Appropriate countermeasures shall be selected or designed based on the results obtained from the survey and the analysis [10]. The prevention is established by constructing gabion mesh and retaining walls in the foothills to decrease the slope dipping and to increase safety factor number. Further improvement is to recondition the previous canal and to build the new canal to anticipate rainwater leaked that could lead to the rise of the soil water table and slope failure.

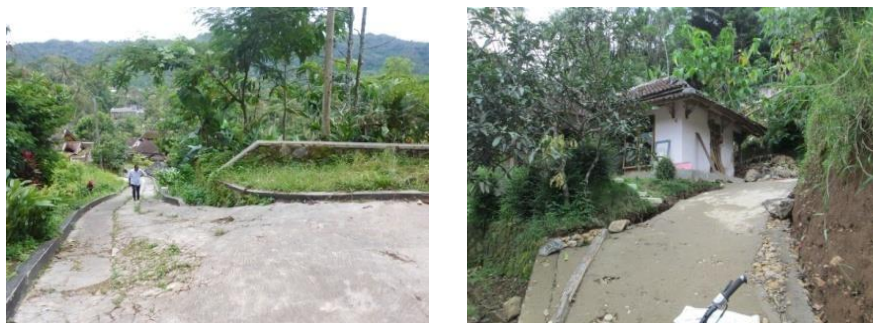
**Figure 6.** The road shape after slope failure

**3.1.1. Road shape.** The road to the tower area is still accessible enough, however, to reach the residential areas exposed to landslide disaster needs more effort since the road access has been cracked due to slope failure although it can be passed yet as in Figure 6.
