Characterization of historic mortars and earthen building materials in Abu Dhabi Emirate, UAE

Benjamin L. Marcus¹

¹Building Conservator, Abu Dhabi Authority for Culture and Heritage (ADACH)

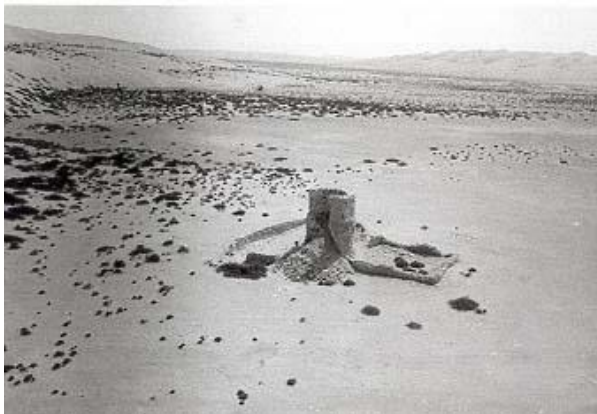
Figure 3: Qalat Umm Hisn in undated historic photograph (circa mid-20th century). Source: Center for Documentation and Research (CDR), Abu Dhabi.

Qalat Umm Hisn is a ruined stone tower at the western end of Liwa oasis, near the mahdar of Arada. The UK and Saudi Memorials of 1955, drawn up at the time of the Buraimi dispute, state that the tower was built by the Manasir tribe in the early years of the Qatar-Abu Dhabi war (1883 – 1890) [4]. Originally consisting of a round tower between two low stone enclosures, today, the structure is largely collapsed with only one section of the tower wall standing (Figs. 3 & 4). Structural assessment carried out in 2010 on the standing wall highlighted the urgent need for stabilization through crack stitching, wall capping and repointing of eroded mortar joints.

Addressing the building's conservation, ADACH conducted materials analysis to understand the type of mortar used in the building and to plan appropriate repairs. Analysis sought to answer basic questions regarding traditional materials used in a remote area with few natural resources. Would the mortar be based on lime or gypsum, and what is the material source and method of production? Three mortar samples were taken from different areas of the remaining tower wall and surrounding low walls. Analysis techniques included optical microscopy to examine resin-embedded cross sections, and scanning electron microscope/energy dispersive X-ray spectroscopy (SEM-EDX) and X-ray diffraction (XRD) to determine elemental composition as well as mineral phases and crystalline compounds (Figs. 5 & 6). SEM investigation was performed on a Quanta 200 (FEI Company), equipped with a Wolfram-cathode with a Quantax microanalytical EDX add-on (Bruker AXS). X-ray diffractograms were recorded by a Philips PW 1729 equipped with a copper tube (30KV, 30 mA) on silicon single-crystal sample carriers [5].

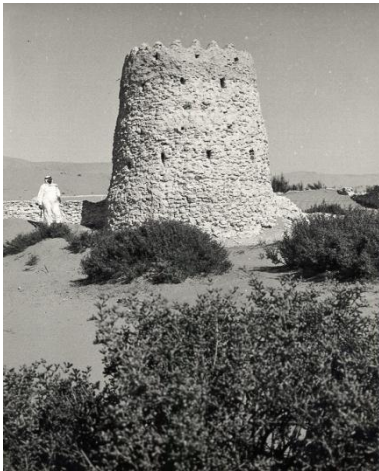
Figure 7: Hayla Tower in undated historic photograph (circa mid-20th century). Source: CDR.

When first surveyed by ADACH, the tower was in extremely dangerous condition. With its roof and floors gone, the walls were left vulnerable and large cracks in the masonry had developed that threatened to cause total collapse of the structure. In 2009, support scaffolding was installed and the largest cracks were stitched with stone and mortar (Fig. 8). This was followed by additional structural stabilization including the installation of retaining straps around the tower exterior. A conservation management plan was initiated which guides conservation decisions and included documentation through 3D laser scanning and laboratory analysis of mortars.

While gypsum was identified as the main component of the building's mortar, conservators have chosen lime as a repair material over gypsum for its stability against moisture and salts. Trials of lime-based repointing mortars, injection grout, and a shelter coating were carried out in June 2011. As at Delma, various mixes of lime, coarse sand and the pozzolanic *sarooj* were tested on a small area of the tower. After evaluation of the trial mortars, taking into consideration factors such as strength, adhesion, color and porosity relative to adjacent materials, full conservation treatment will be implemented followed by fencing, signage, and interpretive features to make the site accessible to visitors.

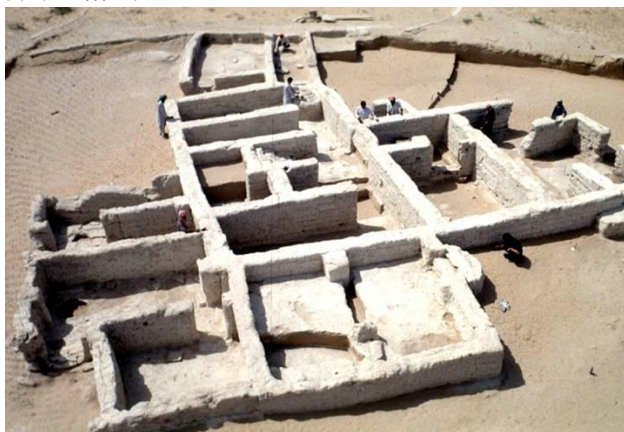
Figure 10: House 1 in the early 1990s. Source: DAA n. 2 **Figure 11:** Detail of deterioration. Source: author.

Hili 17 is an Iron Age II period archaeological site located in Hili Archaeological Park, Al Ain. The site comprises three earthen houses and numerous hearths built over several centuries of occupation. It has been carbon dated to ca. 1000 BCE and is significant as a possible pottery production center [10, 11]. Excavated from 1991-94, Hili 17 has been exposed for over 20 years and has deteriorated significantly with many areas of collapse and general loss of definition from erosion (Figs. 10 & 11). The rapid rate of deterioration is thought to be related to cracks formed by swelling and shrinkage of the white clays used for mud bricks and plaster, and to salts in the walls and surrounding sand. ADACH's conservation approach for Hili 17 has been to document the site through laser scanning, analyze the clay materials to understand deterioration mechanisms, and in the short-term begin emergency conservation treatments while studying the implementation of a long-term protective shelter. Initial materials analysis included microscopy, XRF, XRD, and SEM.
