## The experience of retrofit design in using CFRP of building case study of the ramp structure of palm oil mill in South Sumatera

Johannes Tarigan and Albert Simbolon

Departement of Civil Engineering, Universitas Sumatera Utara, Medan, Indonesia

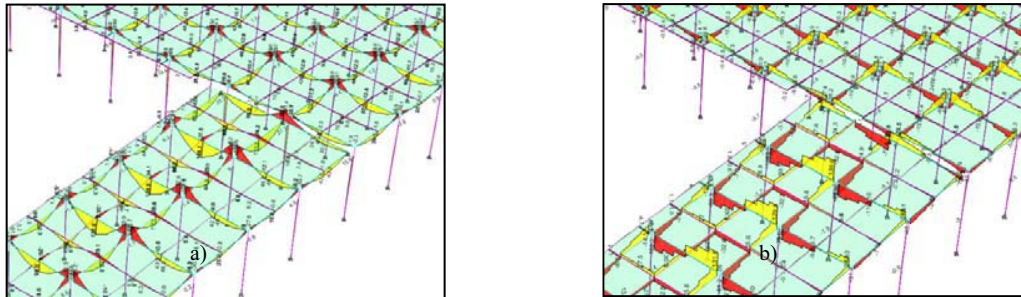
**Figure 4.** a) Moment on the primary beams and the secondary beams, b) The shear force on the primary beams and the secondary beams

The drawing results of the bending moment and the shear-force on the beams can be seen in figure 4a and 4b. As shown, for the beams with the size of 30 cm x 70 cm, the maximum moment on the support was 224.63 kNm (negative moment), while the mid span moment was 144.2kNm (positive moment), and the shear-force which occurred on the support was 138.6 kN. For the beams with the size of 25 cm x 40 cm, the maximum moment which occurred on the support was 37.3 kNm (negative moment), while the mid span moment was 24.5 kNm (positive moment), and the maximum shear force was 25.8 kN.

Beam	Negative Moment	Positive Moment	Shear Force
The primary beams 30 cm x 70 cm	224.63 kNm	144.2 kNm	138 .6 kN
The secondary beams 25 cm x 40 cm	37.3 kNm	24.5 kNm	25.8 kN

According to the calculation sheet of primary beams of 30 cm x 70 cm the reinforcement mid span was 2 Ø 25 mm in upper side and the lower side was 4 Ø 25 mm, whereas in the upper side of the support was 4 Ø 25 mm and the lower side was 2 Ø 25 mm. That's mean the primary beam is still safe.

For the secondary beams with the size of 25 cm x 40 cm, in which the upper side of the mid span reinforcement was 3 Ø 16 mm and the lower side was 3 Ø 16 mm, the moment capacity which occurred was  $M_d = z_1 \cdot F_s = 0.332 \times 65 = 21.58$  kNm, while the moment which occurred was 37.3 kNm (unsafe for the negative moment).

Based on the calculation, it can be concluded that the secondary beams were unsafe and need retrofitting.

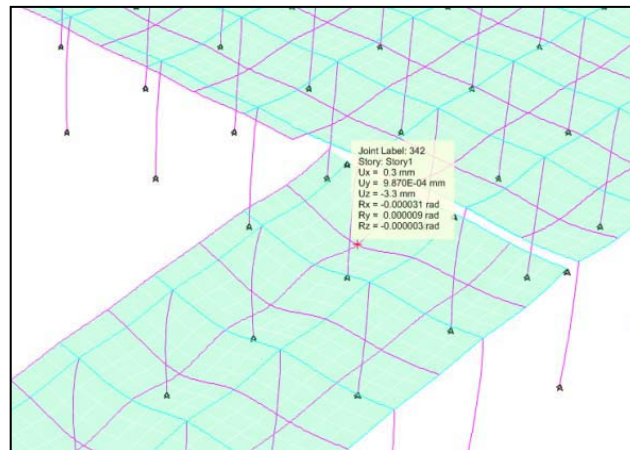
**Figure 5.** Deflection which occurred on the primary beams and the secondary beams

Meanwhile, the floor slabs can be seen in figure 5, in which the maximum deflection occurred was 3.3 mm.
