## ANALYSIS OF QUALITY CONTROL PLANS FOR BRIDGE OVER THE RIVER MAZA JUGLA ACCORING TO COST TU 1406 METHODOLOGY

This article analyses and compares different Quality Control Plans developed according to COST TU 1406 methodology for the existing bridge over the river Maza Jugla, located on regional road P10 at km 34.80 in Latvia.

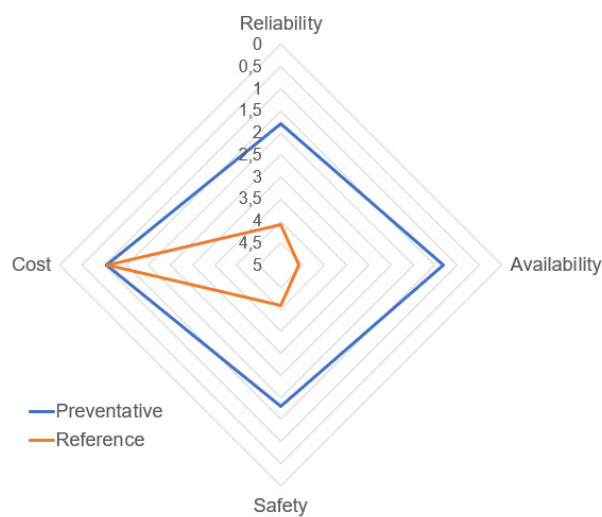
Figure 11. Overview of bridge main defects

Figure 11 shows a comparison of two considered scenarios in terms of “spider” diagram.
