Analysis and Countermeasure of Burnout of Electromagnetic Voltage Transformer of High Altitude Area in Western China

Abstract. 3 burning accidents of electromagnetic voltage transformer of Qinghai power grid in the southern high altitude area was introduced in this paper, and the cause of the accident was analyzed, which is due to a phase grounding line, then the other two phases voltage rising caused voltage transformer damaged; occurrence of Ferro resonance over-voltage, which resulting in serious core saturation, and the over-current caused voltage transformer damaged; due to open delta is short circuit, when the single-phase grounding fault occurred, because the voltage output of 100 V from open delta winding, a very large current is formatted, and a lot of heat is made, also led to the current in primary side very large, resulting in burning TV. In view of these three reasons, the corresponding prevention measures are put forward to ensure the normal operation of the power system.

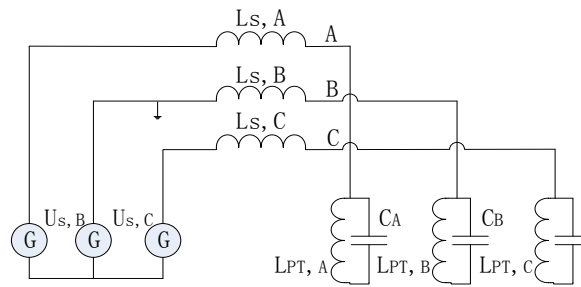
Figure.4 Equivalent Circuit Diagram of B-phase Grounding

After investigation, we found that B phase of the single-phase ground fault occurred at 22:00, the phase voltage of A and C phase changes into line voltage, resulting in C phase 35kV voltage transformer explosion. When B is connected to the ground, the equivalent circuit diagram is shown in Figure 4.

From the formula (1) we can obtained that: The main parameters affecting the instantaneous magnetic flux in the core are the initial phase angle α and the remanence Φ_r when the failure occurs. It can be seen that when single phase grounding occurs, the voltage of the non-fault phase is abrupt to the line voltage; the core enters the saturation area and produces inrush current in the winding. When the core enters the depth saturation, its inrush can reach dozens of times of the steady current, and its heat is enough to cause the damage of the voltage transformer [2].

- 1) To improve the insulation level of the distribution network and reduce the condition of single-phase grounding;
- 2) To add appropriate arc suppression coil to restrain the occurrence of intermittent arc grounding;
- 3) To improve the excitation characteristics of the voltage transformer so that the voltage transformer is not easy to enter the saturation area.
- 4) To adopt a new type of heat resistant material to increase the heat resistance of voltage transformer.

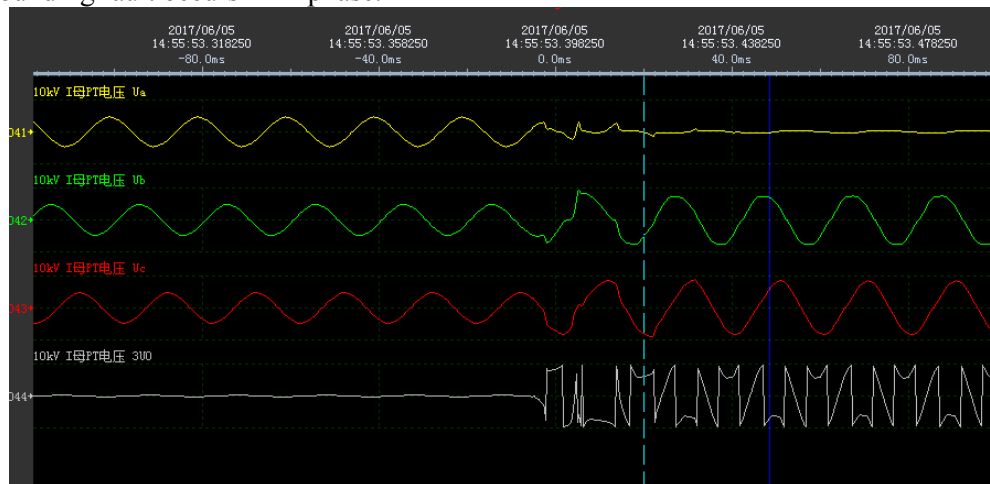
Figure.5 Voltage Waveform Diagram When a Metal Grounding Fault Occurs in A-phase

From analysis of the information collected from the protection device and its fault recorder, at 14:55 we found that U_a, U_b, U_c all change suddenly; U_b, U_c transcends the upper limit, and U_a goes beyond the lower limit. A-phase voltage disappears, indicating the occurrence of grounding fault in A-phase.

the charge or eliminating the ground fault during operation, the ground capacitance of the power grid is matched to the excitation inductance of the B phase voltage transformer. When a grounding fault occurs in A-phase, the condition of the excitation of ferromagnetic resonance is produced, which makes the core of the voltage transformer saturate and produces the neutral point displacement. These conditions are met, so the judge is ferromagnetic coil voltage transformer Ferro-resonance, excitation inductance decreases, the saturation voltage transformer excitation current depth will increase sharply, and finally burned B-phase TV. Figure 5 is the voltage waveform diagram when a metal grounding fault occurs in A-phase.

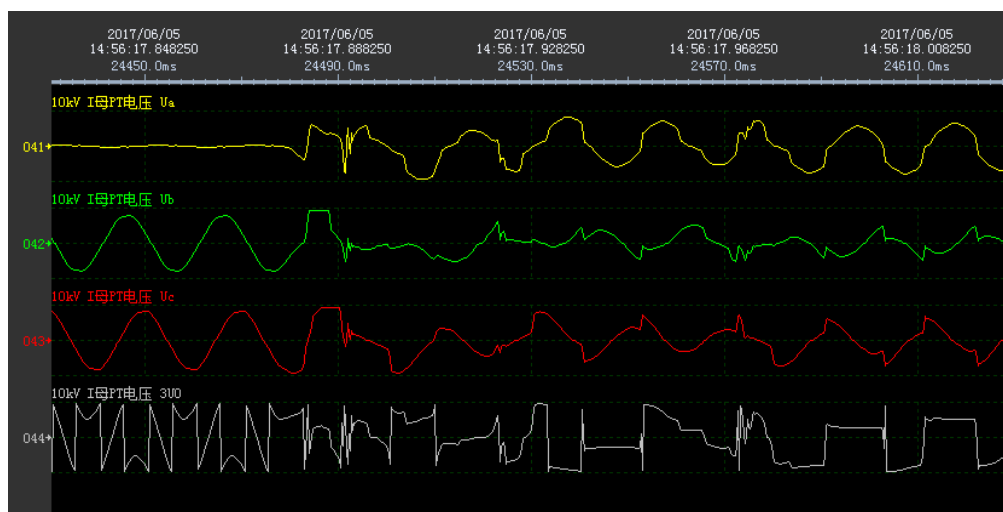
Figure.6 Voltage Waveform Diagram with Ferromagnetic Resonance

In the medium voltage power grid, the voltage transformer is directly installed on the bus. Because of the capacitance of the circuit, the TV will form a zero sequence circuit with the inductance of the transformer, and the system equivalence diagram is shown in Figure 6.

The operation and experiment of the power system show that when the inductance of the TV and the line are matched to the ground capacitance, it produces Ferro-resonance at different frequencies under certain conditions. With the increase of line length, 3 harmonic harmonic resonance, fundamental frequency resonance and frequency division resonance will occur in turn [3]. An equivalent circuit diagram of the system is shown in Figure 7.
