## Failure Analysis of the Leaf Spring of Truck Colt Diesel Using Finite Element Method

## ***Failure Analysis of the Leaf Spring of Truck Colt Diesel Using Finite Element Method***

**Husaini<sup>1</sup>, Rizki Riantoni, Nurdin Ali and Teuku Edisah Putra**

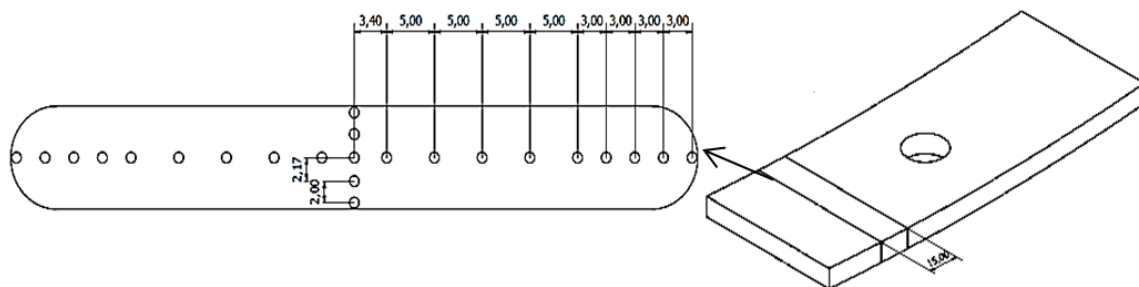
**Figure 4.** Configuration of the specimen and the points for hardness test

Hardness test was performed using Rockwell Type Zwick/Roell ZHR to measure the surface hardness of leaf spring specimens. The indenter used was a steel ball of 1/16-in in diameter and a 100 kg of loading. The size and form of hardness sample is shown in Fig. 4 Configuration of the specimen and the points for hardness test.

After testing the hardness depth reaches 22 mm from the outer surface of leaf springs. Hardness of the AISI 5150 material according ASTM standard is 92 HRB, while the hardness value of leaf springs of the results is 106.9 HRB. This hardness value indicates that the spring had undergone heat treatment and shot peening as surface treatment for residual stress regenerating. The high hardness difference between the value of the standard and the test results can decrease the ductility or tinkering occurs during the spring operation. This may cause the spring elasticity function to tend to decrease and when the maximum spring loading will be easy to crack [16,17].

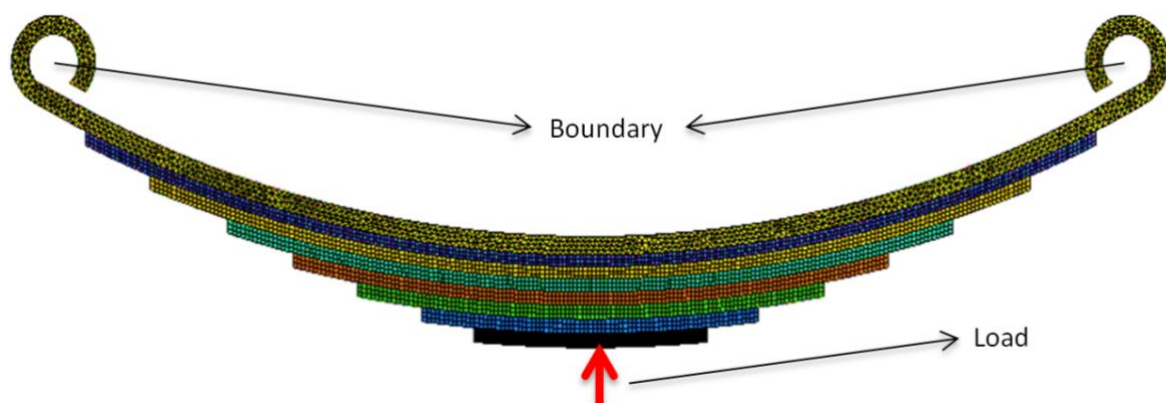
**Figure 5.** Determination of the boundary condition and loading

The simulation of collected data was done on the bolt hole area on leaf springs number eight. The usage of hole area due to the fracture failure is around it. From the result of simulation, the stress distribution known, as well as stress intensity factor and strain also obtained [14,15].

The steps and simulation process for numerical analysis were done using FEM software by giving fixed support on the spring eye. The loading type used was centralized load given on the bottom of the spring. The truck loading can be calculated by analytical analysis as shown in Fig. 5.

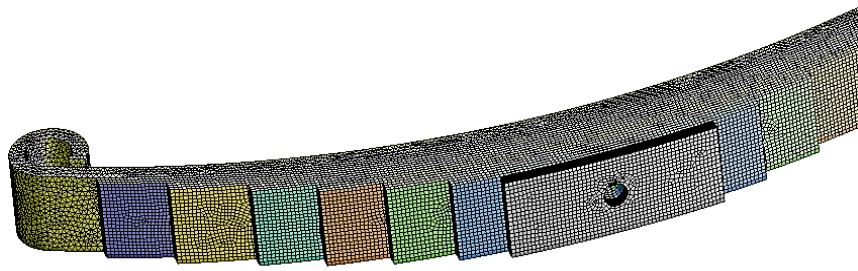
**Figure 6.** Meshing results on leaf springs for FEM analysis

The meshing steps used the obtained nodes number of 633438 and the number of elements of 5280. The meshing result of finite element analysis for all spring is shown Fig. 6.

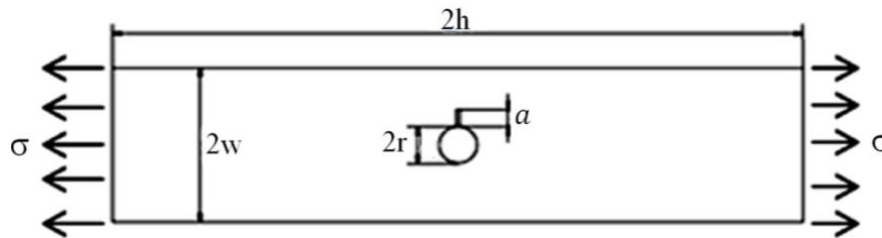
**Figure 9.** Crack configurations single-edge-crack-at-hole specimen for the calculation of  $K_I$  (radius,  $r = 5\text{mm}$ , wide,  $w = 25\text{mm}$ )

Figure 9 shows a single-edge-crack-at-hole specimen. Obtaining a value intensity factor ( $K_I$ ) is calculated using Eq. (2) in the basis of data shown in Fig. 9 [19].

Where  $a$  is the crack length. The crack length is obtained from the visual observation with the value is 4.9 mm,  $\sigma$  is the stress that occurs in the spring (specimen). Stress occurring at the spring is calculated using finite element analysis. From finite element analysis as shown in Fig. 10 with a given load of 26950 N, the maximum value of 132.84 (MPa) is obtained.  $F_{hs}$  is a limiting correction factor calculated by referencing to previous research methods [19]. The results of boundary correction factor analysis obtained value of 2.49.

After calculation of stress intensity factor ( $K_I$ ) on the spring that experienced an initial crack of 4.9 mm, then obtained  $K_I$  value of  $22.53 \text{ MPa}\sqrt{\text{m}}$ .
