Health assessment of large and old trees in Ragunan Zoo, Jakarta

**D Nandika^{1*}, H Kusuma¹, D T Kusumawardhani¹, E Rumiati², Tata²,
L Karlinasari¹, and I Z Siregar³**

²Taman Margasatwa Ragunan (TMR)- Ragunan Zoo, Jakarta Selatan 12550, Indonesia

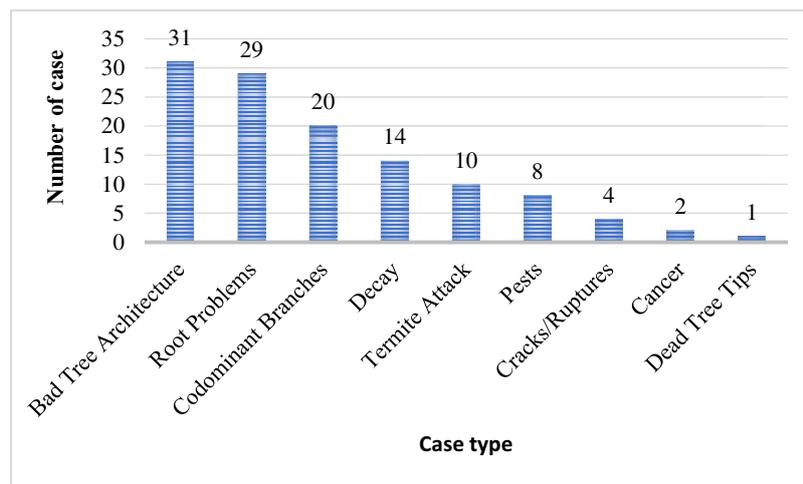
Figure 5. Case distribution on targeted tree

This result shows several case findings found in the targeted trees. Most of them are bad tree architecture (31 cases), followed by root problems (29 cases), codominant branches (14 cases), termite attacks (10 cases), other pests attacks (8 cases), cracks/ruptures (4 cases), cancer (2 cases), and dead tree tips (1 case) (Figure 5). The root problem that usually arises is the disruption of root development by infrastructures such as roads and sidewalks, causing the roots to be cut off or mechanically compressed.

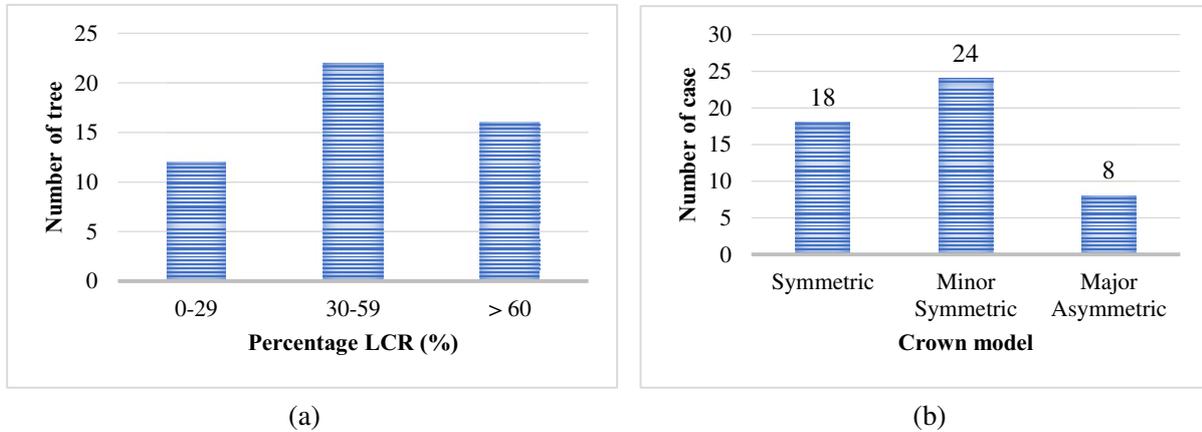
Figure 6. (a) Distribution of percentage LCR and (b) Crown model distribution of targeted tree

The Live Crown Ratio (LCR) measurements showed that 22 trees had LCRs ranging from 30-59%, followed by 16 trees with $\text{LCR} \geq 60\%$, and 12 trees have $\leq 30\%$ of LCR. This shows that some targeted trees need special care for their canopy symmetry, considering it is not only related to the fitness and photosynthesis of the tree, but also the beauty and safety of its surrounding environment. The canopy width is positively correlated with how the roots obtain minerals in the soil, which means photosynthesis will automatically affect the growth of many parts of the tree [22]. From photosynthesis, the tree crown provides carbohydrates for the roots, while the roots are absorbing water and nutrients from the soil to meet the canopy needs. The distribution of LCR percentage and the shape of the tree crown is shown in Figure 6.

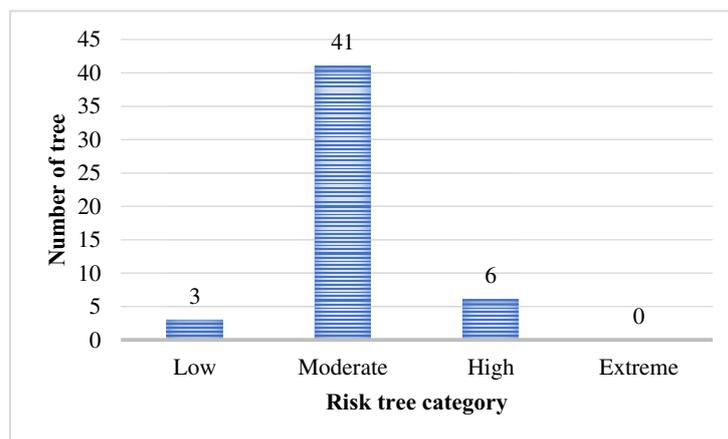
Figure 8. Frequency of risk tree category based on visual assessment

The recapitulation result of visual assessment showed that 41 trees were at moderate risk of failure, 6 trees at high risk of failure, and 3 trees at low risk of failure. Six trees at high risk of failure were Trembesi (no 2), Trembesi (no 15), Kedawung (no 25), Kemenyan (no 28), Cempaka (no 32), and Sengon (no 49) (Figure 8).

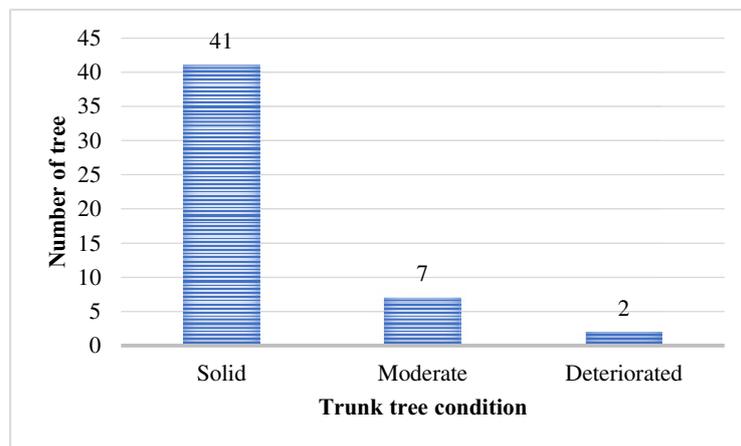
Figure 9. Frequency of trunk tree condition based on *sonic tomography*

The *sonic tomography* result showed there were 41 trees in solid condition, 7 trees in moderate condition, and 2 trees in a deteriorated condition. This refers to the percentage of solid wood on the tomogram results of each tree (Figure 9). Trees with moderate conditions ranged from 70-79% of solid wood found in number

17 (Trembesi), number 33 (Cempaka), number 34 (Cempaka), number 36 (Petir), number 42 (Cempaka), number 43 (Kapuk), and number 44 (Kapuk). Meanwhile, the deteriorated trees are shown by number 37 (Sengon) and number 49 (Sengon).

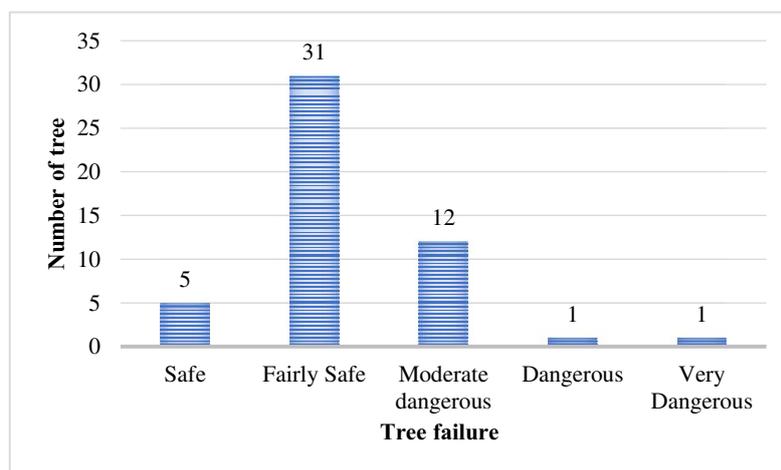
Figure 10. Tree failure risk based on visual dan *sonic tomography* observation

The result showed 31 trees were only fairly safe, while 5 of them were classified as safe. The dangerous and very dangerous trees have one tree each (Figure 10). Number 37, which is classified as dangerous, is a Sengon tree whose trunks are damaged due to a subterranean termite attack. Meanwhile, number 49 (Sengon) is categorized as very dangerous because it also has some heavily damaged trunks and was located on a puddle that causes heavy weathering. The LCR of both trees is at <45%.

of failure are fairly dangerous to make similar observations no later than 6 months after the previous one. Meanwhile, trees with a risk of very dangerous failure are recommended to be cut down. Most of them are Sengon a species which are not historical tree.

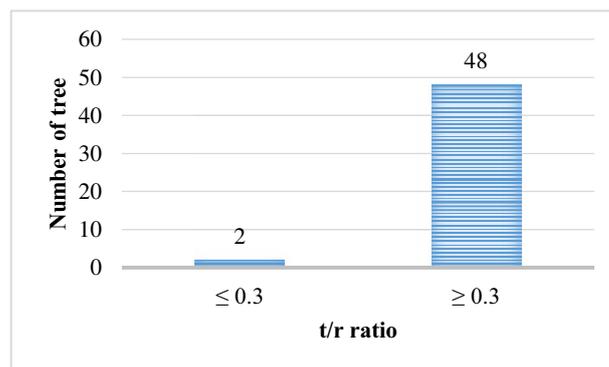
Figure 12. Frequency of t/R ratio of targeted tree

The percentage of solid wood is related to the integrity and fitness of the inner-part of the tree trunk. This percentage can also be used to determine the value t/R ratio, which is the percentage of solid wood mass to the diameter of the tree trunk. This method was adopted from [28] that requires trees to have a t/R ratio of more than 0.3. A value of t/R ratio that is less than 0.3 indicates that the percentage of the mass is too small compared to the diameter of the tree trunk, so the action needed is to cut down the tree.. The result showed that 48 trees have a t/R ratio of more than 3.0. Meanwhile, trees with a ratio of less than 0.3 only amounts to 2 trees (number 37 and 49) (Figure 12).
