## Performance and safety of hydraulic turbines

**Abstract.** The first part of the paper contains the choice of small turbines for run of the river power plants. Then a discussion is given on the optimization of the performance of different types of large turbines. Finally a discussion on the safety and necessary maintenance of turbines is given with special attention to bolt connections.

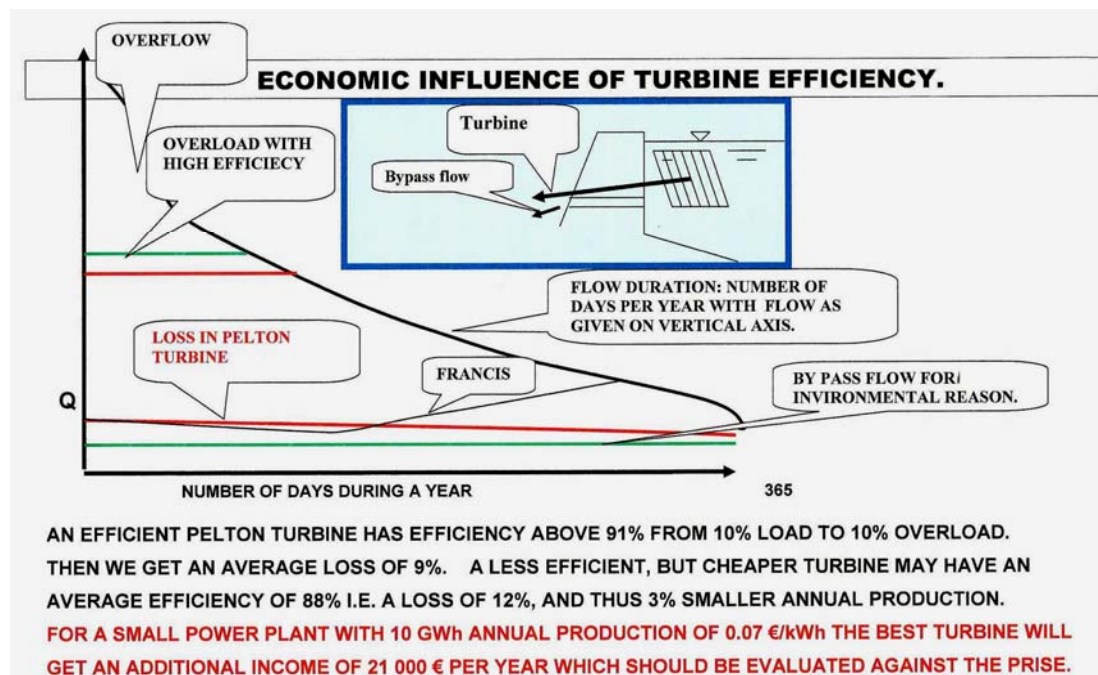
**Fig. 1** Analysis of the flow utilization in a run of the river plant by multi nozzle Pelton turbines with a difference in efficiency of 3%. One Francis turbine would produce around 15% less.

However, when operating at part load in run of the river plants using all available water in the dry part of the year, the loss is depending on the turbine efficiency at part load which goes in favour of Pelton turbines. In Fig. 1

the flow duration curve is shown with illustration of the efficiency of a 6 jet Pelton turbine and a Francis turbine. Further by comparing the efficiency of two Pelton turbines with 3% difference in efficiency the difference in annual income would be € 21 000.

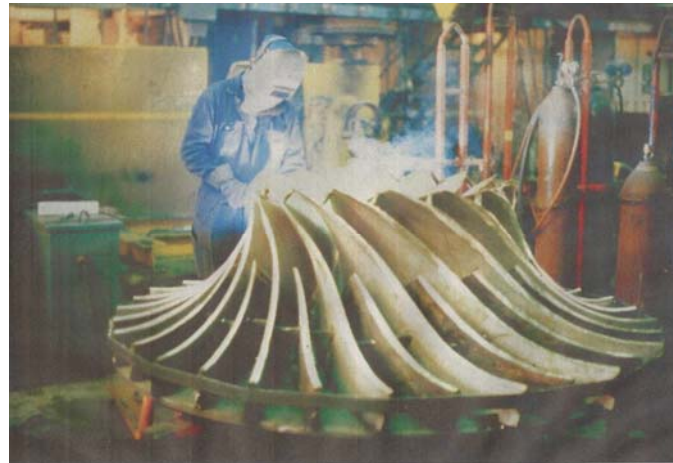
**Fig. 5** A splitter blade runner during fabrication around 40 years ago.

For high head runners the introduction of splitter blades made it possible to operate high head turbines over the whole range of power without restrictions if the splitter blades were designed properly. This know how was invented just before World War II and was improved in Norway during the boom of hydropower installations from 7 000 MW around 1955 to 27 000 MW in 1990. The reason for this was the electric power needed for the electro chemical- and electro furnace industry with requirements of fast changes from no load to full load with operation often on isolated grid. In addition the power production was consumed for heating and light in cities. Also for splitter blade runners the blade lean angle and shape of hub and band is important in the same way as for the X-blade runners. A detailed description will not be possible in this condensed paper. However, for heads around 350 m efficiency exceeding 95% has been obtained with a smooth part load operation.

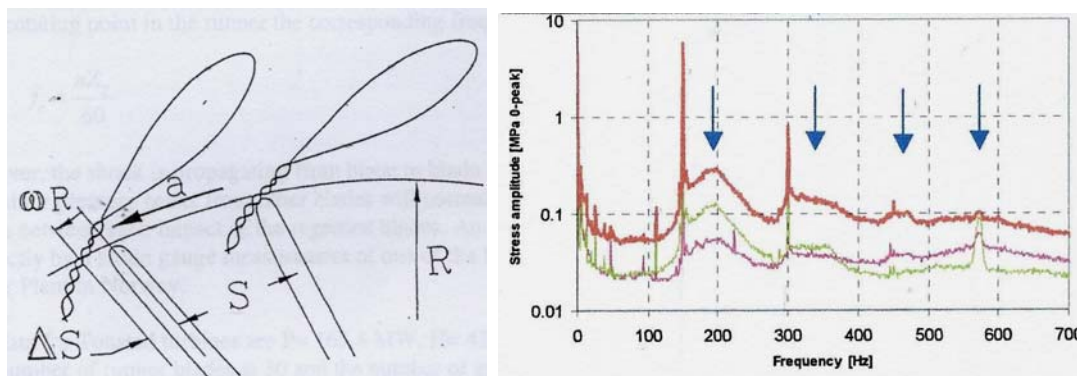
**Fig. 7** Illustration of blade passing (left) and results from stress measurements on runner blade outlets at Tonstad Power Plant (NORCONSULT). (Speed  $n=375$  rpm and number of guide vanes 24). Blue arrows indicate the calculation of possible natural frequencies of the runner.

For high head Francis turbines and Reversible Pump Turbines for high heads relatively strong pressure pulsations occur in the blade channels created by the blades passing the wakes from the guide vanes. The frequency will be the rotational speed per sec multiplied by the number of guide vanes. However, on the outside of the runner the frequency will be the number of runner blades multiplied by the rotational speed per sec. This has been proven by pressure measurements between lower cover and runner band at high head plants in Norway, [2]. In one case described in [2], also a severe noise problem occurred because the shock wave from the blade passing through the wake reached the next guide vane wake simultaneously with the blade in front i.e.  $\omega R = a(S + \Delta S)$ . (See illustration to the left in Fig. 7)

The conclusion will then be as proven by measured stresses on the runner blades in several cases: The natural frequency will probably not have any influence on fatigue problems of low specific speed Francis runners. However, water hammer reflections in the blade channels should be studied. In Fig. 7 an illustration is given of the measured stress amplitudes on the runner blades compared to the calculated natural frequencies marked with arrows.

The frequency of the draft tube pressure pulsations are normally around 1/3 of the runner speed. For comparison to the blade passing frequency of high head turbine we will with 24 guide vanes and  $n=375$  rpm, get a frequency of 148.8 Hz and  $10^8$  cycles will be reached in 7.8 days or around 1.1 week while a low head runner with the same speed needs  $1.1 * 24 * 3 = 79.2$  weeks to reach  $10^8$  cycles.

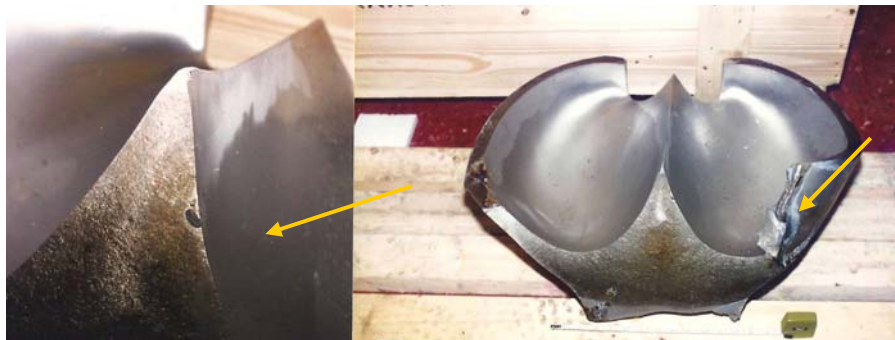
**Fig. 8** Broken Pelton bucket caused by a not successful not heat treated small weld repair. Detail to the left.

In Fig.8 is shown an example of a broken Pelton bucket caused by a small, but incorrect weld repair without heat treatment of a small material defect from casting (MnS) during repair of an old runner. The total fracture occurred around one year after installation of the complete overhauled runner after many years in operation.
