## Analysis of the possibility of a submarine implosion using finite element method

R Kiciński, B Szturomski and K Świątek

Polish Naval Academy, Mechanical and Electrical Engineering Faculty, Śmidowicza 69, 81-127 Gdynia, Poland

**Abstract.** Recently, there have been reports of disasters related to the disappearance of submarines. One of the potential causes of disasters is the ship's descent to the so-called critical depth and its subsequent implosion. However, the occurrence of the submarine implosion phenomenon may be difficult to achieve. This is due to the presence of hydraulic fittings and other more susceptible hull components. The article presents an analysis of the strength of a fragment of the submarine's hull, modelled on Kobben-class ships, to demonstrate the possibility of an implosion. Furthermore, the construction of submarines was presented, and phenomena related to the strength of submarine hulls using FEM were discussed.

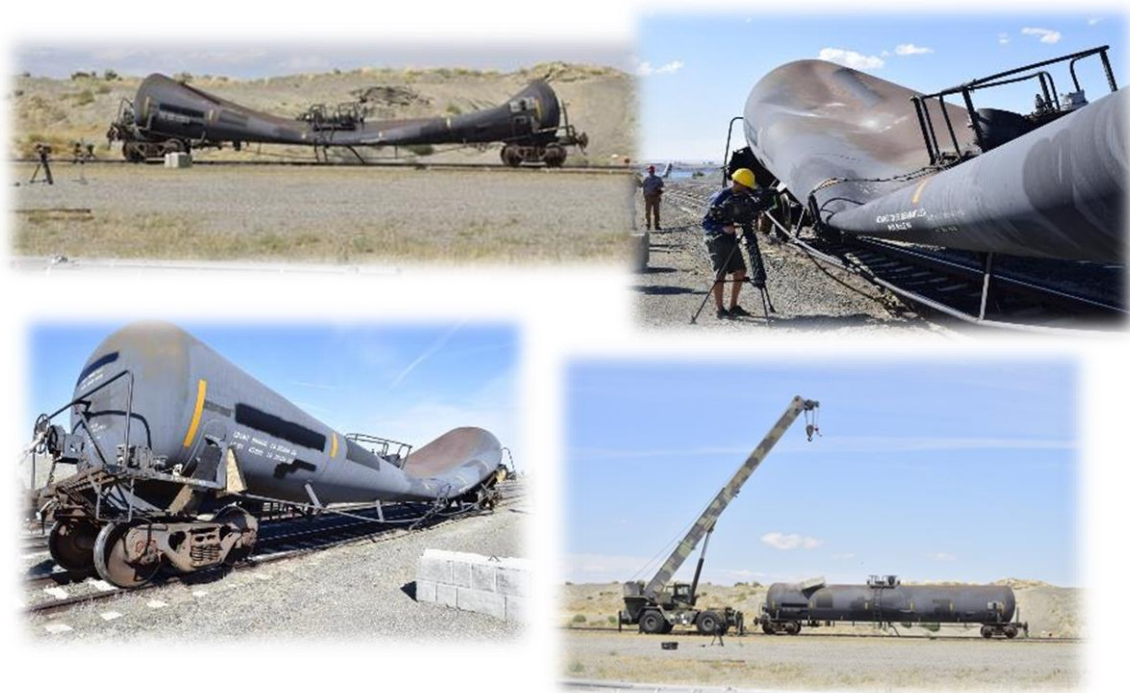
**Figure 1.** The tanker used in the MythBuster program, in the lower right corner, damage preparation.

This does not change the fact that implosion is a relatively difficult phenomenon to achieve. It requires high tightness and a significant pressure difference. There are micro-scale experiments involving implosion of barrels or cans. However, these are simple structures, usually equipped with one or two well-sealed holes. Implosion occurs when the external and internal pressure cannot be equalized in any other way. An example of the difficulties in achieving the implosion phenomenon can be the experiment carried out in the MythBuster program [9]. Even though it is a television show, to achieve the tank implosion, it was necessary to seal it significantly, use advanced vacuum pumps, and locally damage its structure (Figure 1).

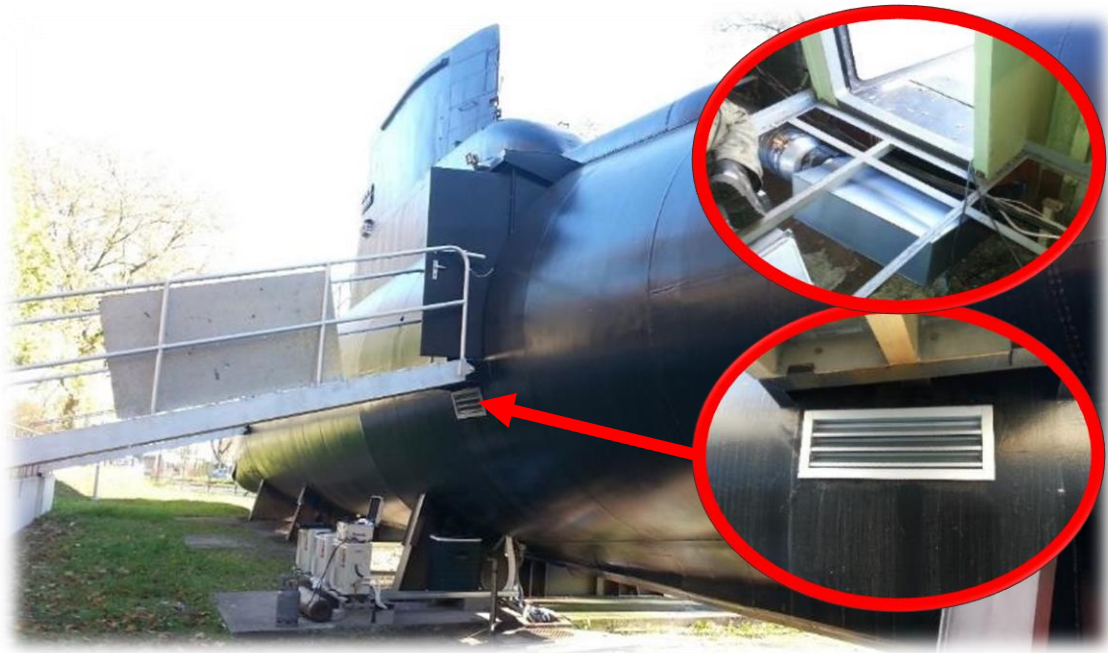
**Figure 4.** ORP "Jastrząb" (S-318 Kobben), places from which samples for testing were taken.

The next stage of the task was assigning material data. These data were obtained owing to the adaptation of ORP "Jastrząb" (S-318 Kobben) as a submarine operation simulator at the Polish Naval Academy in Gdynia, which required numerous hull modifications. Among other things, ventilation and air conditioning openings were cut. In this way, the samples of HY-80 steel for strength tests were obtained (Figure 4).
