Probability analysis of setback distance based on structural damage near earthquake-fault-rupture

Jianyi Zhang¹, Jingshan Bo^{1*}, Ping Li¹ and Chao Shen¹

¹Geological Engineering Department, Institute of Disaster Prevention, Sanhe, Hebei, 065201, China

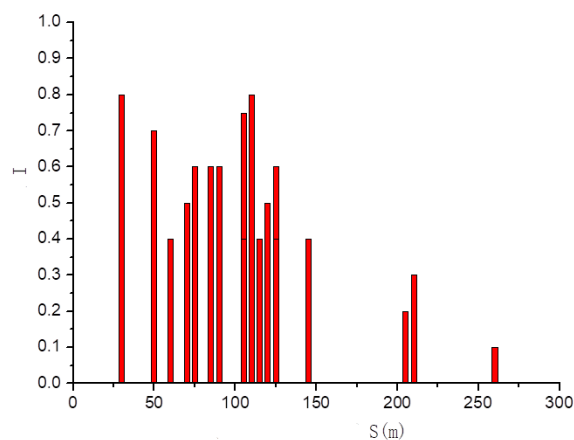
Figure 1. Damage Index of Hollow Brick Structure on rupture trace

Combined with the above investigation analysis, the relationship between the seismic damage index and the setback distance of the hollow brick structure along the rupture trace can be seen in Figure 1 and Figure 2. It can be seen from the figure that with the increase of the distance from the surface rupture (S), the seismic damage index (I) of the hollow brick structure is greatly reduced; if the hollow brick structure is more than 50m away from the surface fracture trace, it is basically in line with the principle of "big earthquake does not fall". If the damage can be repaired under medium level (that is, the damage index is 0.4-0.5), the distance from the fracture trace should be at least 150m.

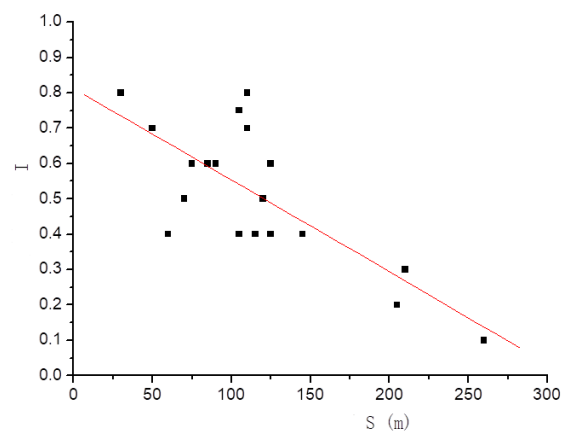
Figure 2. Scatter plot of setback distance and damage index of hollow brick structure

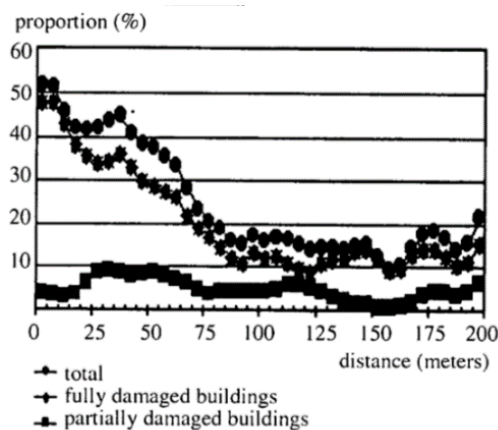
Figure 3. Proportion of damaged buildings in village area

Taiwan's Fengtian Lin[9] used the earthquake investigation team composed of 21 academic and professional units led by Ministry of the Interior Construction Planning Administration (ACP) to provide investigation data on the damage of buildings around Chegongpu fault surface rupture. A plot of the spatial relationship between the surface and its adjacent buildings damage is shown in Figure 3-6.

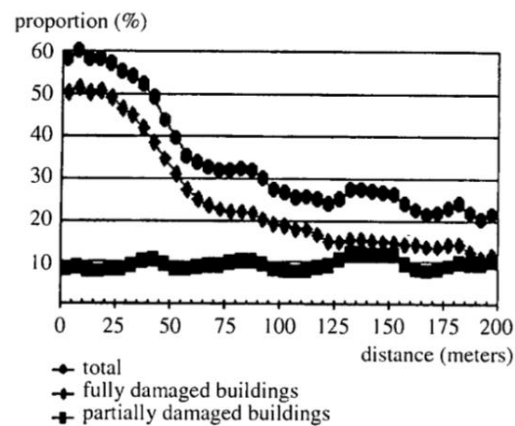
Figure 4. Proportion of damaged buildings in urban area

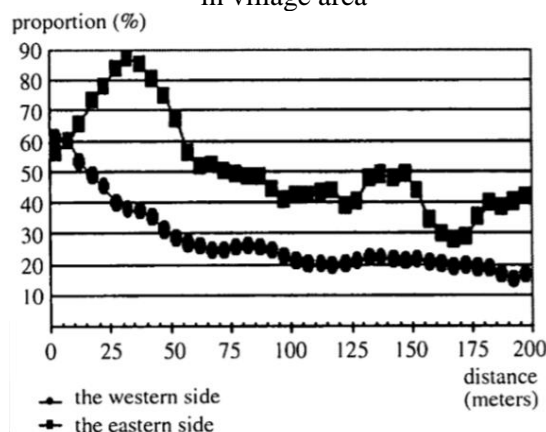
Figure 5. Proportion of damaged buildings on both sides along the fault rupture trace in village area

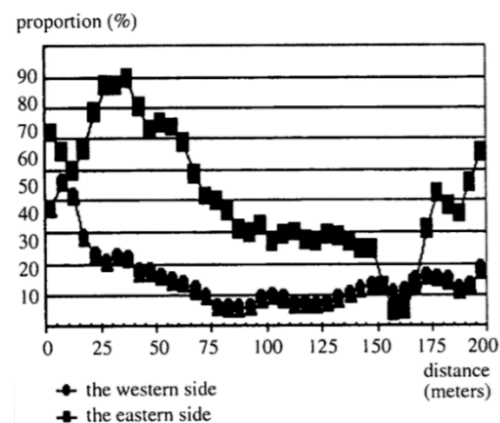
Figure 6. Proportion of damaged buildings on both sides along the fault rupture trace in urban area
