# Analysis of the temperatures measured in very thick and insulating roofs in the vicinity of a chimney

M Neri<sup>1</sup>, D Luscietti<sup>2</sup>, S Bani<sup>3</sup>, A Fiorentino<sup>2</sup> and M Pilotelli<sup>2</sup>

Abstract. Chimneys convey exhaust gas produced in domestic heat appliances to the external environment and to do this they have to pass through elements such as roofs and floors. If these elements are made up of flammable materials the fire hazard may occur. In some European countries the number of roof fire is very high and they affect also certified chimneys, that is, tested following the prescription of the related standards. The aim of this paper is to highlight that the certification procedure does not allow to test chimneys in the worst condition, therefore, chimney installed following the manufacturer prescriptions may in some cases cause the overheating and subsequent roof fire. To do this, experimental tests have been performed for measuring the temperature on roofs in the vicinity of a certified chimney. The results show that the certification procedure should be revised.

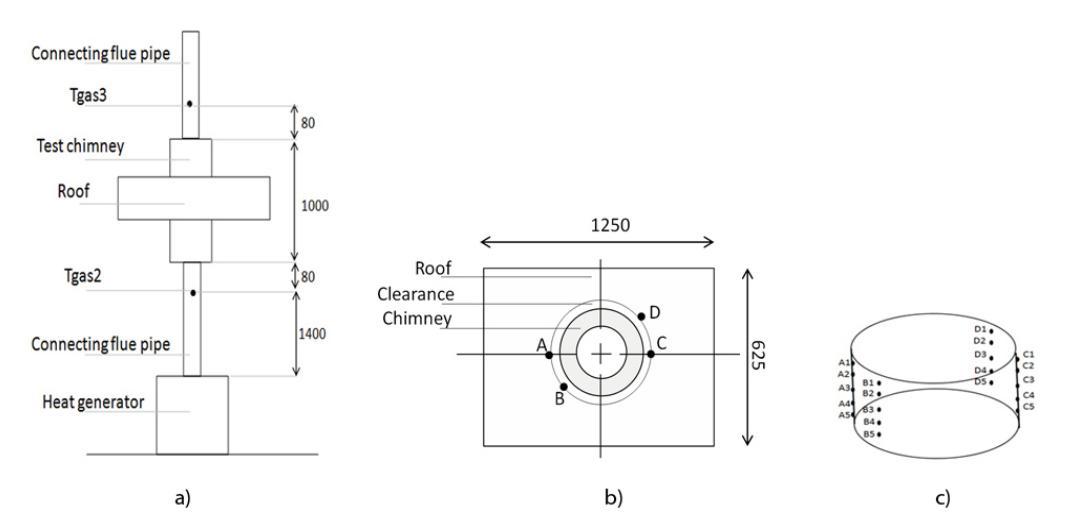
**Figure 1.** Test structure: a) front view, b) top view, c) thermocouples positioning. Letters A, B, C and D indicates the lines on which the thermocouples were posed. Dimensions are in millimeters.

The tests described in this paper consisted in the following steps: installation of a certified chimney in the center of a roof following the scheme in Figure 1 ((a) and (b)), production of exhaust gas at a predetermined temperature  $T_{ch}$ , measurement of the temperatures in the roof at the positions indicated in Figure 1 ((b) and (c)).

The test structure is represented in Figure 1 (a) and it consists of a roof, a chimney and a heat generator. The chimney was installed at the center of the roof, and connected to the heat generator by means of a flue pipe, and an additional one was also installed to convey the exhaust gas far from the test structure. The chimney used in the test is certified T600 when it is installed 20 mm far from flammable materials. This means that during the certification procedure the exhaust gas temperature was 700°C and the maximum temperature measured on flammable materials did not exceed 85°C. In our tests, the chimney was installed respecting the manufacturer prescriptions reported in the label attached on it, that is, 20 mm from the roof and for safety reasons, the exhaust gas temperature was maintained at 500°C instead of 700°C.

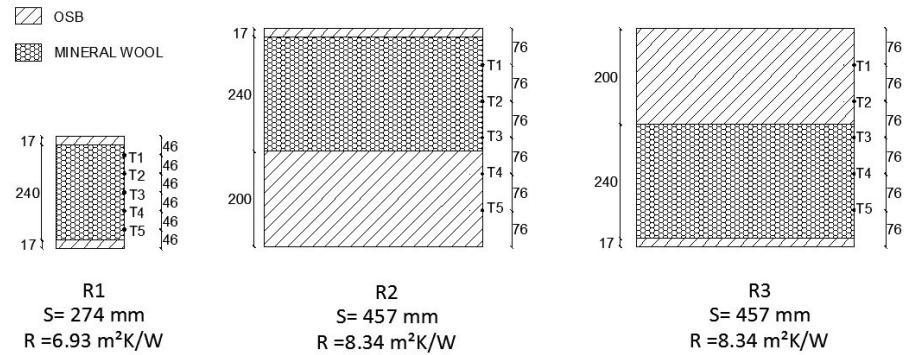
Figure 2. Tested roofs. S represents the thickness and R the thermal resistance of the roof. T1, T2, T3, T4 and T5 indicate the positions where temperatures have been measured. Dimensions are in millimetres.

The roofs in which the chimney was installed are shown in Figure 2. Roof R1 is similar to the lower floor prescribed by the standard [8] but it is a little thicker and more insulating, roofs R2 and R3 have same thickness and same thermal resistance but different layers position and are representative of roofs in energy-saving buildings. By performing tests on roof R2 and R3 has allowed to understand if the layers position affects the maximum temperature on the roof. The chimney was installed 20 mm far from the roof as prescribed by the manufacturer and the clearance was sealed in four ways that are represented in Figure 3. The clearance was left open (op), sealed by means of metal sheets (ms), sealed with insulating materials (ad) and filled with insulating materials (fi). The sealing with metal sheet (ms) allowed air movement in the clearance and heat transfer through the sealing, the sealing with insulating panels (ad) allowed air movement in the clearance but prevented heat transfer through the sealing and it has been realized to approach an adiabatic sealing. Finally, the filling  $(f_i)$  of the clearance reproduced the installation usually adopted in energy-saving buildings. Each roof was tested with each sealing mode, for a total of 12 tests, which are reported in Table 1. The tests are identified by acronyms: the first two letters represent the roof and the last two the clearance sealing mode. The standard [8] prescribes to stop the test when the increase in temperature is lower than  $2^{\circ}$ C in 30 minutes, or after 8 hours. However, it was not possible to reach this condition in all the tests as specified in Table 1.

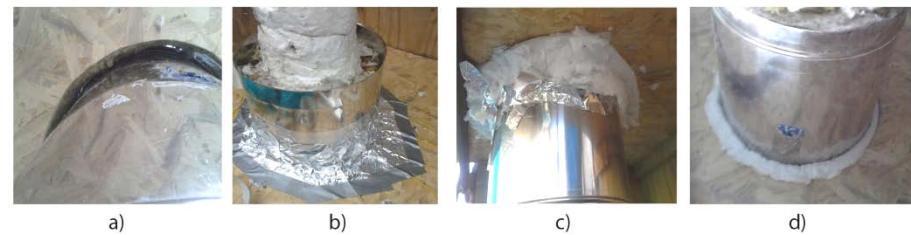
Figure 3. Tested clearance sealing mode: a) open (op), b) sealed with metal sheet (ms), c) sealed with insulating material (ad), d) filled with insulating material (fi).

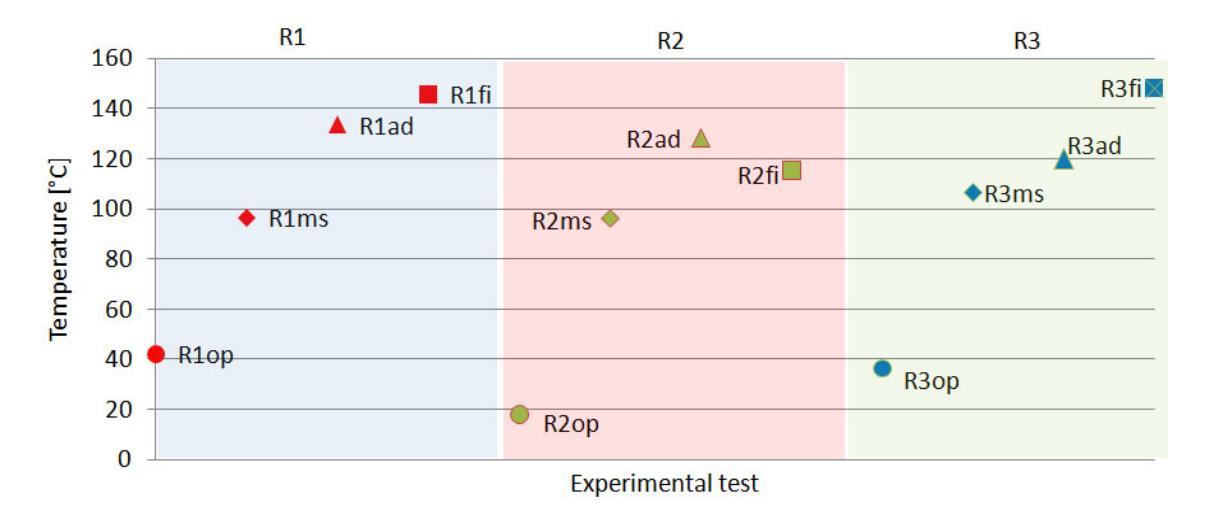
Figure 4. Maximum temperatures measured in the experimental tests performed on roofs R1, R2 and R3 with the four clearance sealing modes (open (op), sealed by means of metal sheets (ms), sealed with insulating panels (ad) and filled with insulating materials (fi)).

Figure 4 shows the maximum temperature measured in the tests. It can be noted that, despite the exhaust gas temperature was 200°C lower than in the certification procedure, in the majority of the tests, the maximum temperature exceeds the limit of 85°C. The only configuration that allows to respect the limit temperature is with open clearance ( $R1_{op}$ ,  $R2_{op}$  and  $R3_{op}$ ) and for the others configurations ( $R2_{ms}$ ,  $R2_{ad}$ ,  $R2_{fi}$ ,  $R3_{ms}$ ,  $R3_{ad}$ ,  $R3_{fi}$ ) the more insulating the clearance sealing mode, the higher the temperature in the roof. In the test  $R2_{fi}$  the measured maximum temperature is lower than that measured in the test  $R2_{ad}$ : this is due to the fact that  $R2_{fi}$  test was interrupted at an instant farther from the stationary condition with respect to  $R2_{ad}$ . However, by estimating the stationary temperature by means of the lumped element model proposed in [19], also for roof R2 the higher temperature has been reached in the case with filled clearance. In roof R3, the clearance has been sealed with aluminum adhesive tape in order to reduce air infiltration.

By analyzing the temperatures in Figure 4 it can be noted that the roof characteristics do not affect strongly the maximum temperature in the roof, but rather the temperature distribution. Higher temperatures occur in the more insulating layer especially in the configurations with filled clearance. In the configurations with blocked air between chimney and roof (clearance sealed either with metal sheets or sealed with insulating panels) temperature distribution is more homogeneous because the effect of the layers arrangement is counterbalanced by radiation and convection.

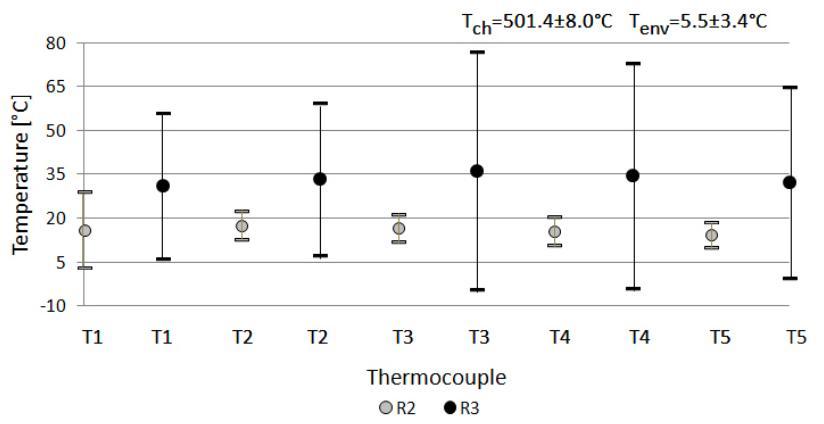
**Figure 5.** Temperatures on roofs R2 and R3 measured with open clearance. T1, T2, T3, T4 and T5 indicate the thermocouple positions, where T1 is the highest one.

Figure 5 shows the temperatures measured on the roofs when the clearance was left open. It can be noted that for this installation mode the mean temperatures are quite homogeneous but for the roof R3 they are affected by high variability. High variability can be attributed to the loss of the axial-symmetric condition due to environmental conditions (speed and direction of the wind), and the presence of the heat generator.

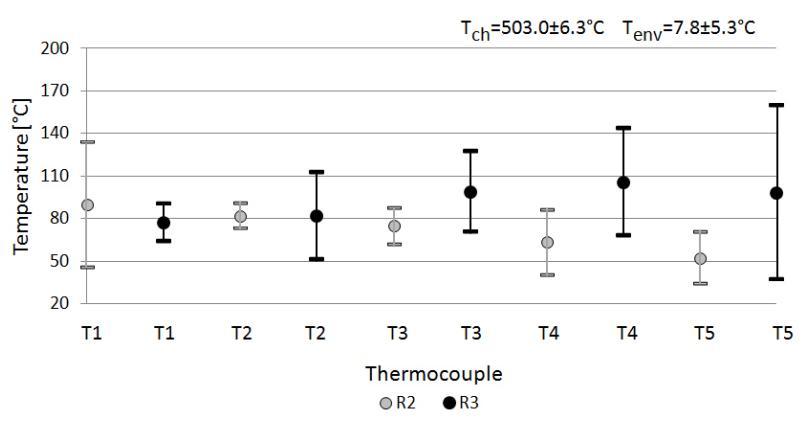
**Figure 6.** Temperatures on roofs R2 and R3 measured with clearance sealed by means of metal sheets. T1, T2, T3, T4 and T5 indicate the thermocouple positions, where T1 is the highest one.

Figures 6 and 7 show the temperatures measured on roof R2 and R3 when the clearance was sealed by means of metal sheets (ms), and by means of insulating material (ad) respectively. It can be noted that with respect to the cases with open clearance (Figure 5) the temperatures are less homogeneous: in both cases the higher temperature have been measured on the insulating layer, that is, in the upper part of roof R2 and in the lower part of roof R3.

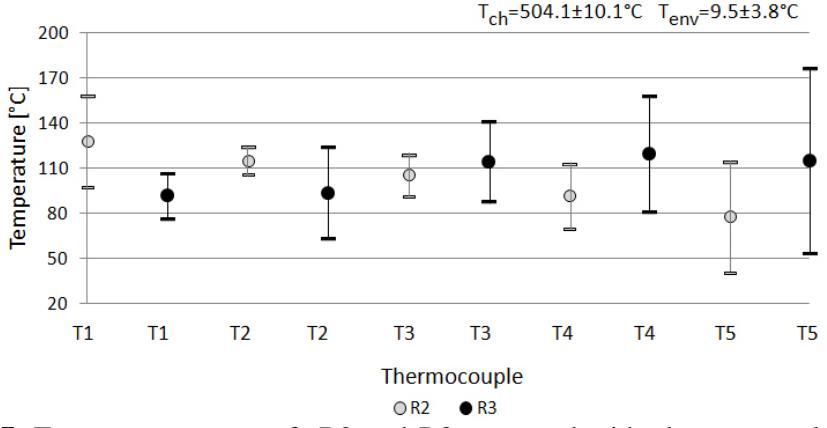
**Figure 7.** Temperatures on roofs R2 and R3 measured with clearance sealed by means of insulating panels. T1, T2, T3, T4 and T5 indicate the thermocouple positions, where T1 is the highest one.

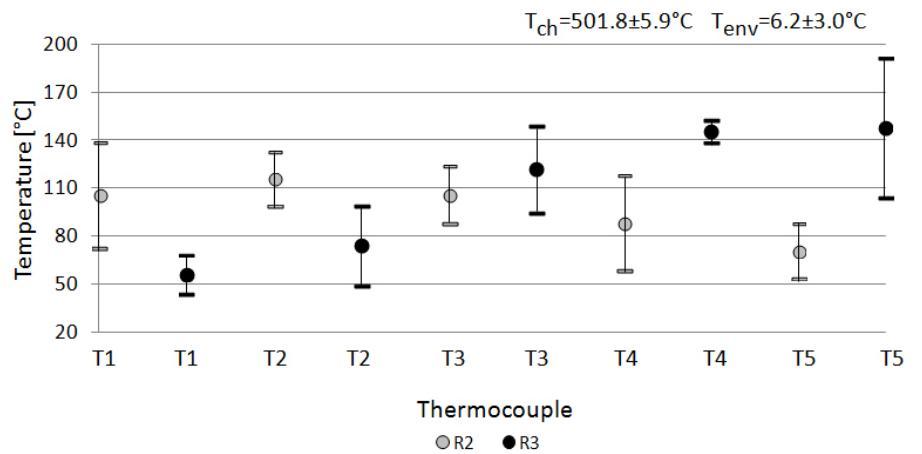
**Figure 8.** Temperatures on roofs R2 and R3 measured with clearance filled with insulating material. T1, T2, T3, T4 and T5 indicate the thermocouple positions, where T1 is the highest one.

Figure 8 shows the temperatures measured when the clearance was filled with insulating material. Also in this case the maximum temperature was measured on the insulating layer, but the difference in temperature between the upper and the lower zones of the roofs is up to 100°C for roof R3 and it is higher than in the tests performed with other clearance sealing modes. When the clearance is sealed in the upper and lower parts the natural convection push hot air upward but the radiation tends to make uniform the horizontal heat flux in the vertical direction: on roof R2 the effect of the natural convection is accentuated by the presence of the insulating layer in the upper part. When the clearance is filled and only conduction takes place, the temperature increases on the more insulating layers. If thermocouples are installed following the standard [8] prescription - i.e. on the center line of the roof - the maximum temperature on flammable materials may not be measured.

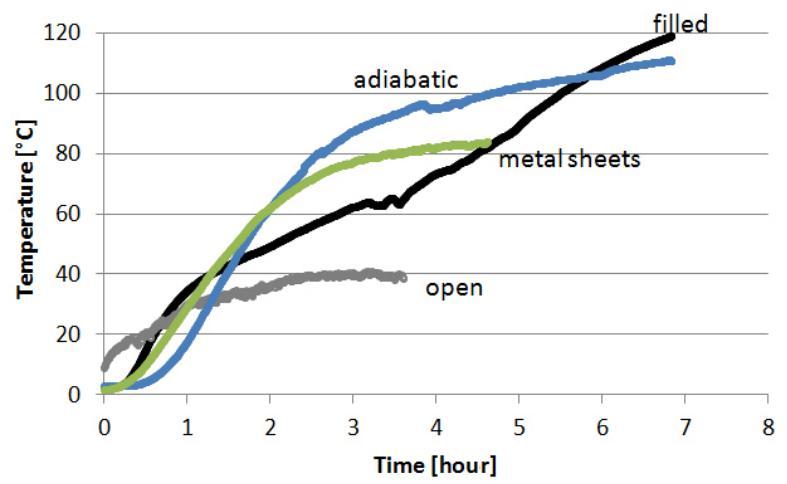
**Figure 9.** Temperatures time traces measured in the tests performed on roof R1 for different clearance sealing modes.

The standard [8] prescribes to stop the heat stress test when the increase in temperature on the test structure is less than  $2^{\circ}$ C in 30 minutes or after 8 hours. In Figure 9, four temperature time traces measured in tests with different clearance sealing modes are reported. All of them represent temperatures whose increase at the end of the test was less than  $2^{\circ}$ C in 30 minutes except for the thermocouple related to R1<sub>fi</sub>. It can be noted that if the tests had continued, the temperatures would have increased. Then, the standard [8] should be modified in order to allow the stationary temperature detection. Since the achievement of the stationary temperature may take long time, the stationary temperature could be estimated by means of the lumped element model proposed by [19] applied to the temperatures measured during the heat stress test.

By filling the clearance the increase in temperature is slower with respect to the configurations with air in the clearance, but it leads to higher temperature on flammable materials, as can be seen in Figure 9.
