## Protective materials thermal conductivity research for heat exchanger tubes of a networking heater

To cite this article: D V Chugunkov et al 2018 J. Phys.: Conf. Ser. 1128 012111

# D V Chugunkov, Yu A Kuzma-Kichta, G A Seyfelmlyukova, A V Lavrikov, A D Skurikhina

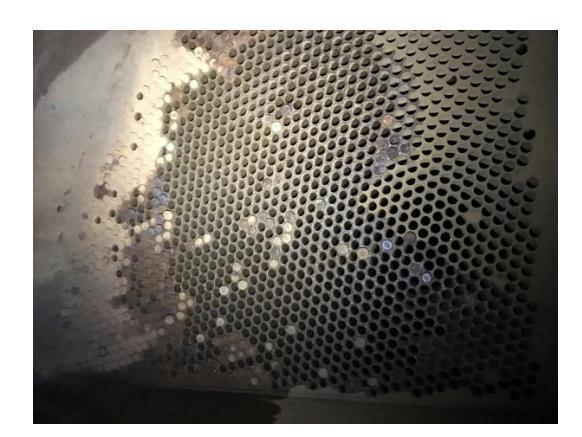
Figure 1. Distribution of the "muffled" tubes in the sector of HNH.

When the normative number of "muffled tubes" is achieved, the whole tube bundle of the heater must be replaced, that makes the equipment repair expensive.

HNH chosen for experiment were in work since 1986. In the explored heater 1009 damaged tubes (figure 1) from steel AISI 321 [1] were muffled.

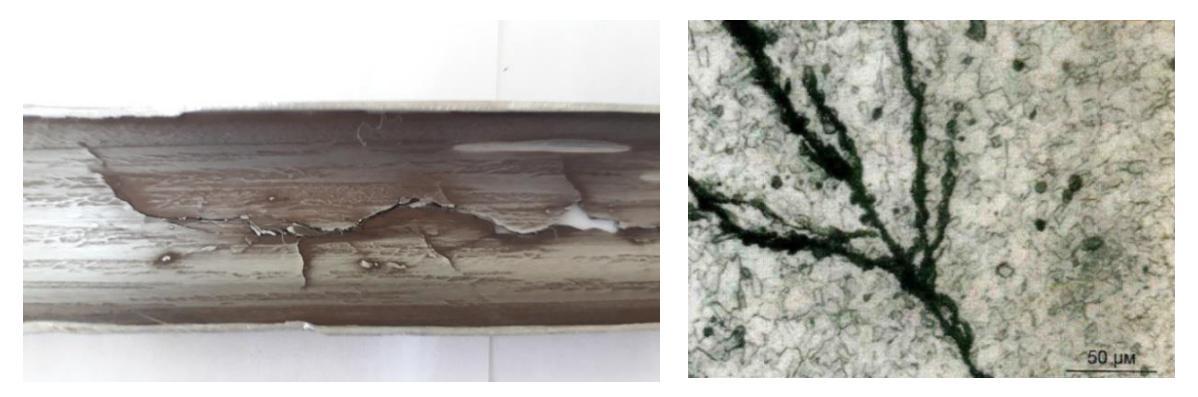
Figure 2. The cutting tube with a zone of partial cleaning and a microstructure of tube metal.

As a result it has been established that the corrosion damage and the destruction of the heater tube metal happen on the mechanism of intergranular cracking (figure 2). Intergranular corrosion of stainless steels is connected with depleting the grains boundaries of chrome or forming the impurity – chrome carbides. The cause of intensive corrosion is the content of sulfur in water, which being connected with oxygen, dissolved in water, formed sulfur-containing acids, the action of which was enhanced by high temperature.

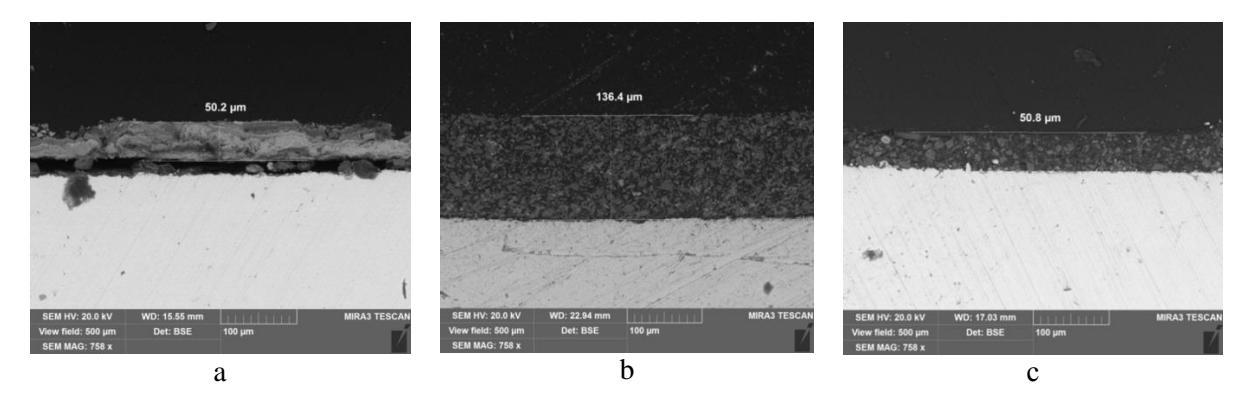
**Figure 3.** Images of tube specimen : a – tube with deposit, b – tube with covering No. 1, and c – tube with covering No. 2.

thickness ( $\delta_{wall}$ ) was determined with microscope and the specimens of tubes in various cross-sections are shown on figure 3.

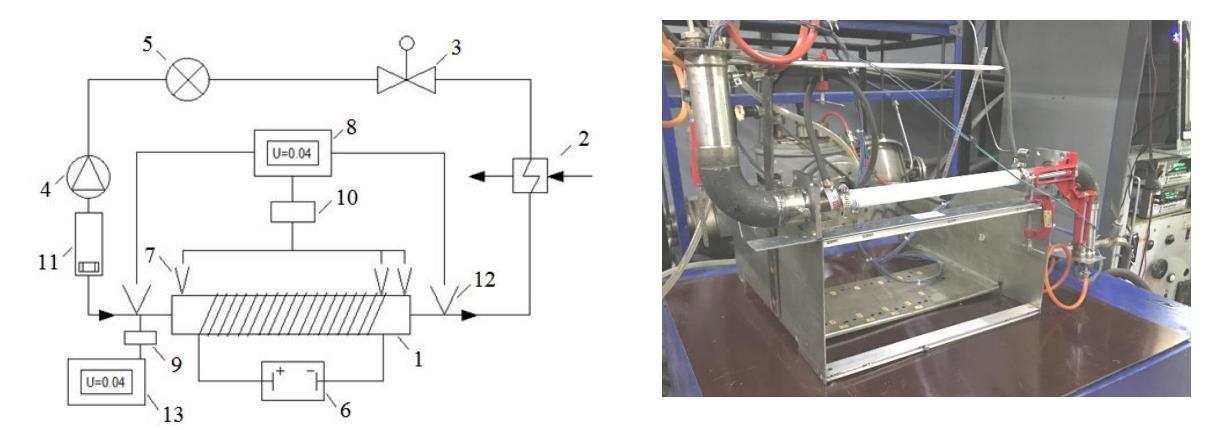
Figure 4. Scheme and general view of experimental installation:
1 – working section; 2 – condenser; 3 – regulation valve; 4 – circulating pump; 5 – flowmeter;
6 – dc power supply; 7 – thermocouple; 8, 13 – digital multimeter Fluke 8045A; 9, 10 – platinum resistivity thermometer PT-100; 11 – heat-exchange facility; 12 – multi spike chromel-alumel differential thermocouple.

The research was conducted on experimental stand (figure 4) [4]. Temperature of the external wall of the tube (1) was measured in two points over the input perimeter and in four points over the output perimeter. Temperature of the water was measured before the input and behind the output of the heated sector. Changes in temperature of liquid in the tube as a result of heating were measured by means of the differential-thermocouple, the cold junction of which located at the input, and the hot junction – at the output. The tube temperature was measured with copper-constantan thermocouples. Thermocouples were welded to the wall by spot welding through holes in the heater.

To obtain data on thermal resistance of the investigated tubes the displacer with a diameter of 20 mm was installed in each tube and the liquid flow with a necessary velocity in an ring slit. The electric heater had the form of a flexible tape and reeled up on an external surface of a tube. Junctions of the differential thermocouple and the platinum resistance thermometer were setting. The signal of the differential thermocouple was measured by a digital multimeter Fluke 8045A.

During the experiment the coolant temperature was measured at the input and the output from the working section. Before experiment the thermocouples were calibrated by means of the platinum resistance thermometer. For each thermocouple installed on a wall the calibration of thermal losses was realized to determine the wall temperature of the tube.

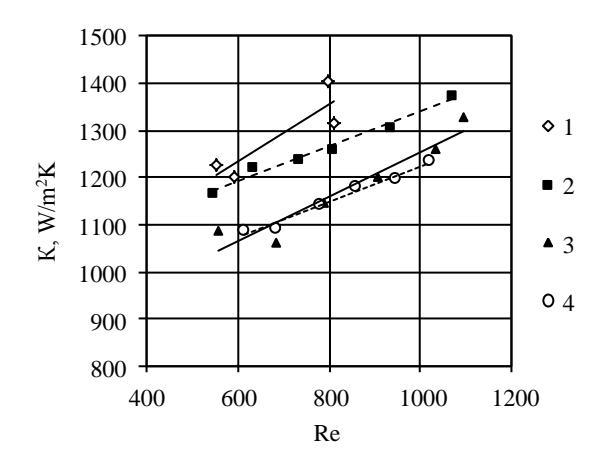
**Figure 5.** Overall heat transfer coefficient and line of approximation: 1– the cleaned tube ( $\delta_{wall} = 1.20 \text{ mm}$ ); 2 – tube with deposit ( $\delta_{wall} = 1.28 \text{ mm}$ ); 3 – tube with covering No1 ( $\delta_{wall} = 1.49 \text{ mm}$ ); 4 – tube with covering No.2 ( $\delta_{wall} = 1.28 \text{ mm}$ ).

During experiments, the data on thermal resistance of the tubes with coating at various Reynolds numbers were obtained (figure 5). Measurements were taking in areas of laminar and transient flow in a ring slit. This area was chosen because owing to the small tube length of  $\Box$  0.5 m, at large Reynolds numbers the stream ca not be heated to the temperature that can be measured by the differential thermocouple with a sufficient accuracy.

The thermal resistance of the investigated tubes was found as an average three thermal regimes and thermal conductivity of investigated coatings was determined.

The research method was developed, the experimental setup was created and the thermal resistance of the studied tubes with coating and without coating were measured. According to results the thermal conductivity coefficient of coating No. 1 amounted to 0.91 W/m\*K, and that for coating No. 2 – to 0.93 W/m\*K. Thus, protective materials with creating thickness will not lead to essential thermal resistance and can be applied to effective repair of heat exchange tubes of various network heaters in comparison with "muffled" technology of the destroyed tubes.
