# Improving the Hot Corrosion Resistance of Nanostructured $ZrO_2$ -7wt.%Y<sub>2</sub>O<sub>3</sub> Thermal Barrier Coatings Fabricated by Plasma Spraying

To cite this article: Dongsheng Wang 2021 J. Phys.: Conf. Ser. 1732 012118

# Dongsheng Wang<sup>1, 2,\*</sup>

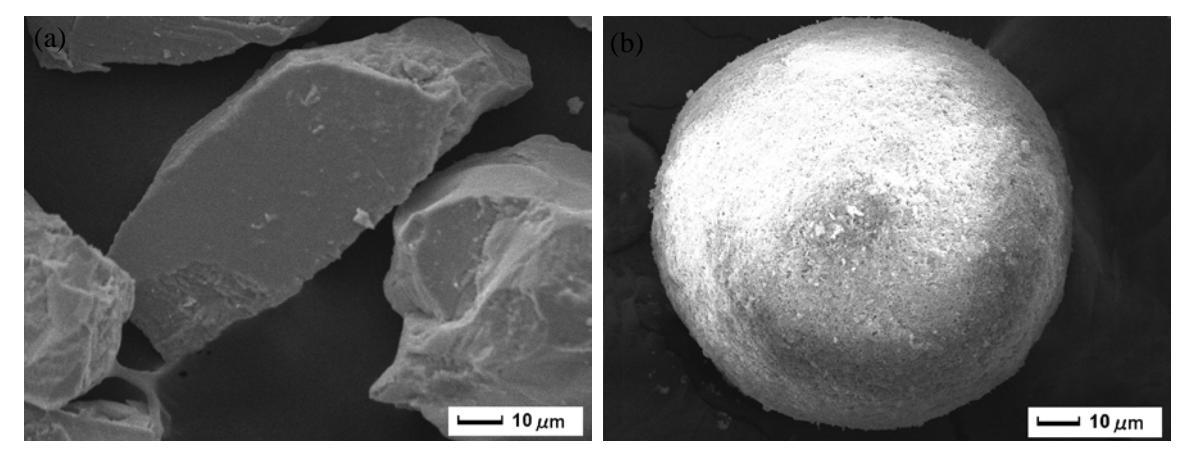
Figure 1. SEM morphologies of ceramic powder: (a) conventional powder and (b) nanostructured agglomerated powder.

$\gamma$ -TiAl based alloy (20 mm×20 mm×8 mm) which was smelted by High-temperature Material Center of Iron and Steel Research Institute was applied as the base material in the experiment. The nominal chemical components of  $\gamma$ -TiAl based alloy were Ti-46.5Al-2.5V-1Cr (mole fraction, %). The metal bonding layer MCrAlY applied the NiCoCrAl superalloy powder which was produced by Metal Material Center of Beijing General Research Institute of Mining and Metallurgy through diffusion of Y<sub>2</sub>O<sub>3</sub>. Granularity of the NiCoCrAl superalloy powder was 45~105 µm. Irregular commercial powder which was crushed conventionally into granularity of 20~74 µm which was produced by Shenyang Ronghua Company was used as conventional ceramic material. Nanostructured agglomerated powder used the Nanox 4007 powder with a granularity of 40~100 µm (Inframat, USA). The nominal component of two materials was ZrO<sub>2</sub>-7wt.%Y<sub>2</sub>O<sub>3</sub>. The morphologies of corresponding powders are shown in figure 1.

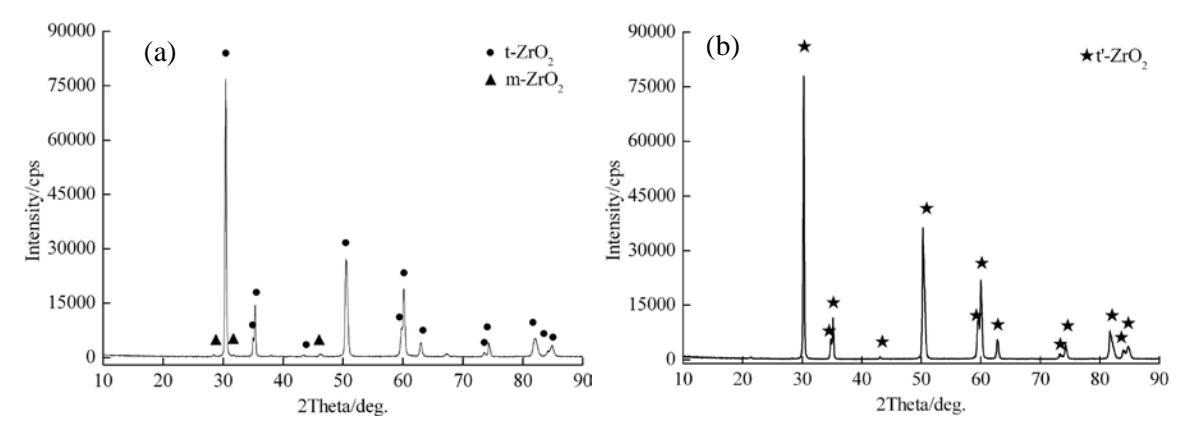
The X-ray diffraction analysis results of conventional and nanostructured TBCs which are prepared by plasma spraying are shown in figure 2. Conventional TBC contains tetragonal phase (t-ZrO<sub>2</sub>) and monoclinic phase (m- $ZrO_2$ ). Tetragonal phase takes the dominant role. This is because all phases of powder are transformed into tetragonal phase and cubic phase  $(c-ZrO_2)$  by high-temperature heating of plasma flame. However, there's inadequate content of the stabilizer yttrium oxide to make tetragonal phase maintained to room temperature during fast consolidation and cooling process after particles impact onto the matrix. Instead, transformations from cubic phase to tetragonal phase or cubic phase to tetragonal phase and then to monoclinic phase occur. The transformation from cubic phase to monoclinic phase belongs to a martensite transformation, which is related with not only grain size and chemical components, but also cooling speed. Generally speaking, temperature in the beginning of phase transformation is low and temperature at the end of transformation is high, which is attributed to the increase of cooling speed. In other words, the temperature interval from tetragonal phase to monoclinic phase is narrowing, and the transformation volume decreases. Plasma spraying is a process of collision between melted powder and base, flattening of transverse flowing and fast cooling and consolidation. In this process, the cooling speed is relatively high and finally only few monoclinic phases are produced in the final coating.

Figure 2. XRD analysis results of TBCs: (a) conventional TBC and (b) nanostructured TBC.

TBCs which are prepared by plasma spraying only contains non-equilibrium tetragonal phase (t'- $ZrO_2$ ), but involves no monoclinic phase. This is significantly different from conventional TBCs. During plasma spraying some stable  $ZrO_2$  onto  $Y_2O_3$  layer, only tetragonal phase with grain size higher than the critical size can be transformed into monoclinic phase. This is because the smaller grain size, the higher the interface energy and phase transformation resistance will be. However, nanostructured agglomerated powder is composed of nano-particles with small grain size. It is

believed that nano agglomerated composed of fine crystals is the main cause of tetragonal phase in coatings.

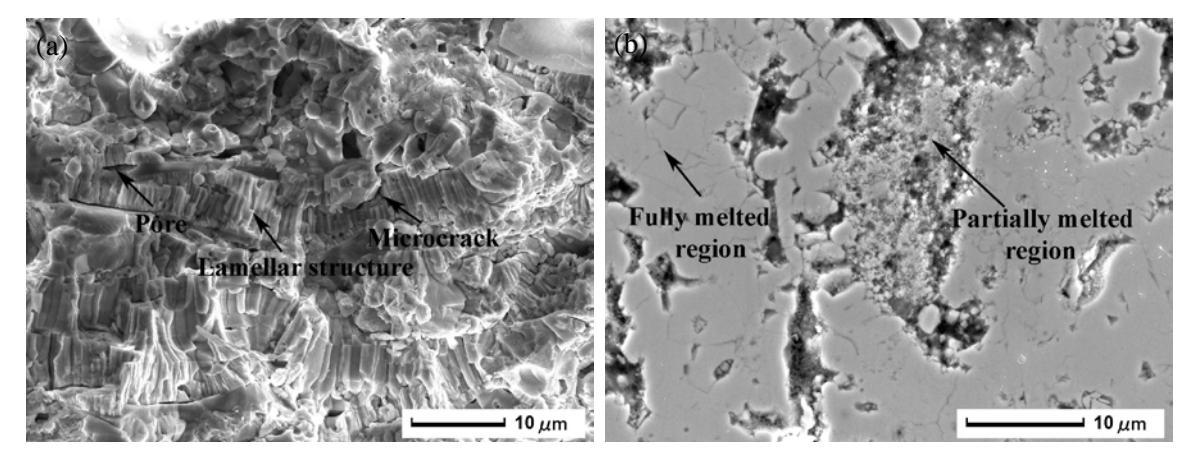
Morphologies of conventional and nanostructured TBCs prepared by plasma spraying are shown in figure 3. It can be seen from figure 3(a) that the conventional ceramic coating prepared by plasma spraying has lamellar stacking structures of countless deformed particles and shows typical stratified structure of plasma spraying state in wave mode [8]. Most lamellas are composed of columnar crystals which are approximately perpendicular to base surface. In the plasma spraying, powder is melted and impact onto the base or paved and re-crystallized on the subsided surface. In the process of crystallization, the growth direction of crystals is corresponding to the direction with the fastest heat conduction. Nevertheless, crystal growth perpendicular to this direction is restricted to some extent. There's the maximum heat flux along the normal direction (perpendicular to base) of paving of molten drops. Hence, columnar crystals in lamellas basically grow along the direction perpendicular to the base [8]. Moreover, lamellas are not bonded tightly, but there are some pores or holes. Performance of TBCs is closely related with content, shape and distribution of pores. Pores can decrease ceramic density and heat conductivity, but increase the thermal shock performance [8]. However, pores are stress concentration regions and might be further developed to cracks directly, thus decreasing strength of the ceramic layer. If there are excessive pores on the ceramic layer, these pores are easy to be connected into penetrability cavities. Corrosive media are easier to arrive at the interface between the ceramic layer and the transition layer under hot corrosion conditions, thus accelerating growth of oxidation film on the transition layer surface and increasing thermal stress. Hence, the coating is easy to crack and peel off.

**Figure 3.** Cross-section morphology of TBCs prepared by plasma spraying: (a) conventional TBC and (b) nanostructured TBC.

In figure 3(b), the nanostructured ceramic coating prepared by plasma spraying consists of fully melted region of nano-particles and partially melted region. The partially melted region is enclosed by fully melted regions. The whole coating has a base phase which is gained from recrystallization of fully melted nano-particles and the embedding phase of partially melted nano-particles. This conforms to the research results of Lima et al [9]. The fully melted region presents a typical stratified structure, which is basically consistent with the structure of conventional coating which is prepared by plasma spraying. The partially melted region is formed by melted or non-melted nano-particles. Structure of this partially melted region is very similar with the original  $ZrO_2$  nano-powder, showing typical nano-powder aggregate has experience high temperature during the plasma spraying, powder stays in efflux very shortly. The driving force for combination and growth of crystal boundaries of partially melted region on the sprayed coating still maintains some growing nano-particles. It is compared with internal morphology of the original nano-powder aggregate and finds

that density is increased significantly after high-temperature sintering by plasma flame in the plasma spraying process.

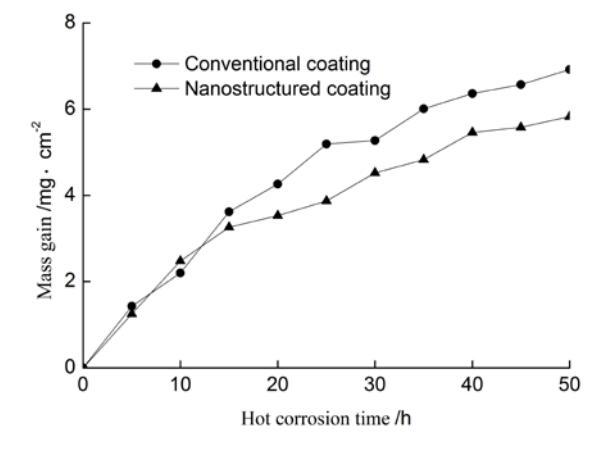
The corrosion kinetic curves of the prepared conventional and nanostructured TBCs in  $75\%Na_2SO_4+25\%NaCl$  molten salt under 850 °C are shown in figure 4. Corrosion mass of both conventional and nanostructured TBCs is positively related with time. The kinematics curves are approximately parabolas, indicating strong resistance to hot corrosion of TBCs. Generally, corrosion mass gain of the nanostructured TBC is kept smaller than that of the conventional TBC. After hot corrosion for 50 h, weights of the conventional and nanostructured TBCs are increased by 6.92 mg·cm<sup>-2</sup> and 5.83 mg·cm<sup>-2</sup>, respectively. Obviously, the nano coating can improve resistance to hot corrosion of TBC to a limited extent. The improvement of resistance to hot corrosion of nanostructured TBC might be attributed to the increase of density of the coating. On the one hand, the increased density narrows corrosion area. On the other hand, it decreases penetrations of melted salt into metal bonding layer and base, thus weakening the corrosion behavior.

Figure 4. Kinetic curve of hot corrosion on TBCs.

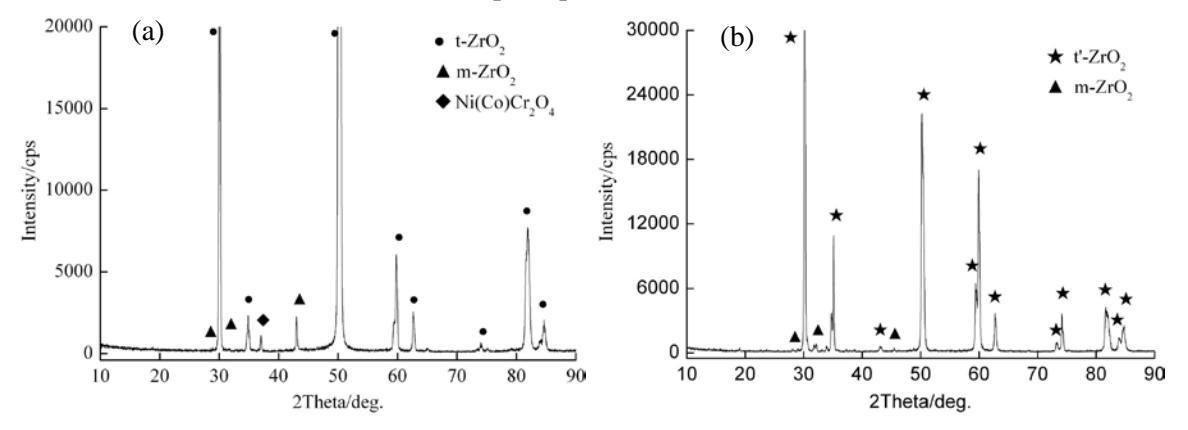
XRD analysis results of the prepared conventional and nanostructured TBCs after hot corrosion are shown in figure 5. Compared with the original coating, monoclinic phase in the conventional TBC is increased significantly, whereas tetragonal phase is decreased accordingly. Moreover, an evident Ni(Co)Cr<sub>2</sub>O<sub>4</sub> spinel diffraction peak is observed. Some new partially monoclinic phases are produced in the nanostructured TBC, but there's no spinel peak in conventional TBC.

Figure 5. XRD analysis results of TBCs surface after hot corrosion: (a) conventional TBC and (b) nanostructured TBC.

As the hot corrosion goes on, content of the stabilizer  $Y_2O_3$  in  $ZrO_2$ -7wt.% $Y_2O_3$  TBCs is decreased. Some tetragonal phases are transformed to monoclinic phases, accompanied with volume expansion of the coating. As a result, tensile stress in coatings is transformed to a pressure stress, resulting in cracks on the stratified structure after hot corrosion. Some seriously damaged regions have been peeled off from the surface and cavities are produced (figure 6(a)). Since the reaction product  $Y_2(SO_4)_3$  is dissolved in melted salt, no  $Y_2(SO_4)_3$  phase is detected from XRD analysis of TBCs corrosion.

The production of Ni(Co)Cr<sub>2</sub>O<sub>4</sub> spinel structure in conventional TBC is related with corrosion of the metal bonding layer. In the melted Na<sub>2</sub>SO<sub>4</sub>+NaCl solution, since samples are isolated from the external air, solubility and diffusion velocity of oxygen in melted salt are very limited. Hence, oxygen supply mainly depends on decomposition of Na<sub>2</sub>SO<sub>4</sub>. This implies that SO<sub>3</sub> produced by the equation (1) further makes the following thermal equilibrium [10]:

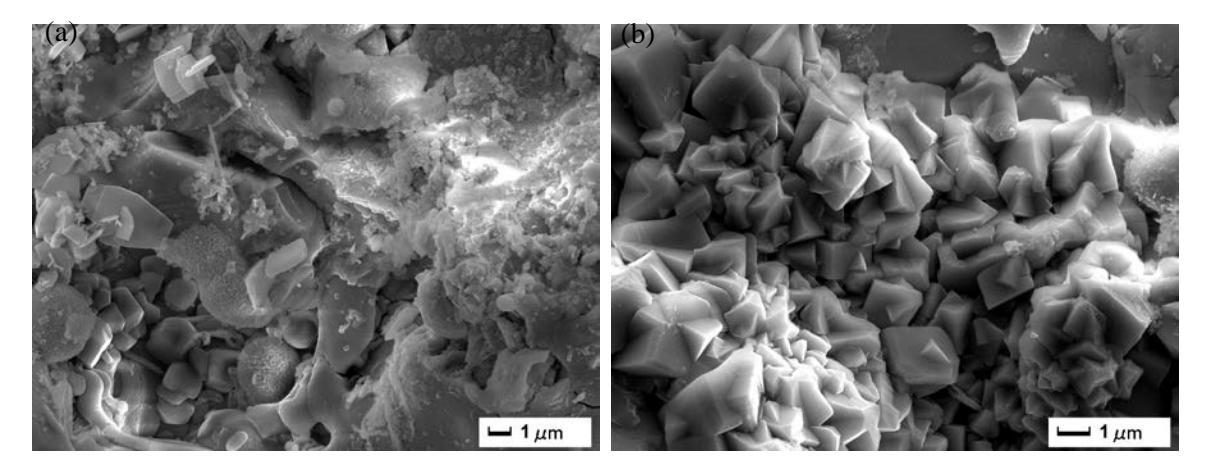
Some precipitated Ni(Co)Cr<sub>2</sub>O<sub>4</sub> spinels are recrystalized onto local surface of TBCs (figure 6(b)).

**Figure 6.** SEM images of corrosion surface of conventional TBC: (a) Stratified structure fracture and cavities on coating surfaces and (b) Spinel structure on coating surfaces.

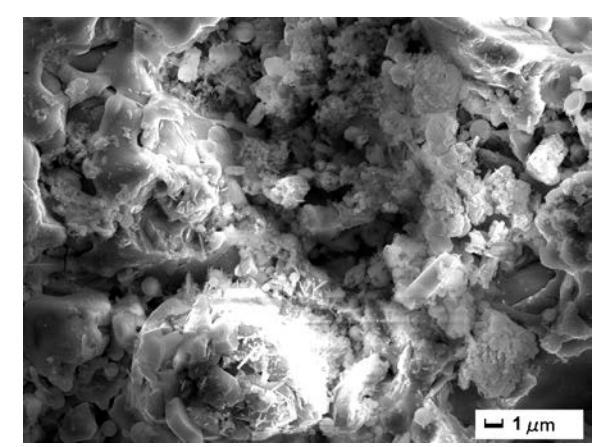
Nanostructured TBC surface after corrosion is shown in figure 7. Compared with the conventional TBC, the nanostructured TBC has broken stratified structure and fewer cavities, indicating the light degree of hot corrosion. Besides, no spinel structure similar with figure 6(b) is detected, indicating that the nanostructured TBC can protect the metal bonding layer during hot corrosion better. This is mainly because the high specific surface area and strong activity of nano-powder aggregate make it easier to

Figure 7. SEM image of nanostructured TBC after hot corrosion.

be heated and melted during plasma spraying. The powder surface is melted well and deformed significantly upon impact onto the base or deposited surface. The pavement performance of nano-powder aggregate is significantly better than that of conventional powder, resulting in the lower porosity and higher density. These are conducive to decrease penetration of corrosion solution during hot corrosion, that is, reducing corrosion and protecting metal bonding layer and base effectively.
